AC & E HOME INSPECTION CORP.

CONCLUSION

Cold Spring Harbor NY
09/21/2011

DESCRIPTION OF HOUSE: Manor house

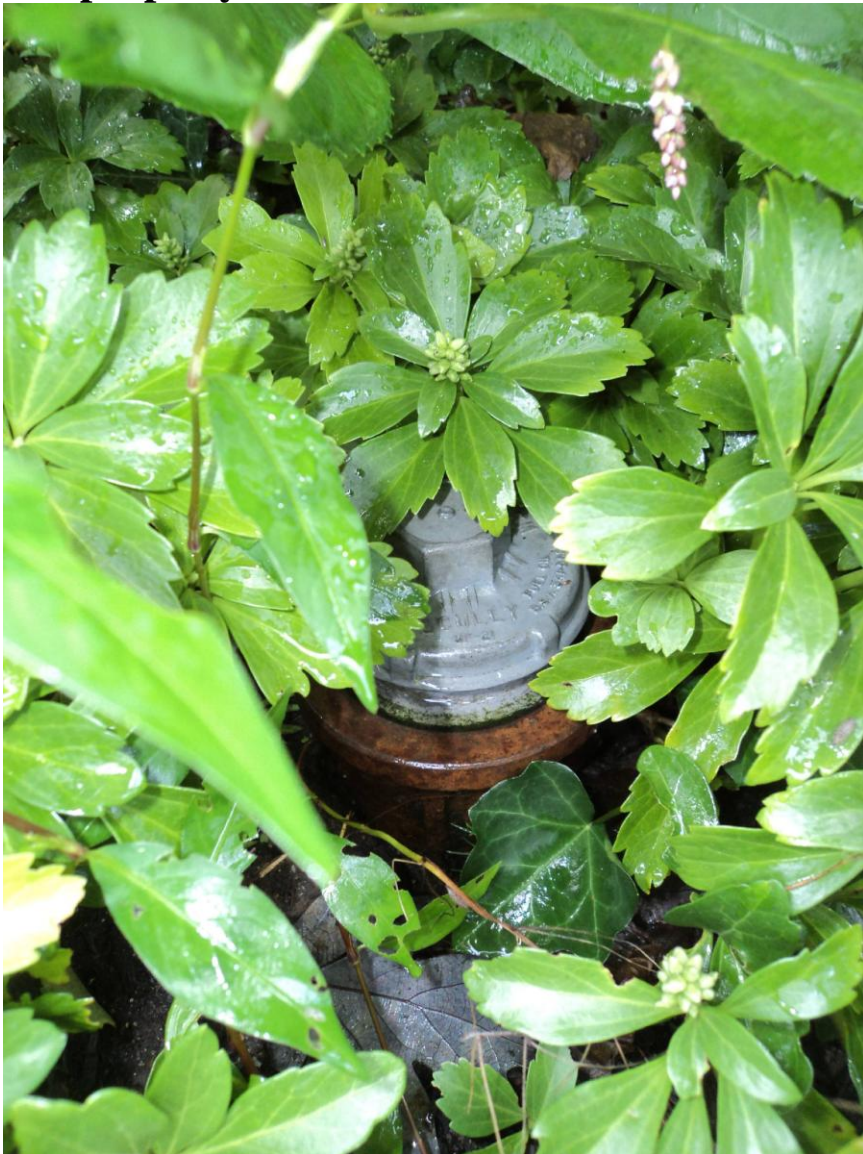
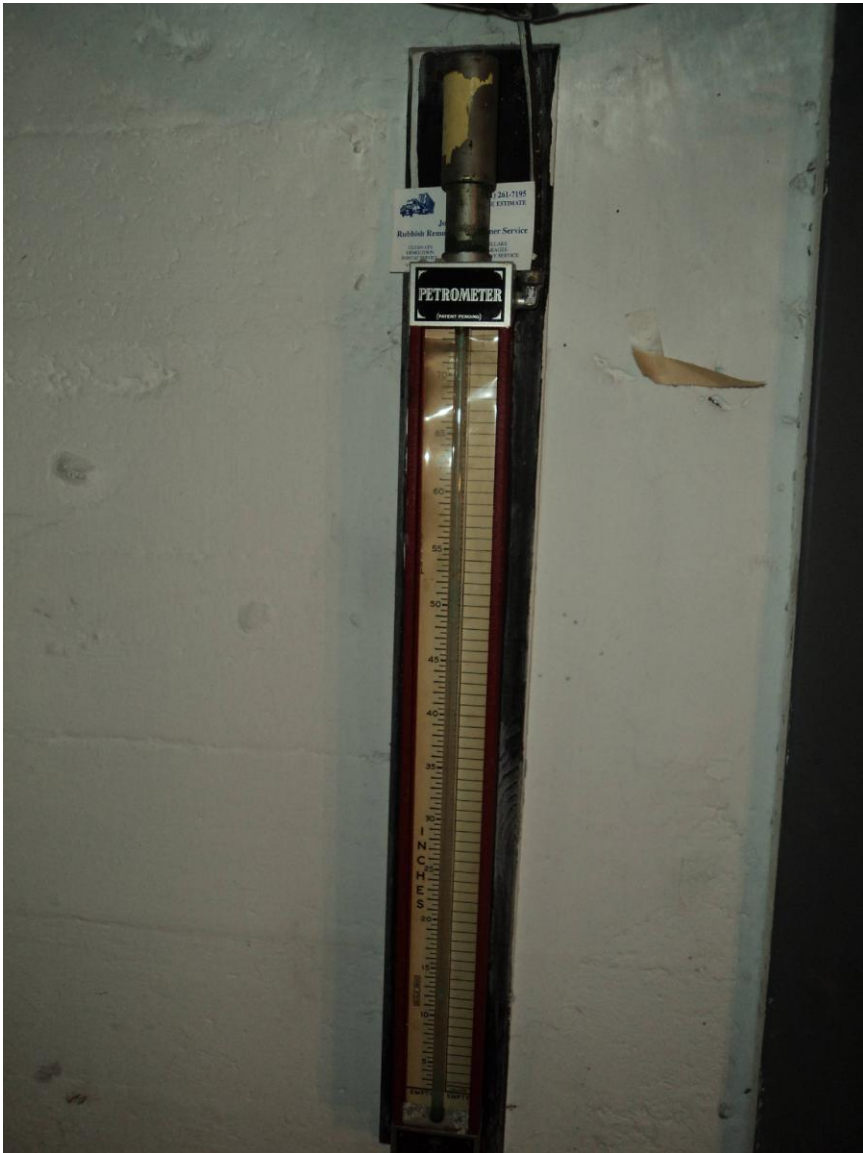
At the time of the inspection there was an inground xxx gallon oil/gas tank at xx years of age. It is our highest recommendation to accomplish a leak check at this time due to possible contamination to the soil. Often times the owner would rather abandon the tank in place than test, but this would not tell you whether or not the tank is leaking. Past oil bills can possibly determine whether or not there is a large leak in the tank, but would not pick up a small leak. Soil and/or tank testing is the only way you can be sure you do not have an environmental problem. If needed, at AC&E we can accomplish an EPA approved, NON-pressure test and/or soil testing. Please see the enclosed literature on in-ground tanks. Recommend checking to see if this is the only tank that has ever been on this property.

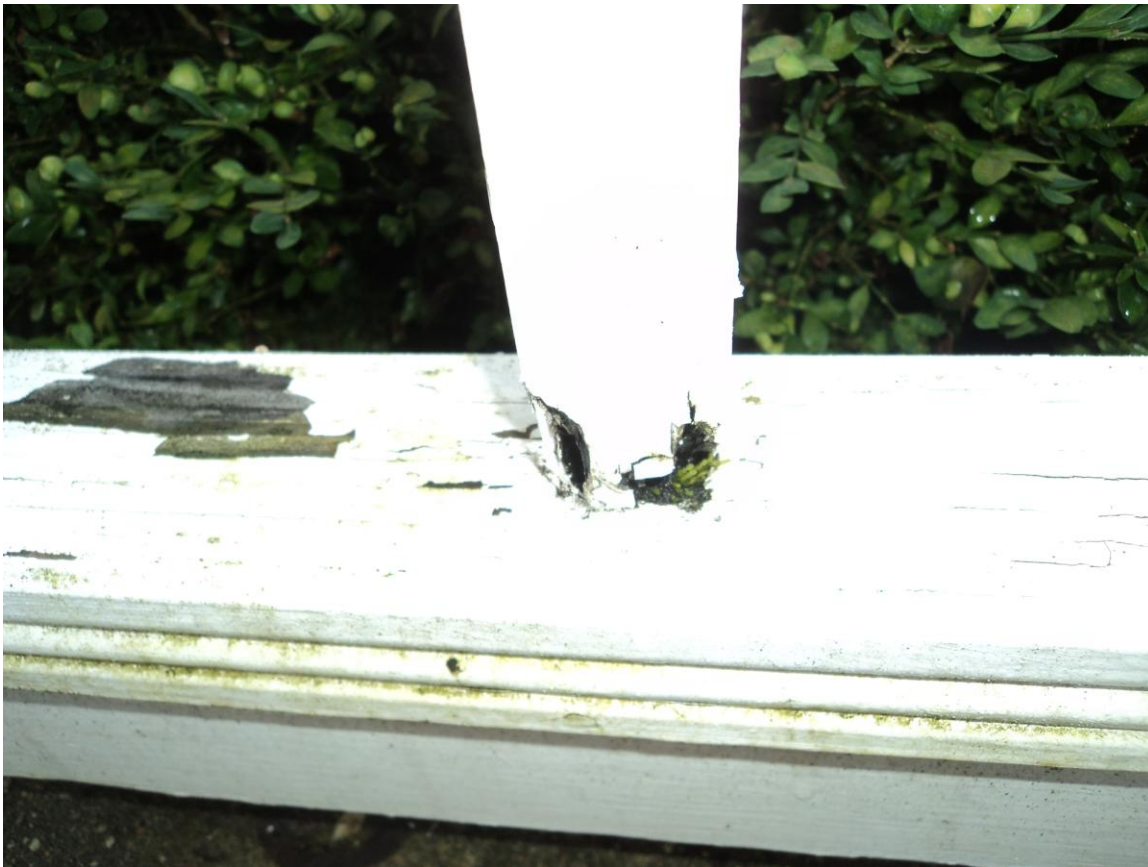
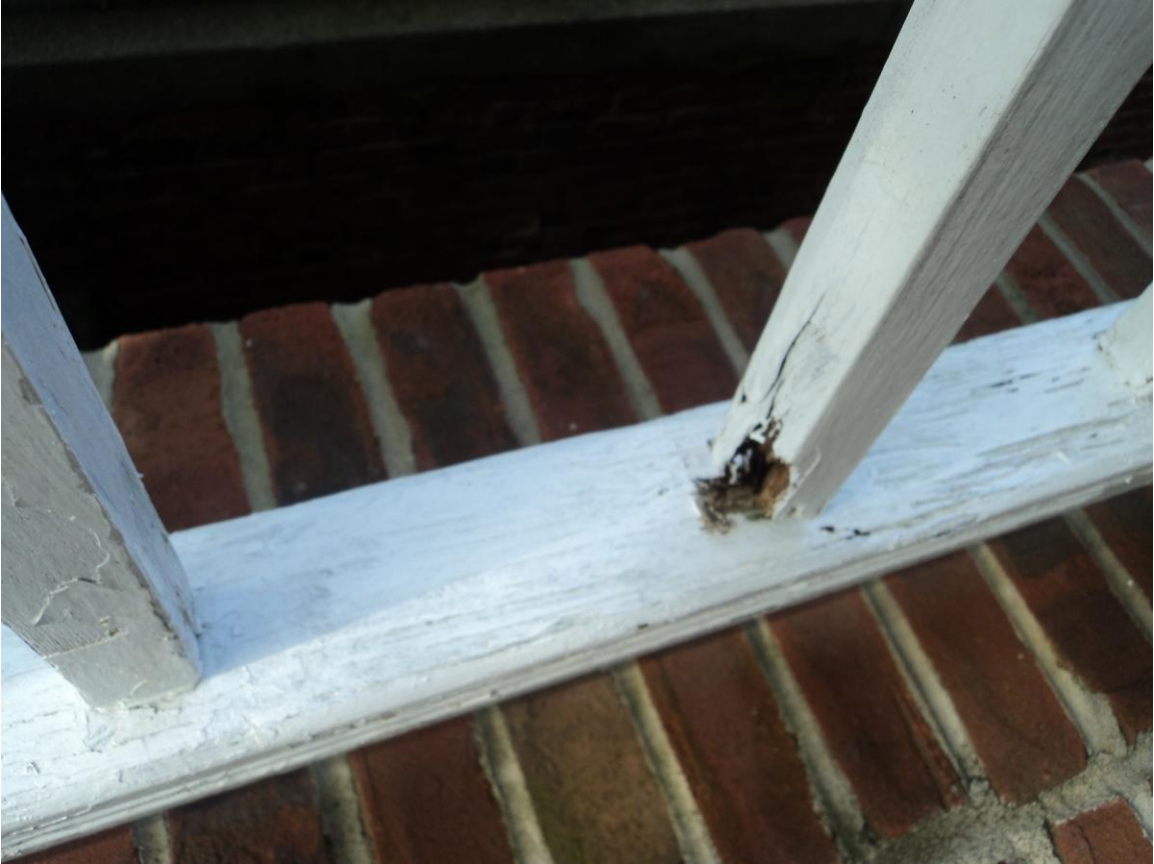
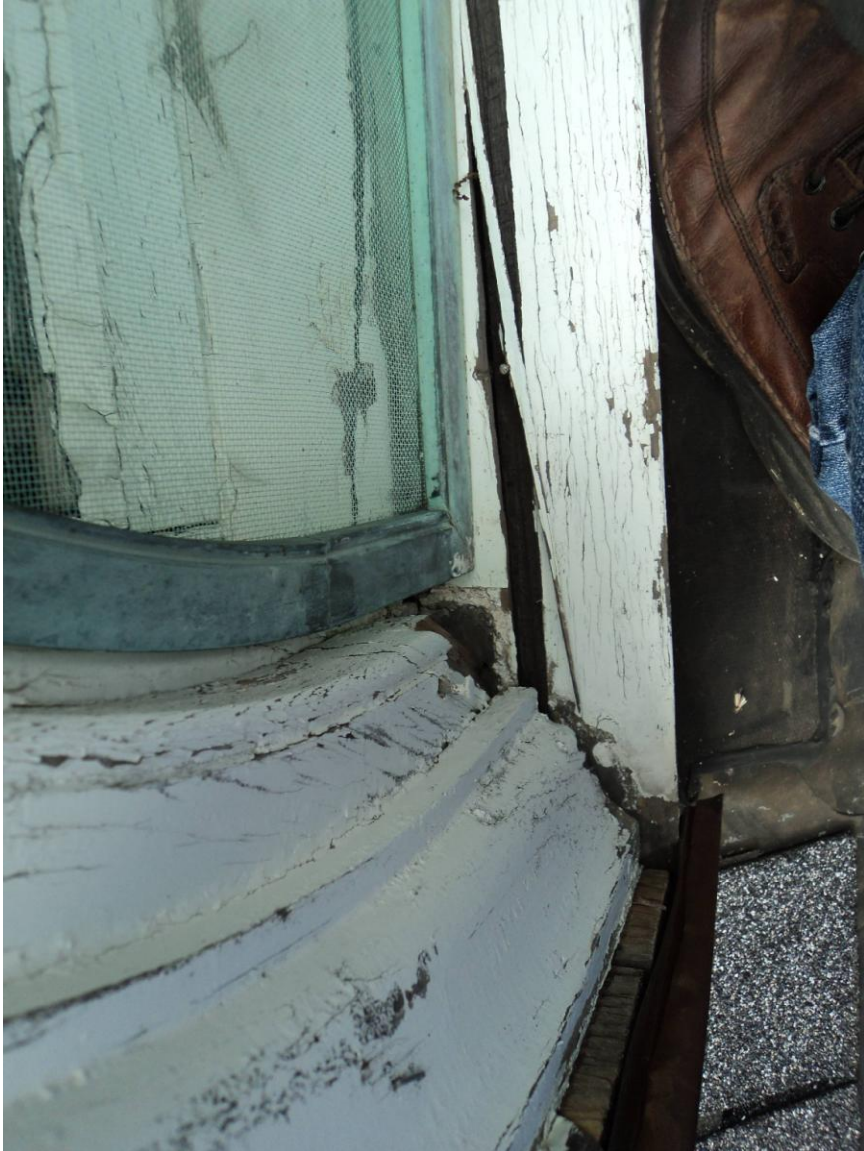
Some wood rot was observed in exterior wood pieces (i.e. wood rails on the far left side of the house for the patio and basement steps as well as the attic window on the far left side of the house near the air condition units etc.). I recommend that all affected wood pieces be replaced.

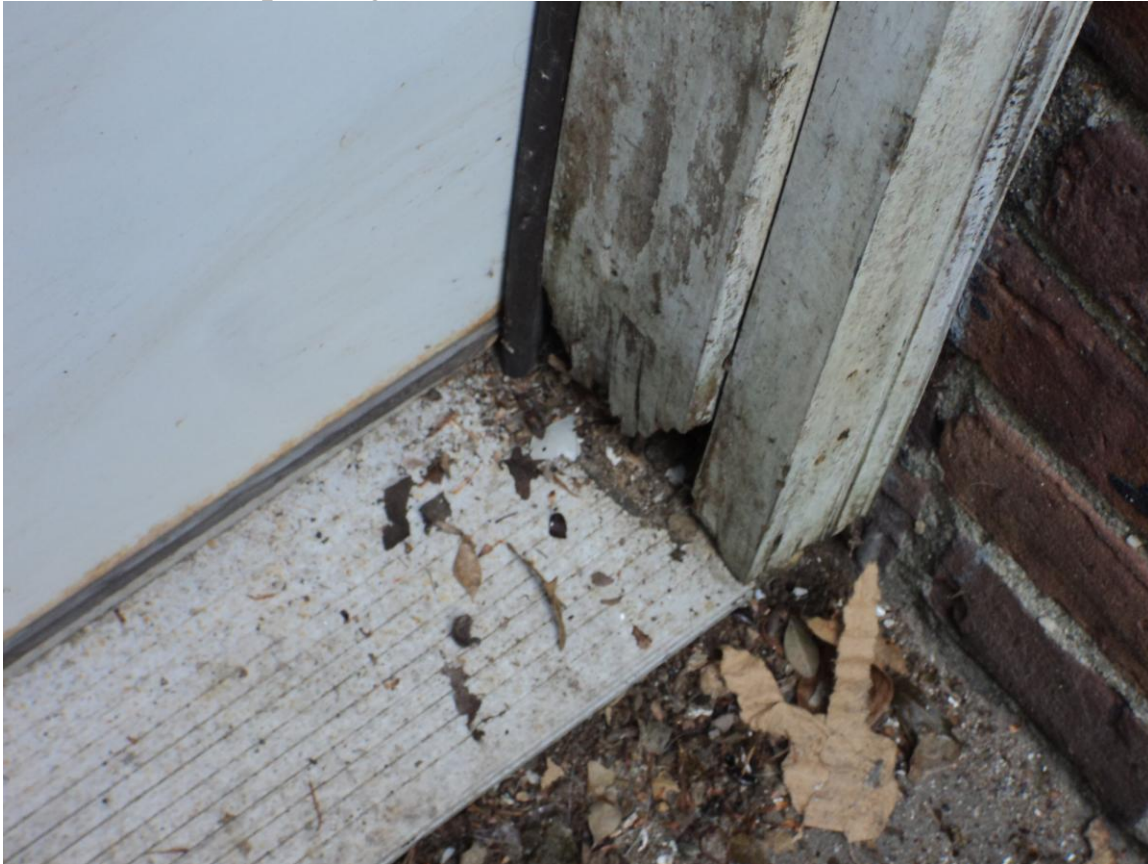
Recommend replacing the rotted wood at the base of the basement entrance door.

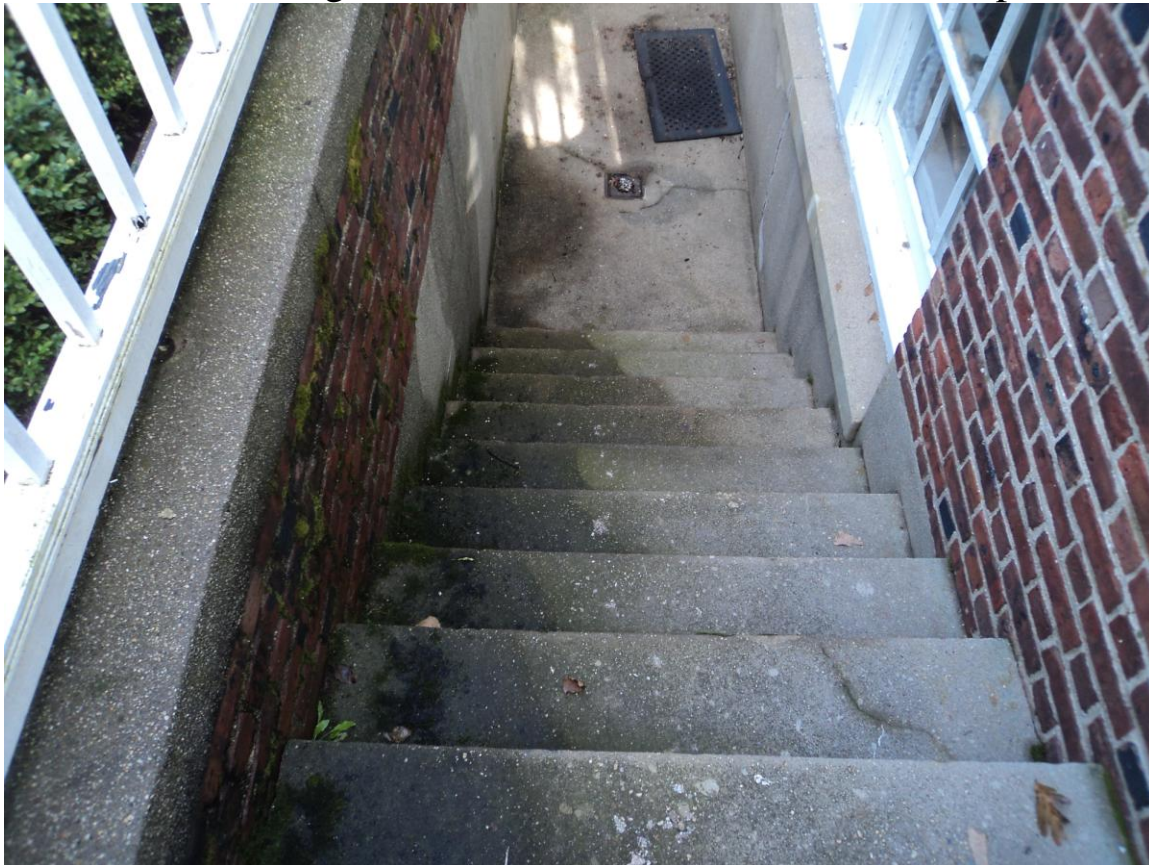
Recommend adding a handrail to the outside basement steps.

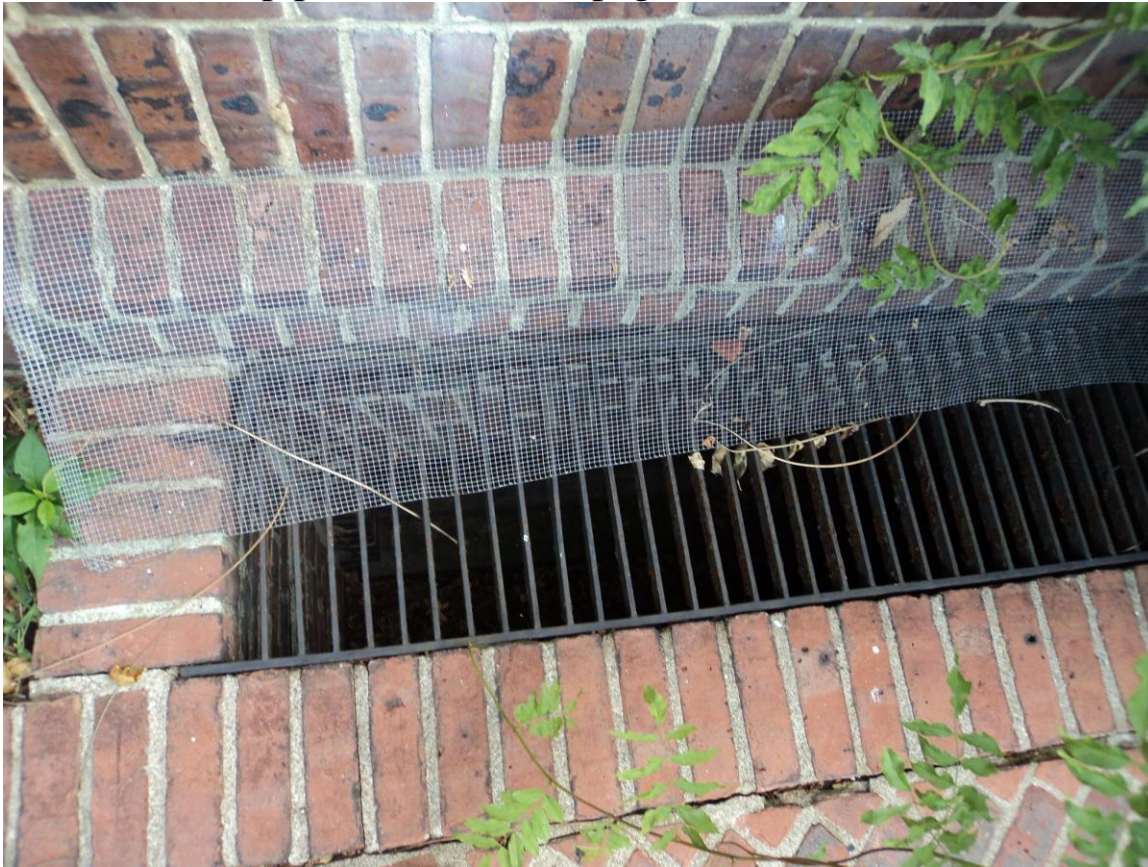
Recommend adding window well covers to the basement windows and digging out the wells to help prevent water seepage in this location.

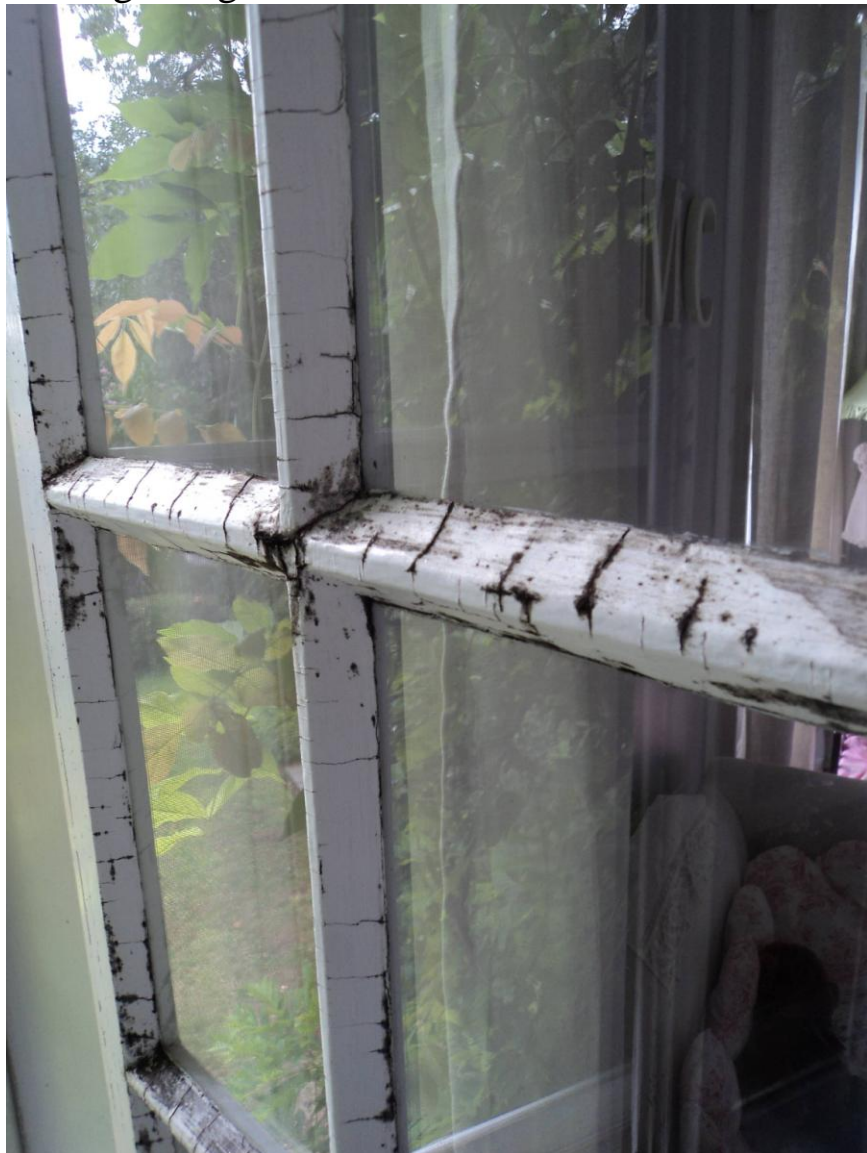
Worn glazing was noted on some of the windows in the house.

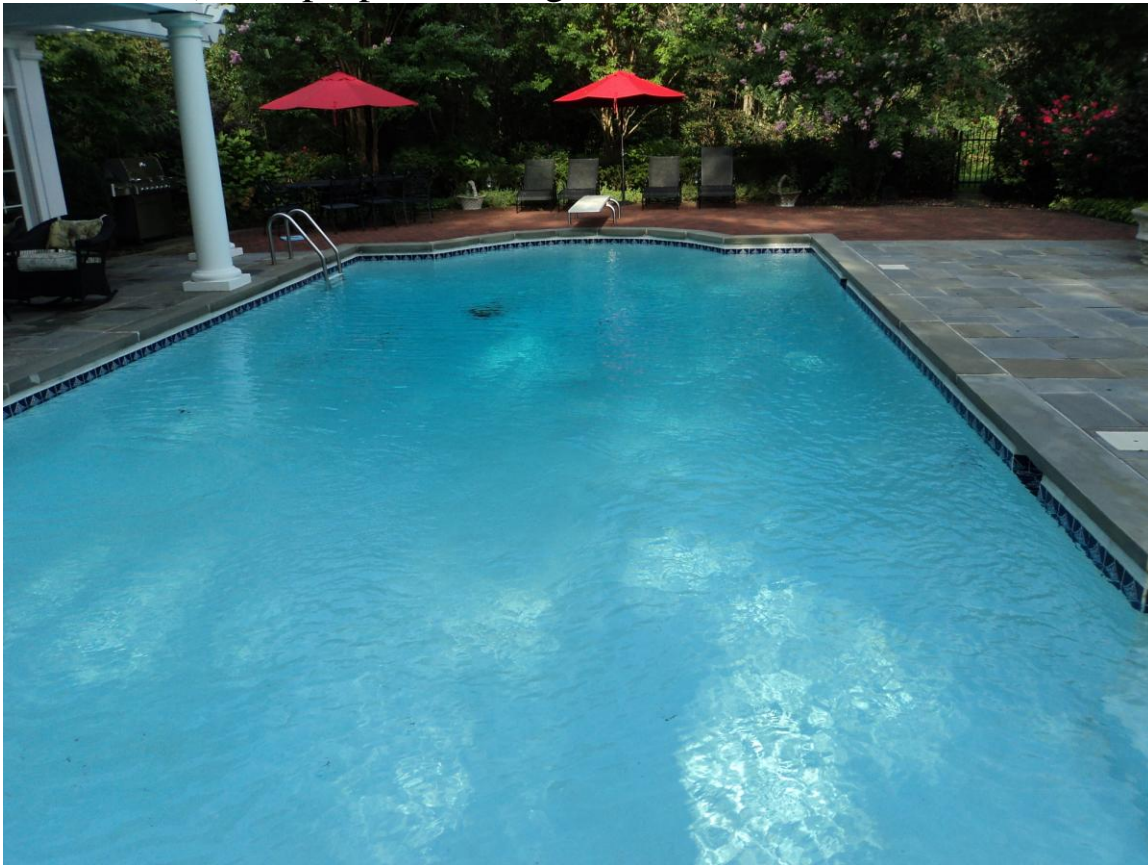
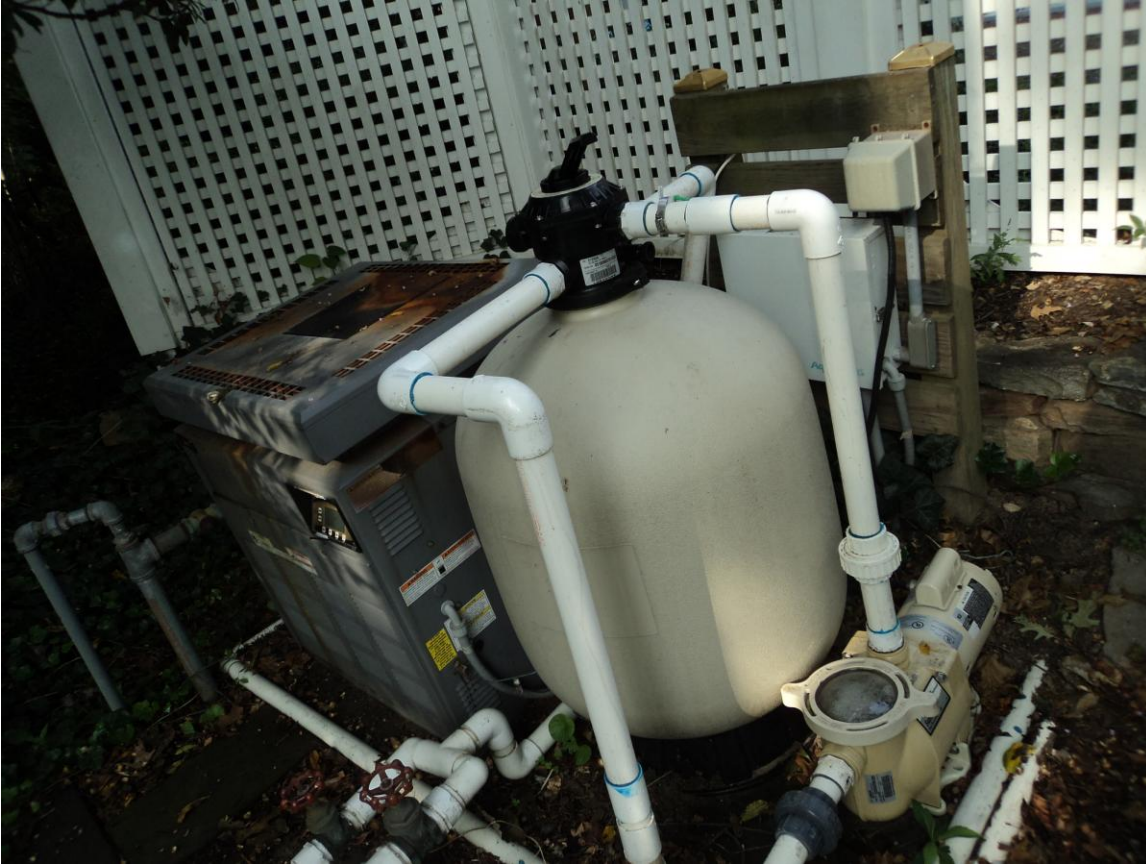
An in-ground pool is present in the rear yard. On day of inspection, the pool was running. Recommend the current homeowner verify that the pool (i.e., filter, pumps, heaters etc.) is in proper working order and free of leaks.

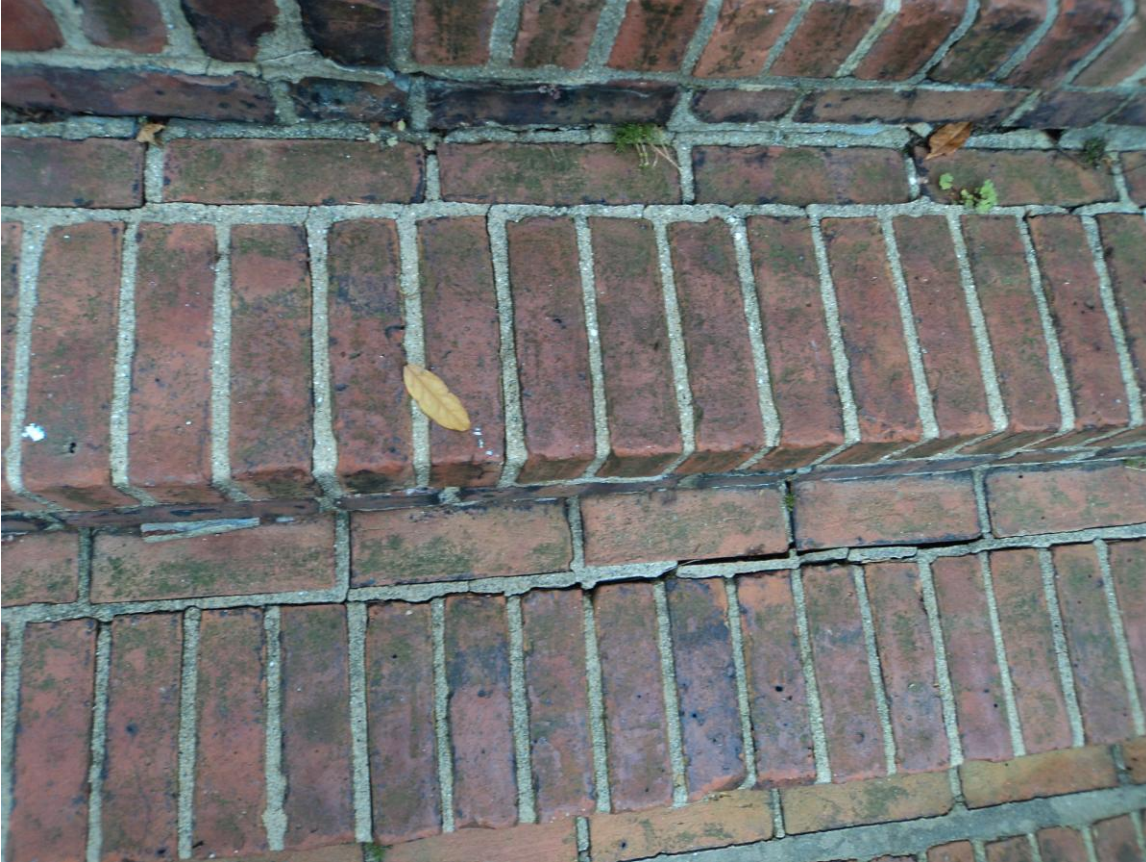
Recommend having a mason re-point the brick work on the brick patio on the far right side of the house.

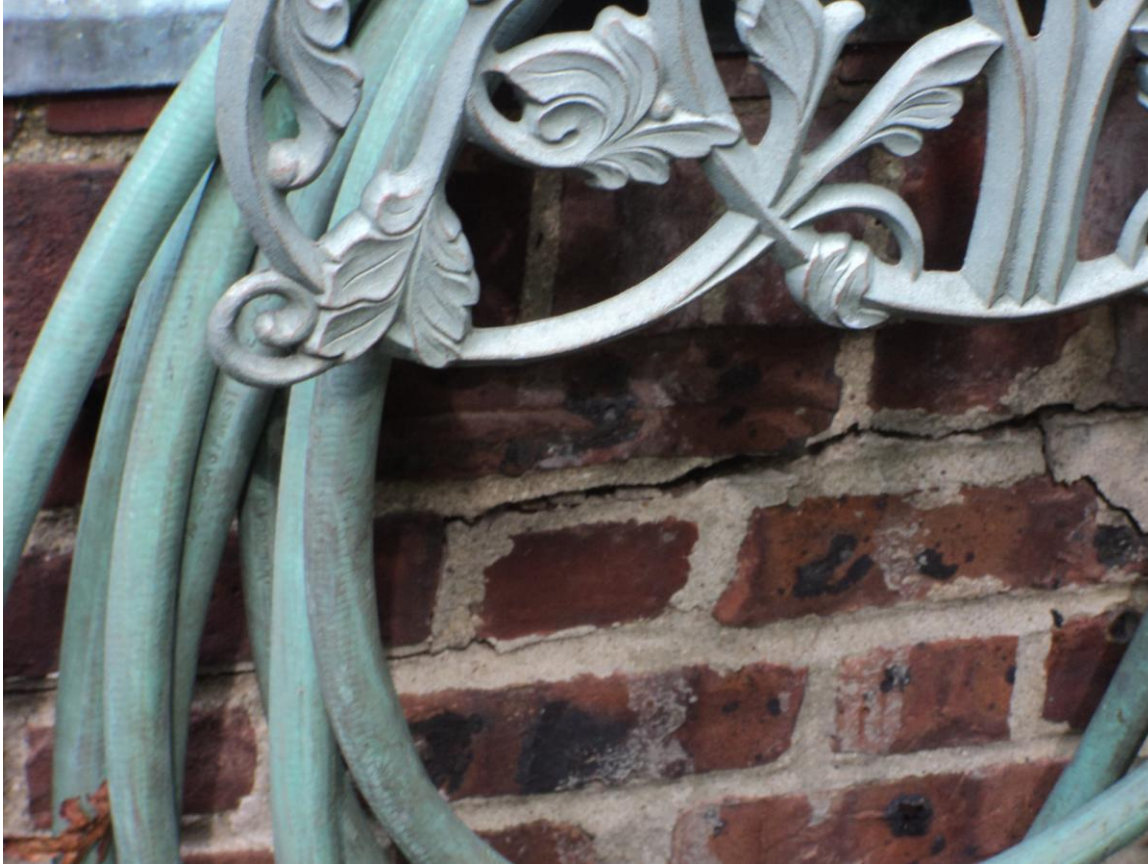
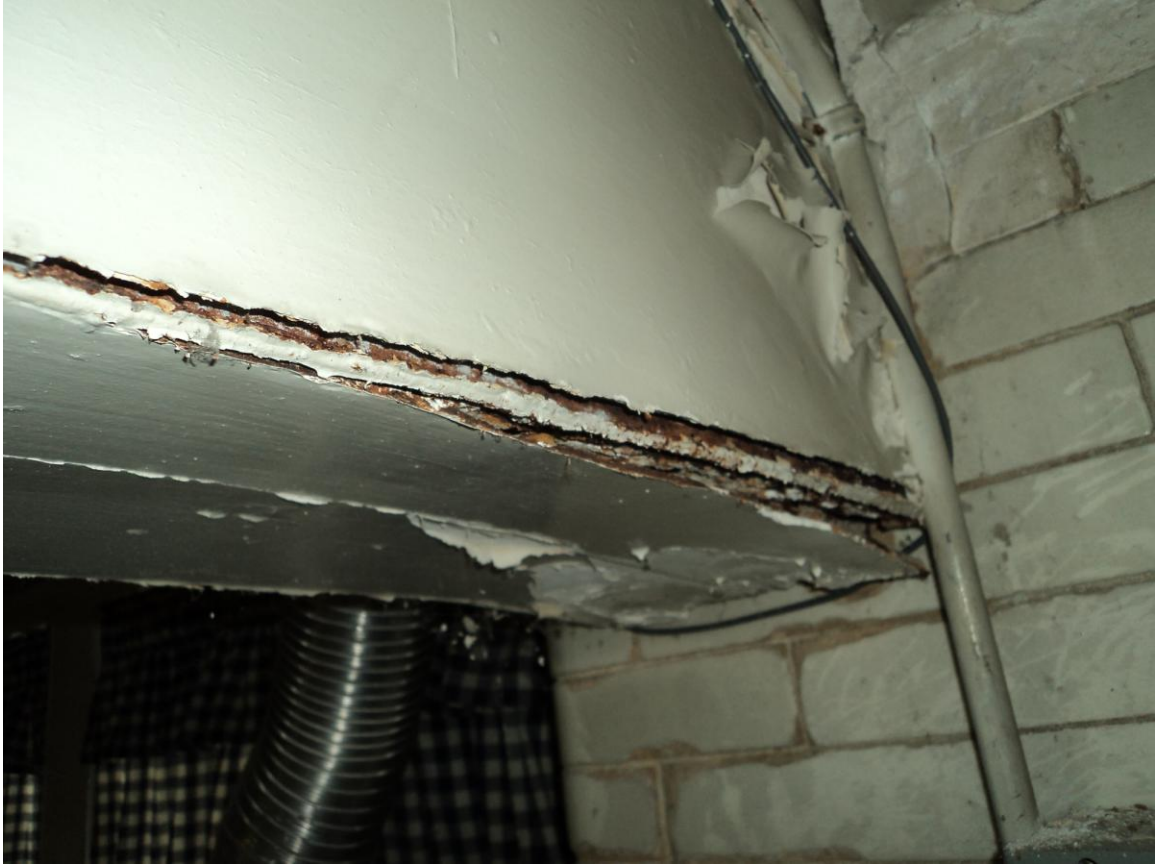
Recommend re-pointing the brick work around the patio on the far left side. There was also water seepage into the basement in this location and the ceiling needs to be opened for a further investigation in this area due to water damage to the main header in this location of the laundry room below.

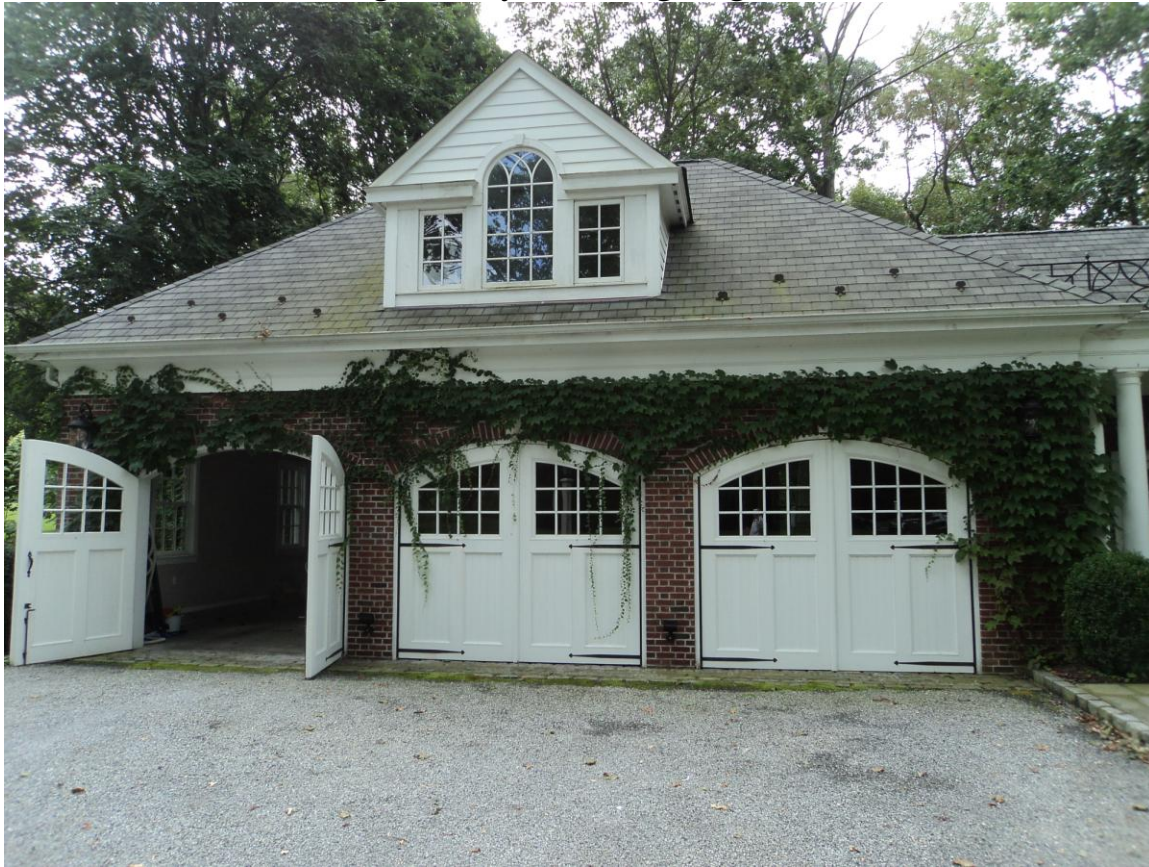
Recommend removing the ivy off the garage at this time.

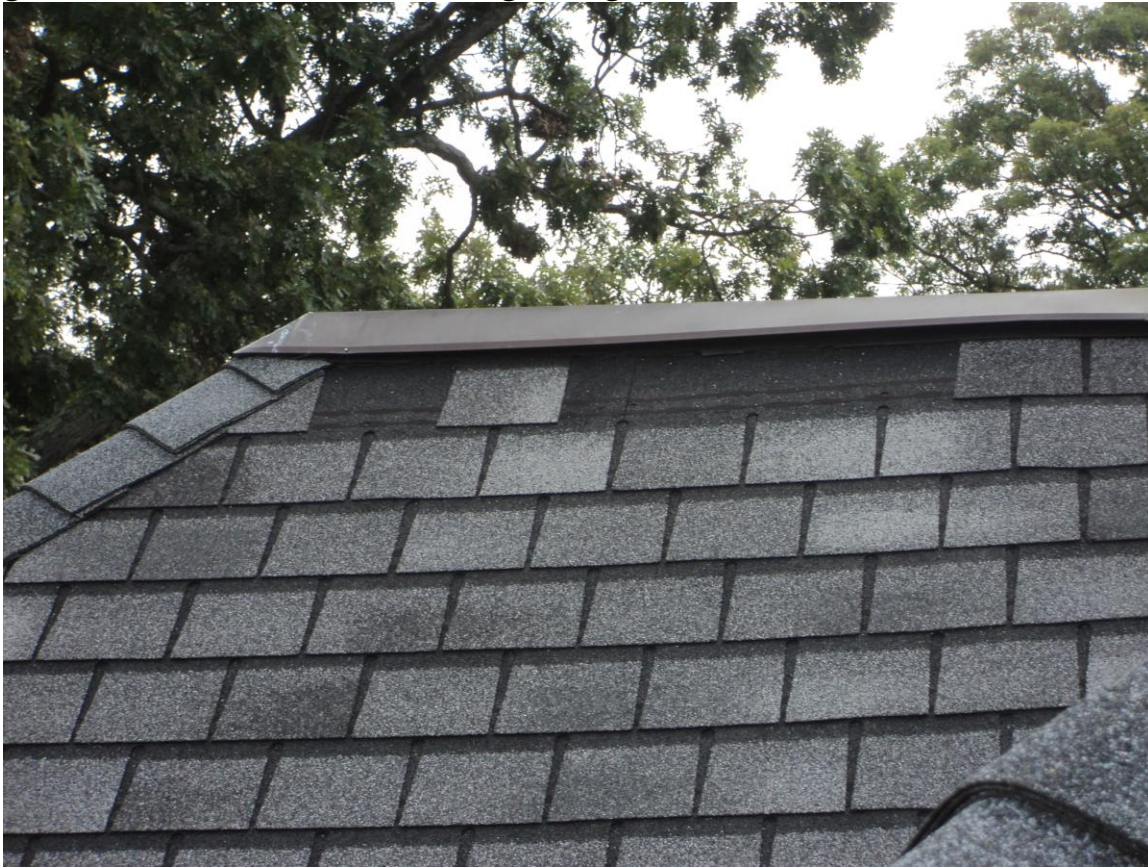
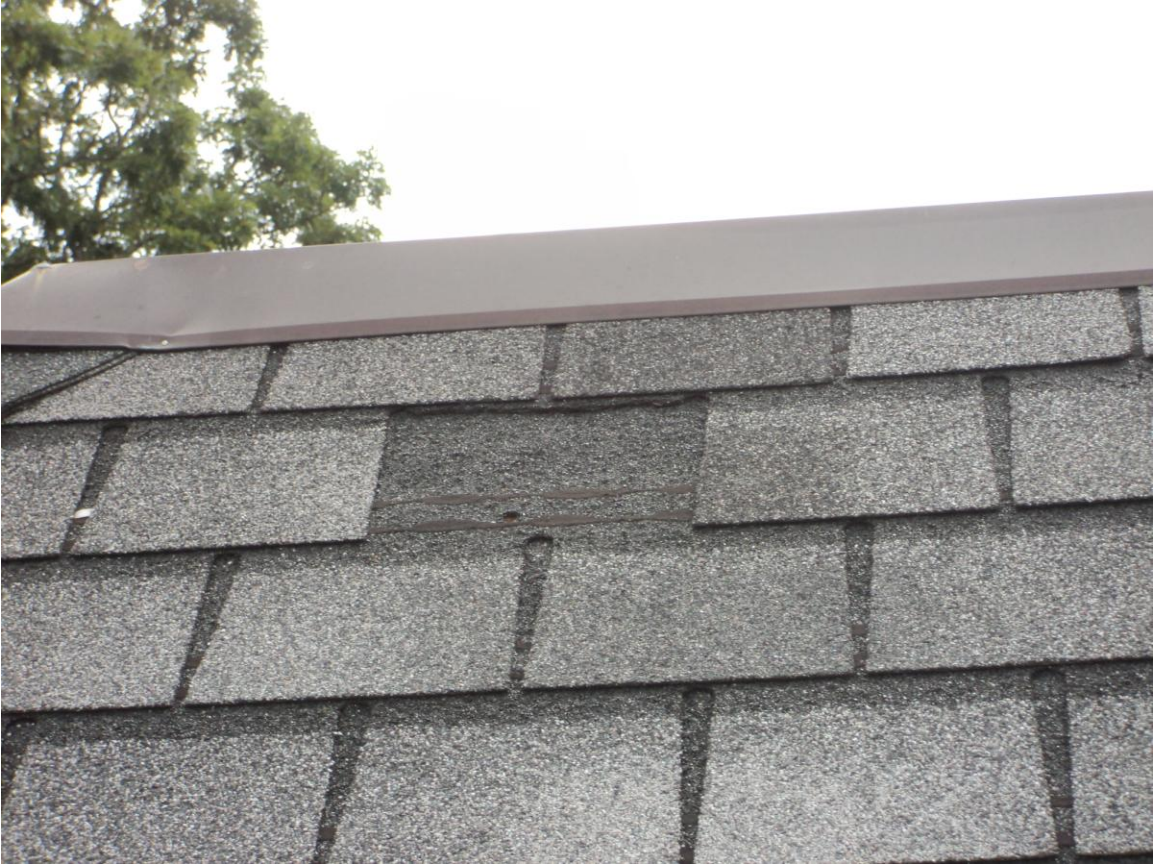
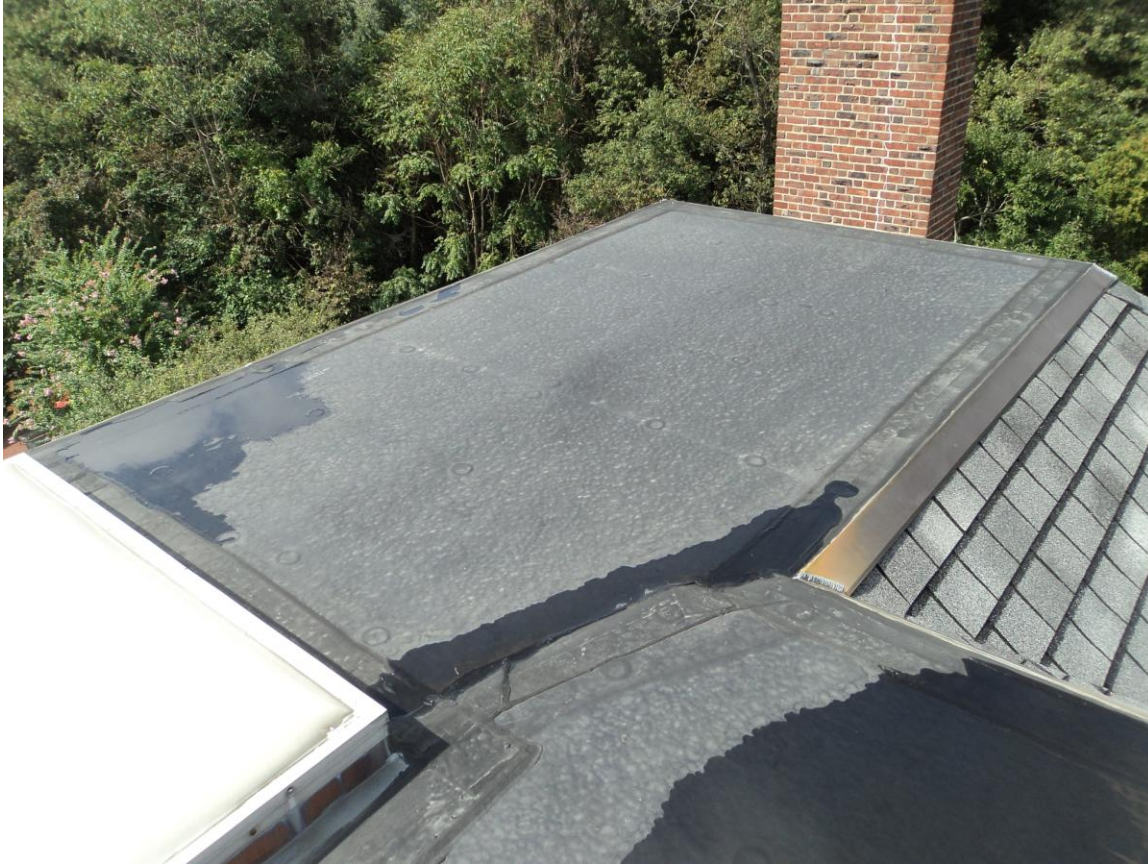
ROOF: The house had 4 different types of roofs. The main roof was an asphalt shingle roof that was under 10 years of age and a rolled rubber roof. This roof was in good condition with 4 missing shingle noted.

Recommend replacing the missing shingles on the upper roof at this time.

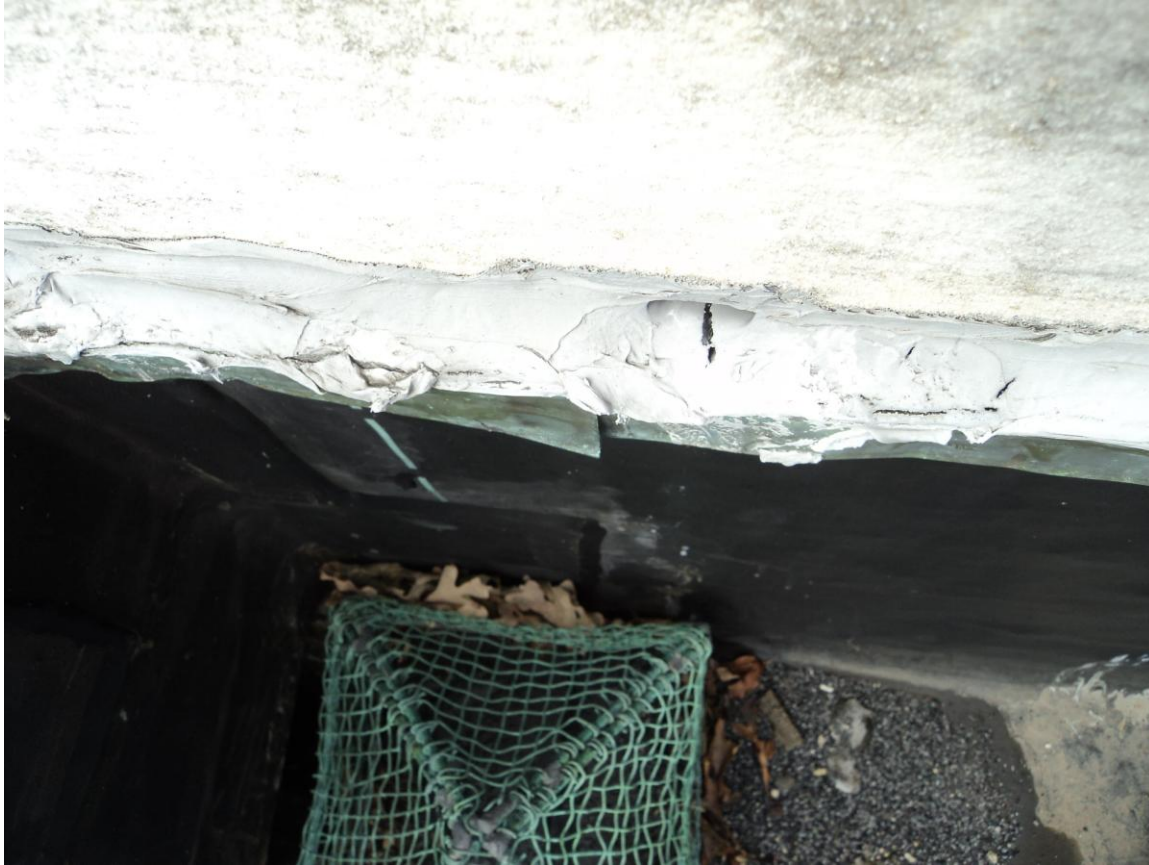
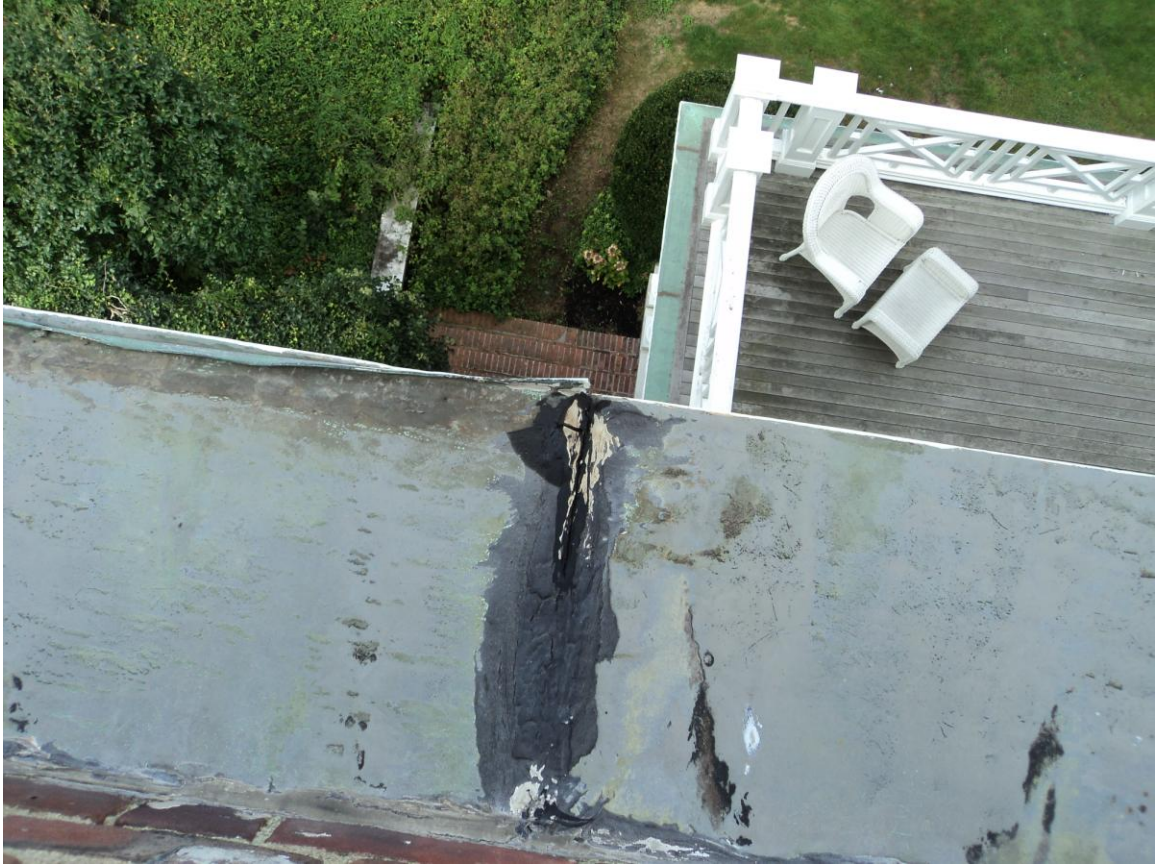
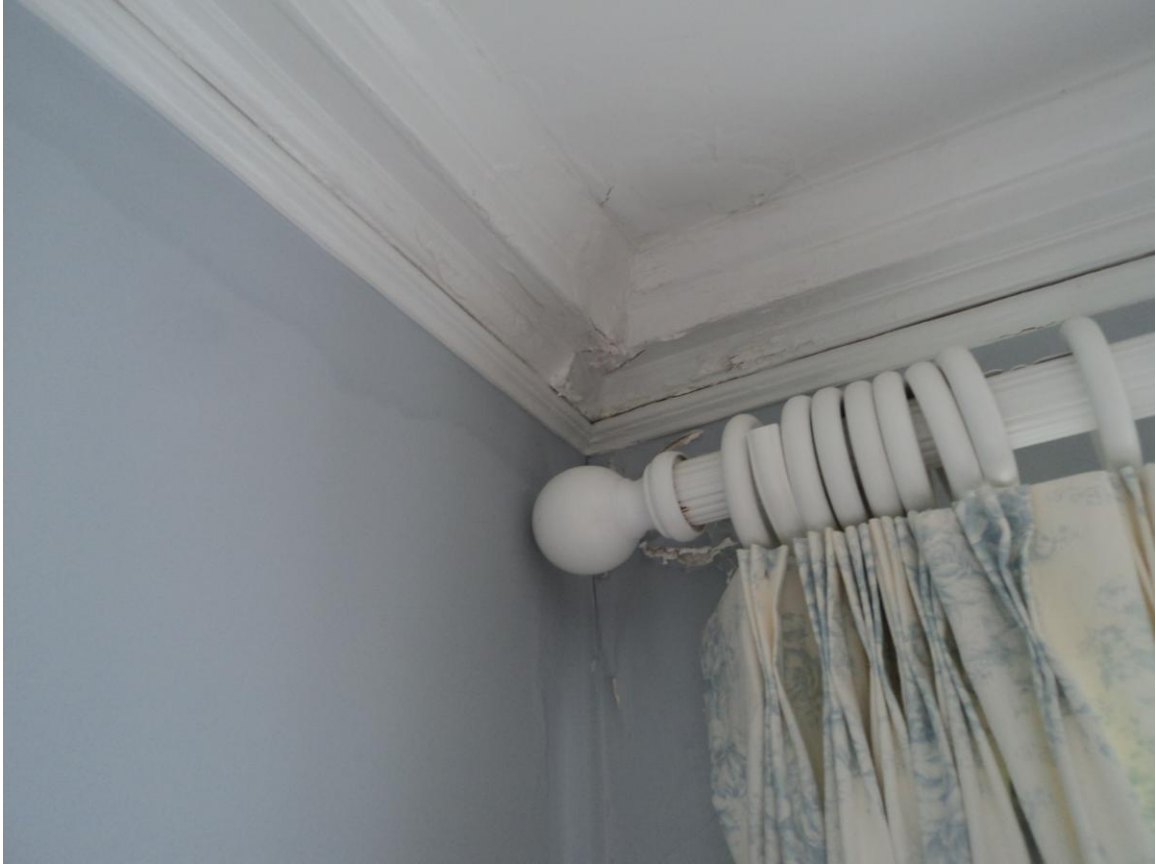
Recommend having the flashing repaired around the upper roof at this time. As there was some gaps noted and past leaks noted in the back right bedroom on the 3rd floor far left corner.

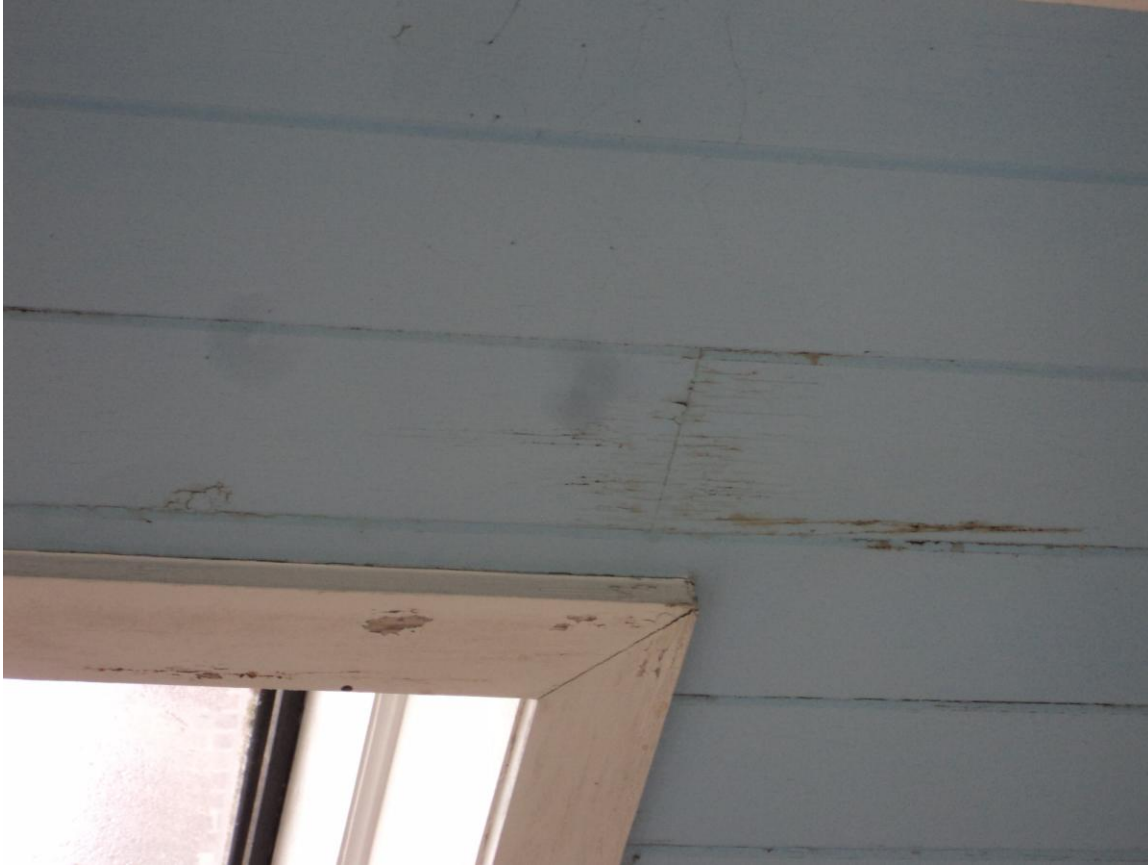
There was also a rolled roof over the porch on the far left side of the house. This roof appears to be leaking at this time as there was water stains noted below this area. Recommend having this roof repaired at this time.
