AC & E HOME INSPECTION CORP.

CONCLUSION

Cold Spring Harbor NY
09/21/2011

DESCRIPTION OF HOUSE: Manor house

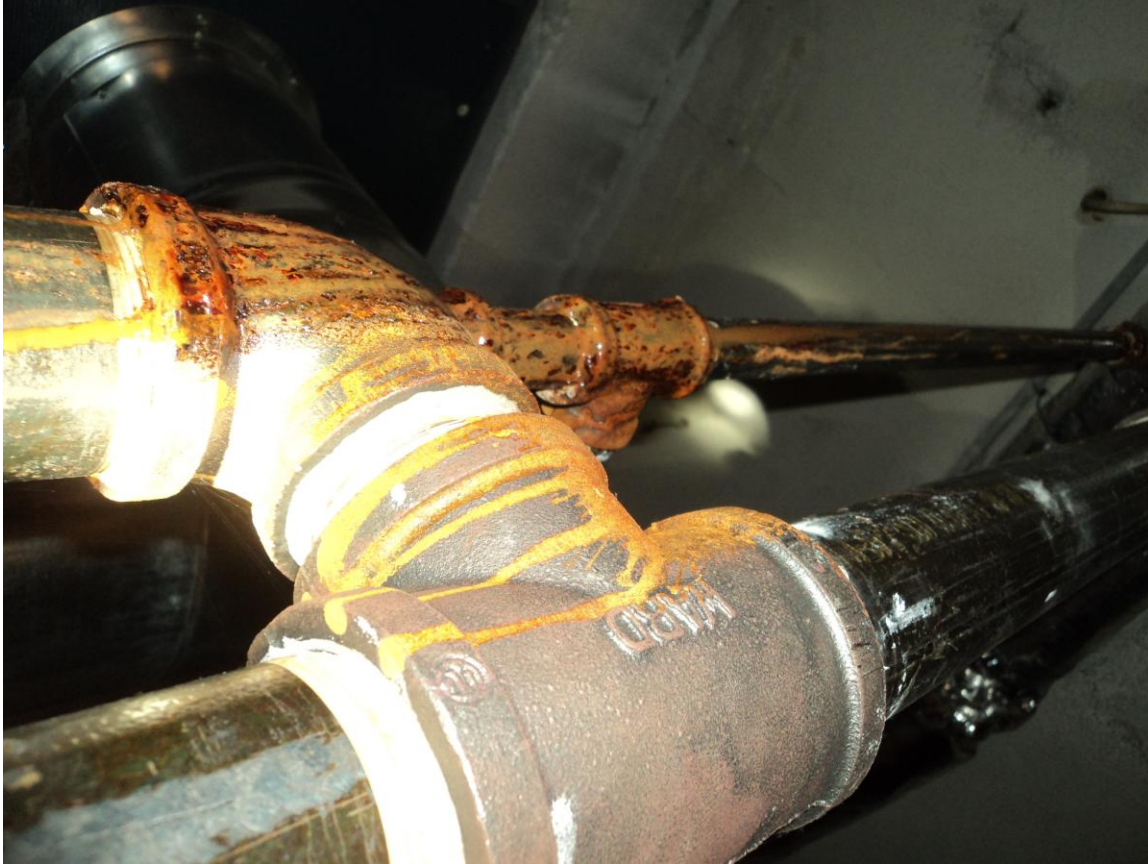
At the time of the inspection there was a water leak on the boiler piping in the rear of the system. Recommend having this leak repaired at this time.

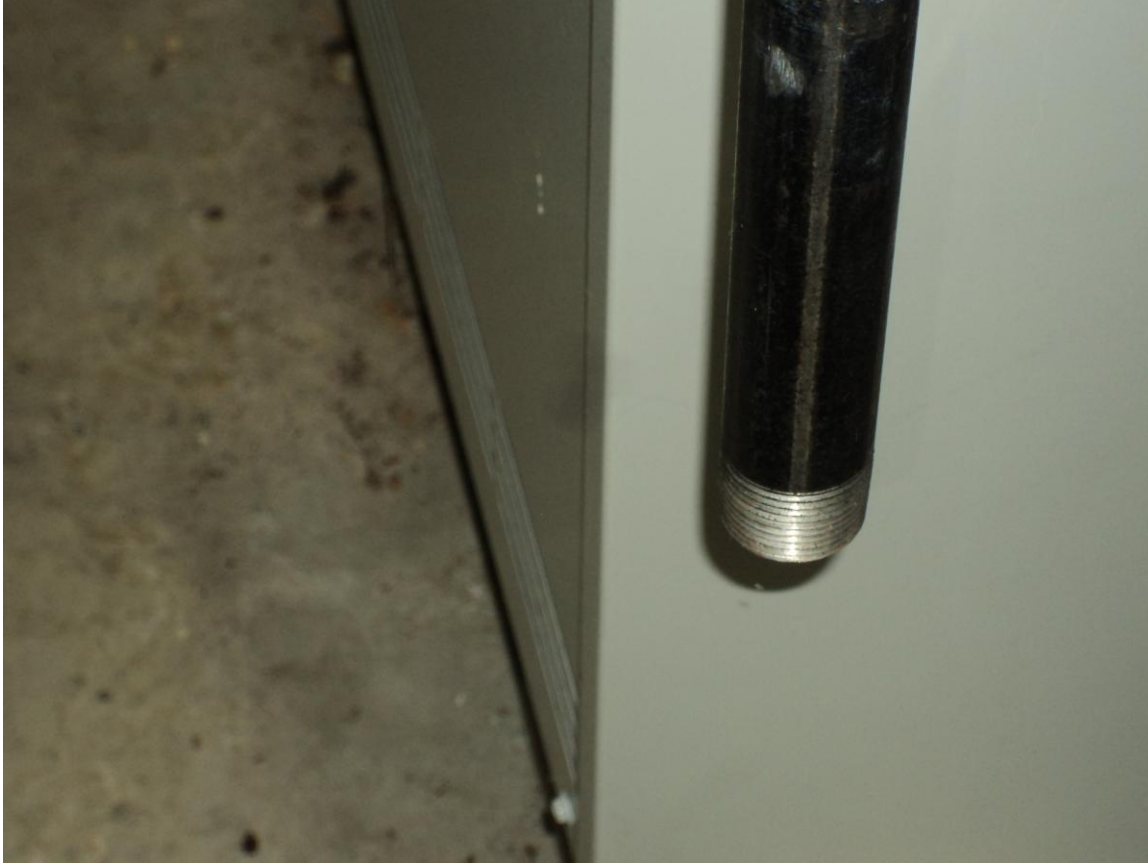
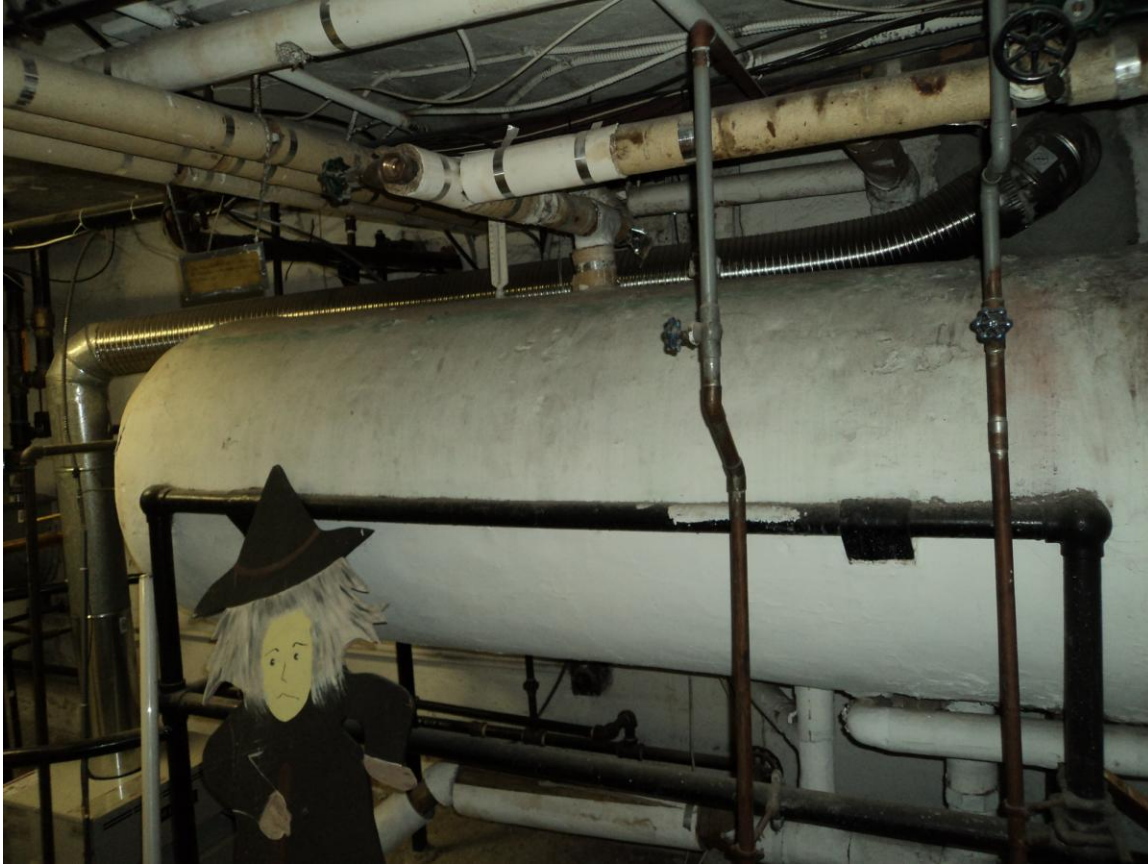
Recommend having the over pressure relief valve on the hot water boiler properly piped at this time as the pipe should have no threads at the discharge.

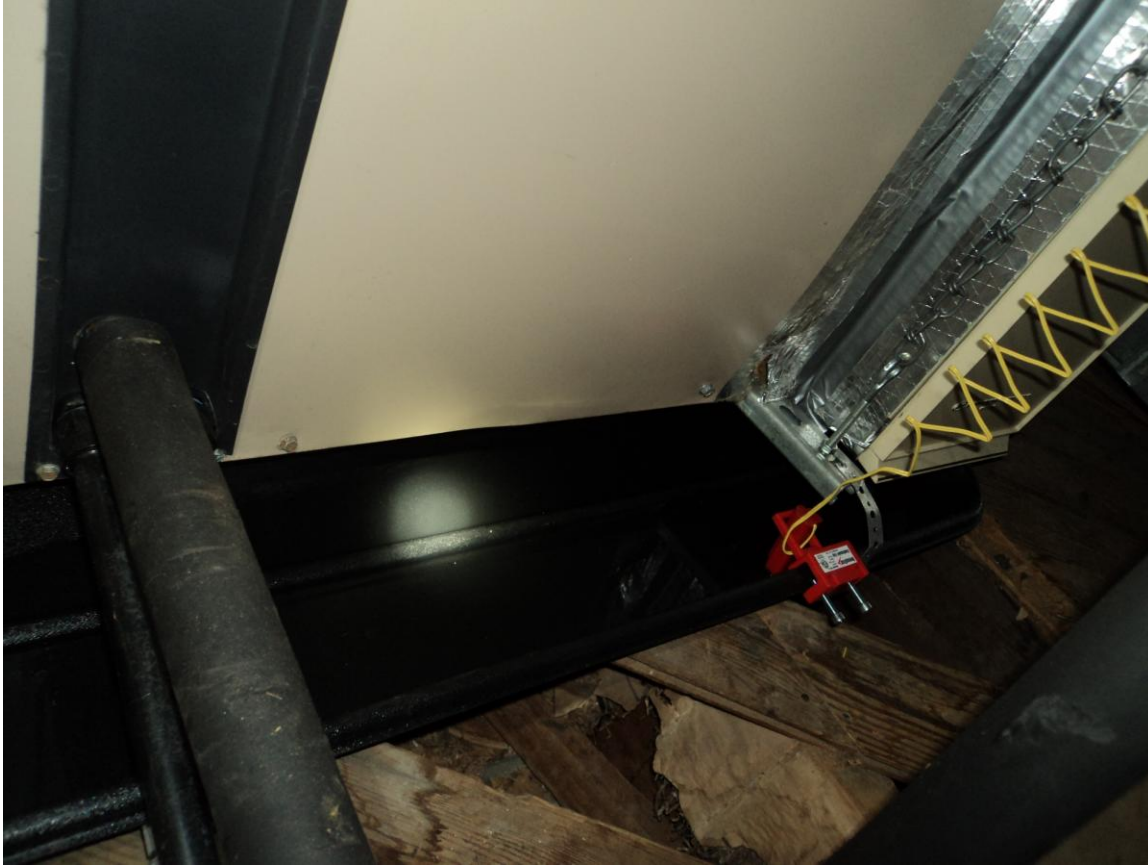
At the time of the inspection there was a problem with one air handler in the 4th floor front left attic. Water was noted in the emergency over flow pan. No water should be in this pan. Recommend having the system repaired or replaced at this time.

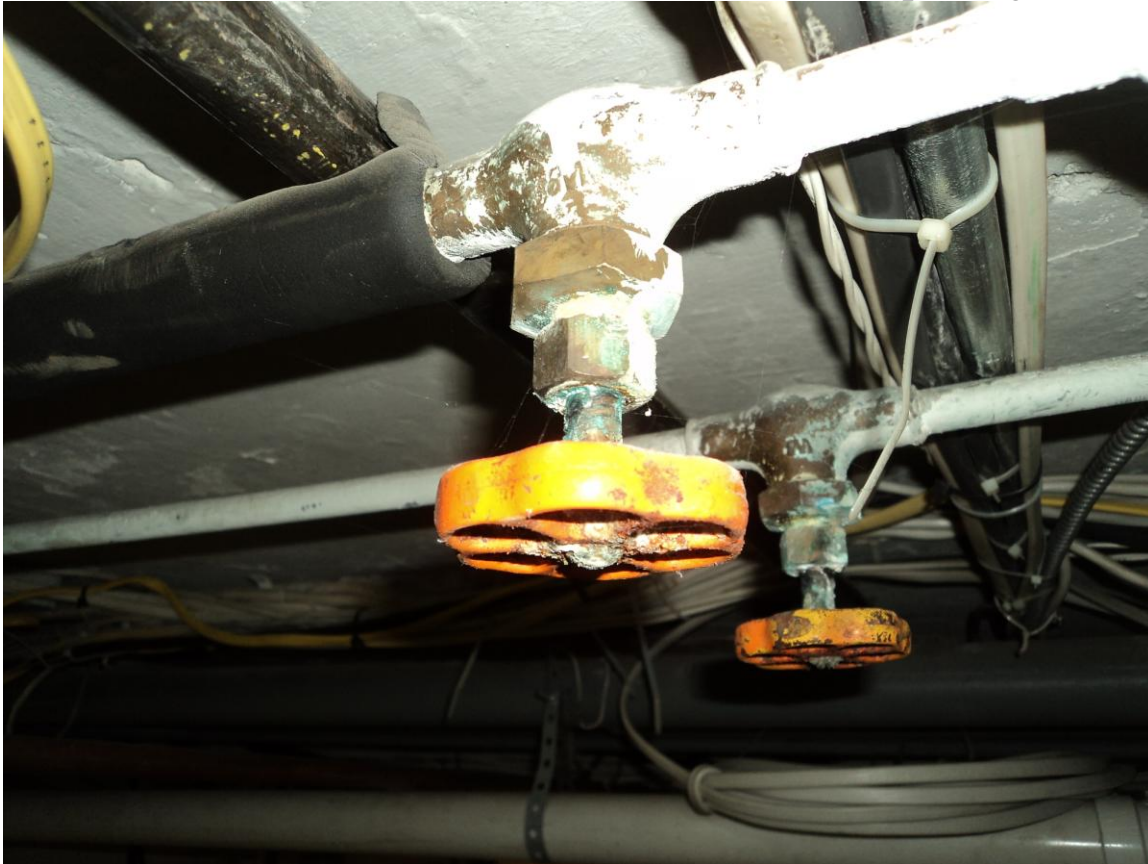
Several copper pipes and valves were observed to have surface corrosion and should not be handled or a leak could occur. Recommend replacing all old valves.

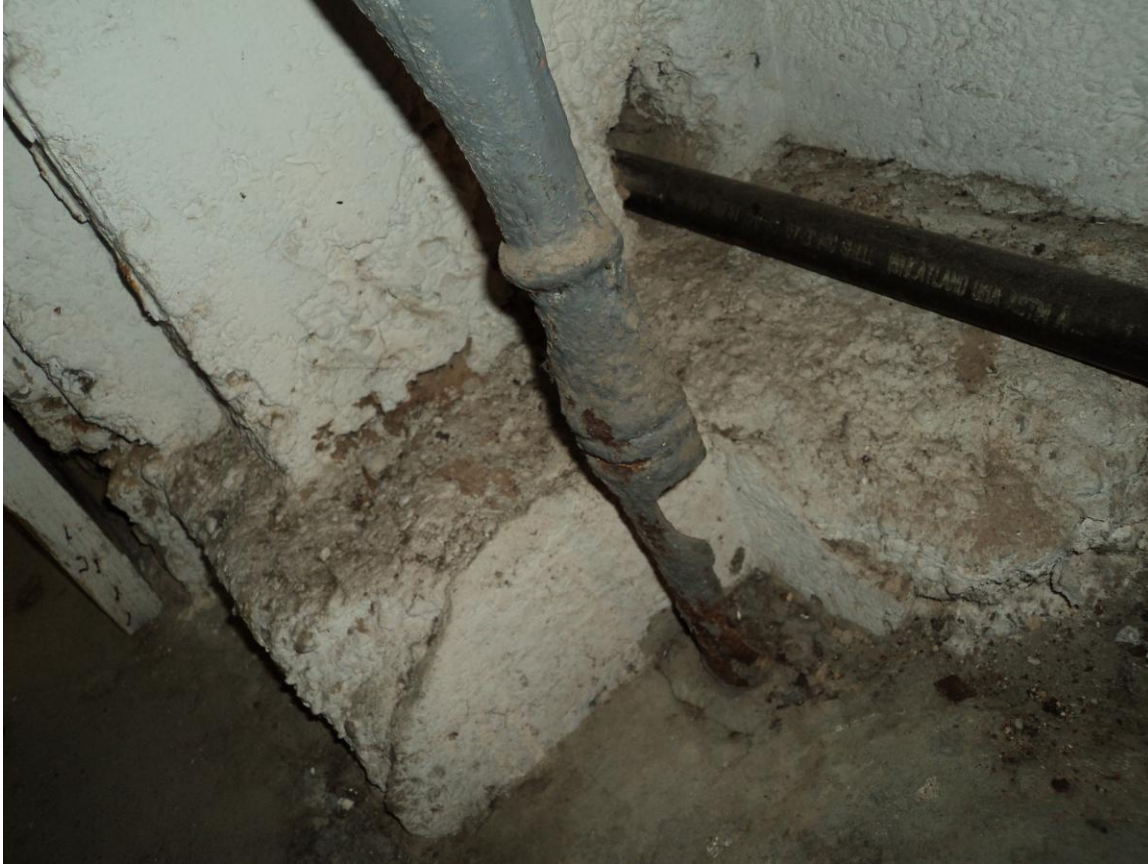
Recommend replacing the slop sink in the basement that had a rotted out leg at this time.

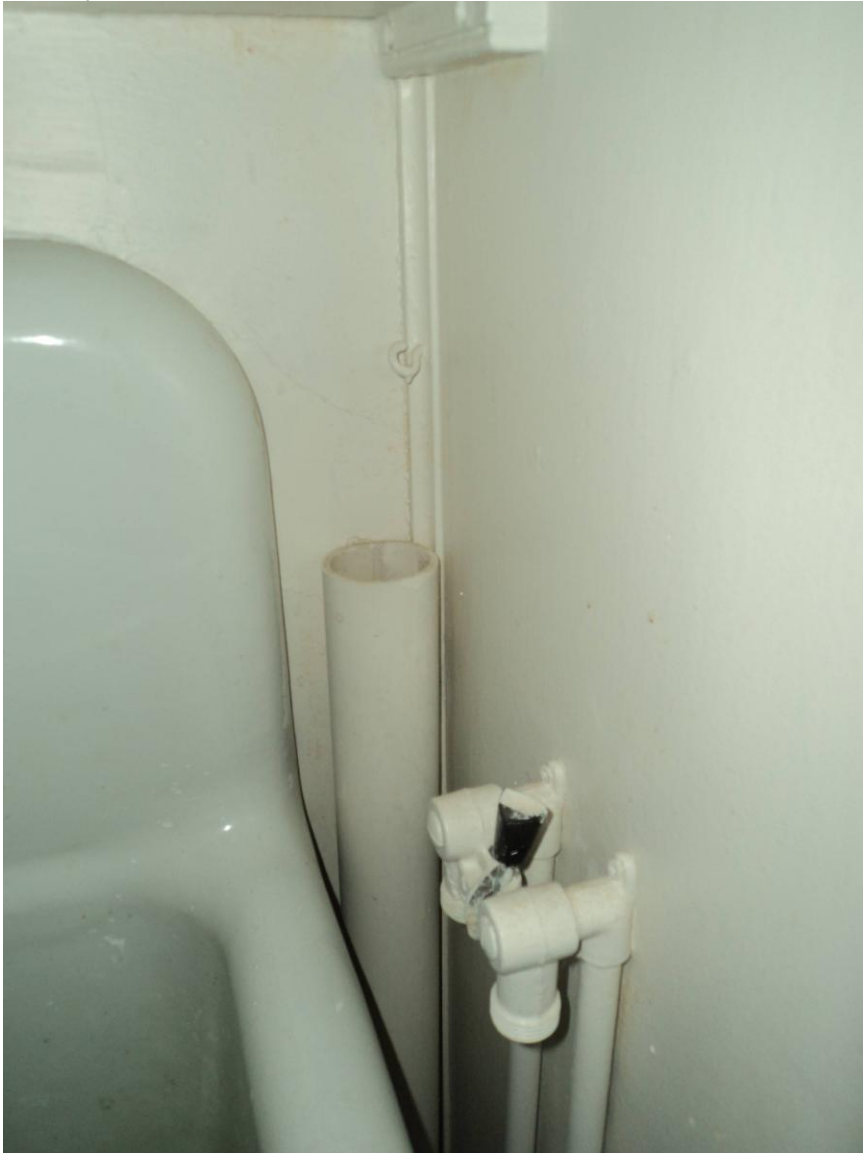
Recommend installing an inline vent on the vent pipe for the slop sink in the 2nd floor utility room.

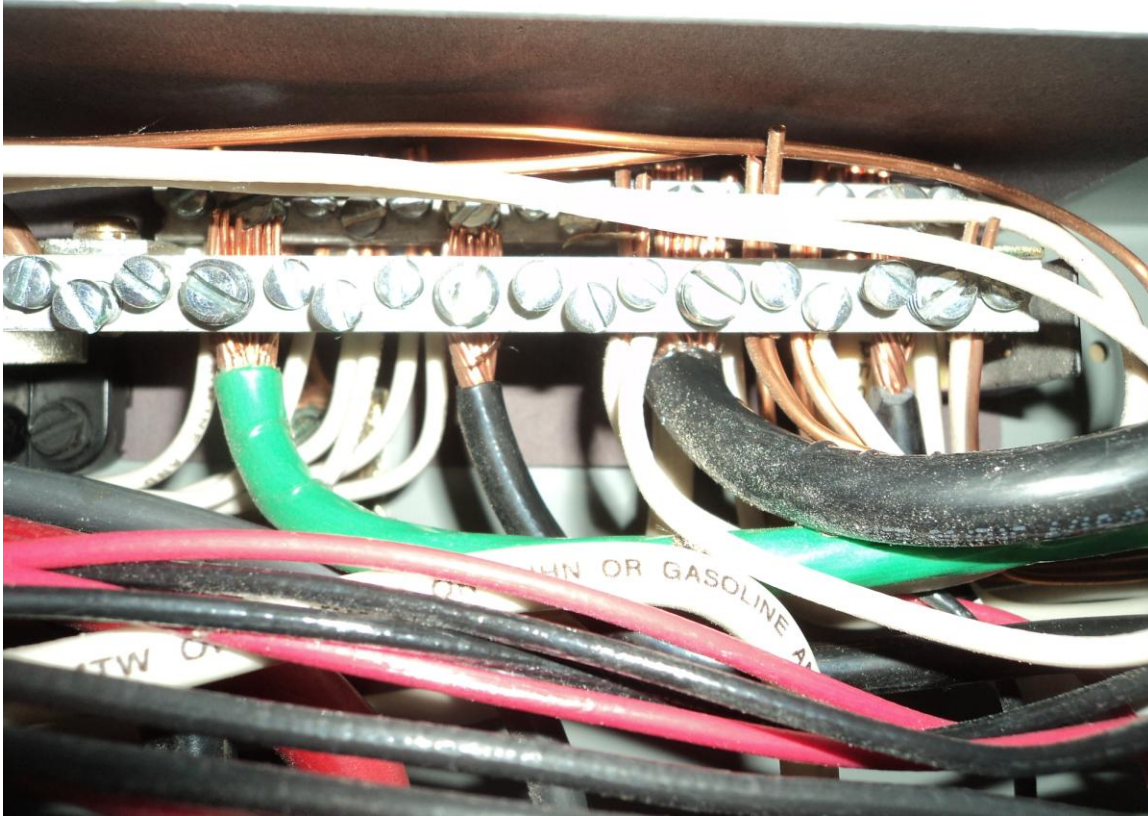
SERVICE: 400-amp service with 220 volts with aluminum incoming service and copper branch circuits throughout the house. The main electric is fed into the rear of the basement into (2) ea 200 amp electric panels. The panel on the left is a 200 amp panel with 32 breakers. At the time of the inspection there was more than one white

wire under a screw head on the side bus bar in this electric panel. Only one white wire should be under a screw head in this location. Recommend having an electrician correcting.

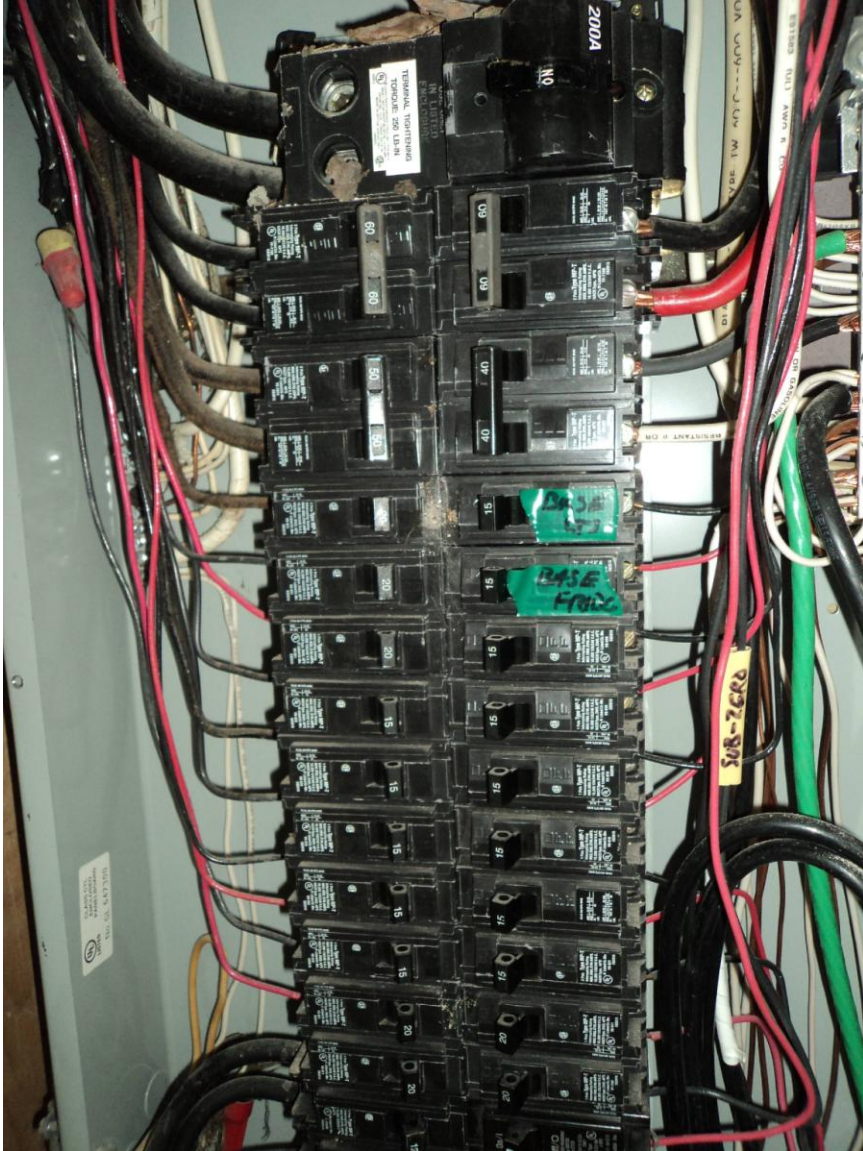
Install knockout covers where missing in this electric service panel.

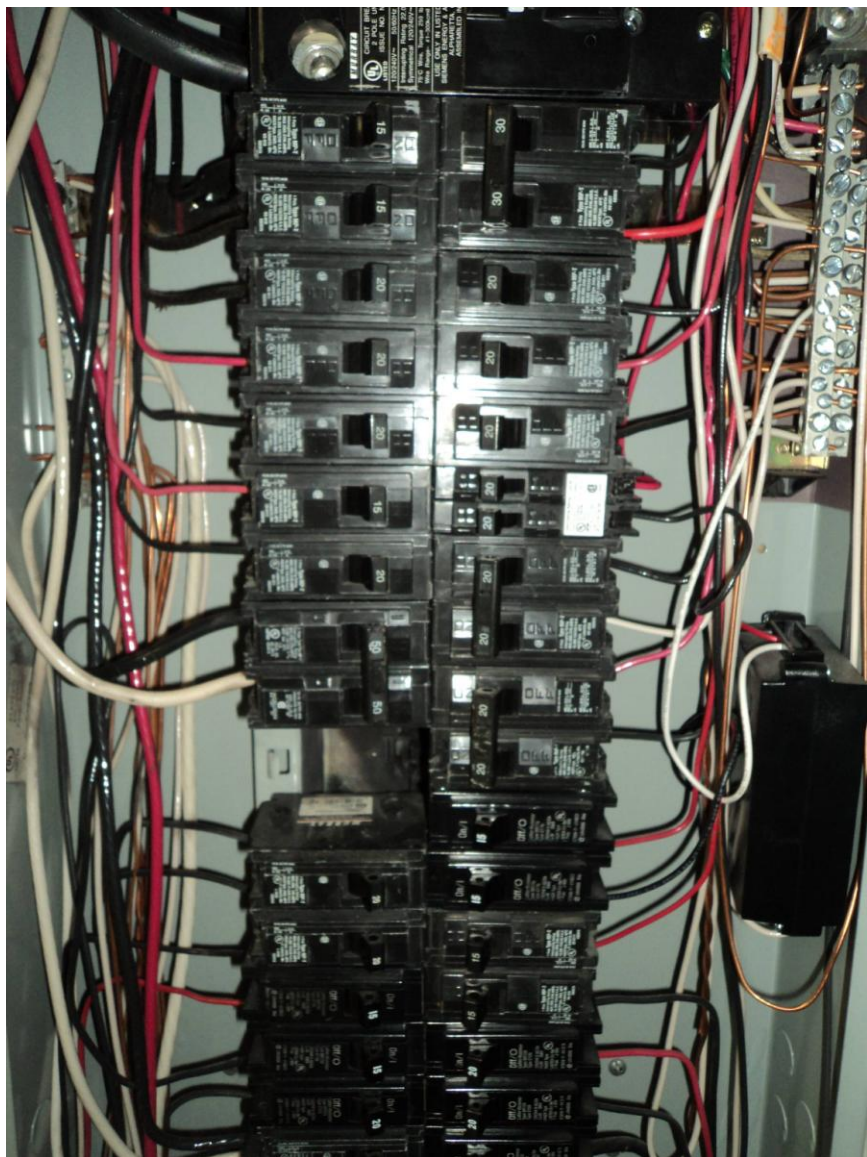
The 2nd main electric panel was also located in the basement on the rear wall on the right. This panel was a 200 amp panel with 31 breakers. At the time of the inspection

there was more than one brand of breakers in this electric panel. For insurance reasons only the brand called out for on the panel should be installed.

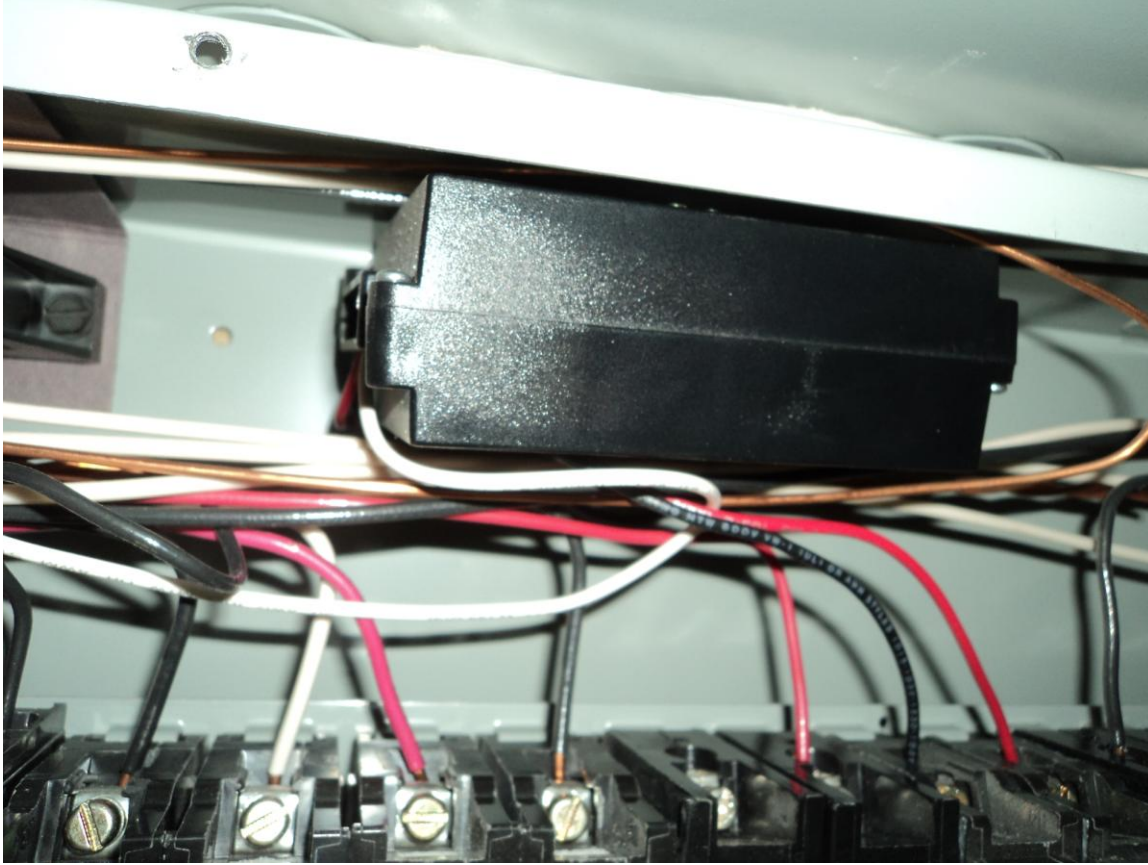
There was a Leviton electric box located in this panel that should be moved outside the main electric panel box at this time.

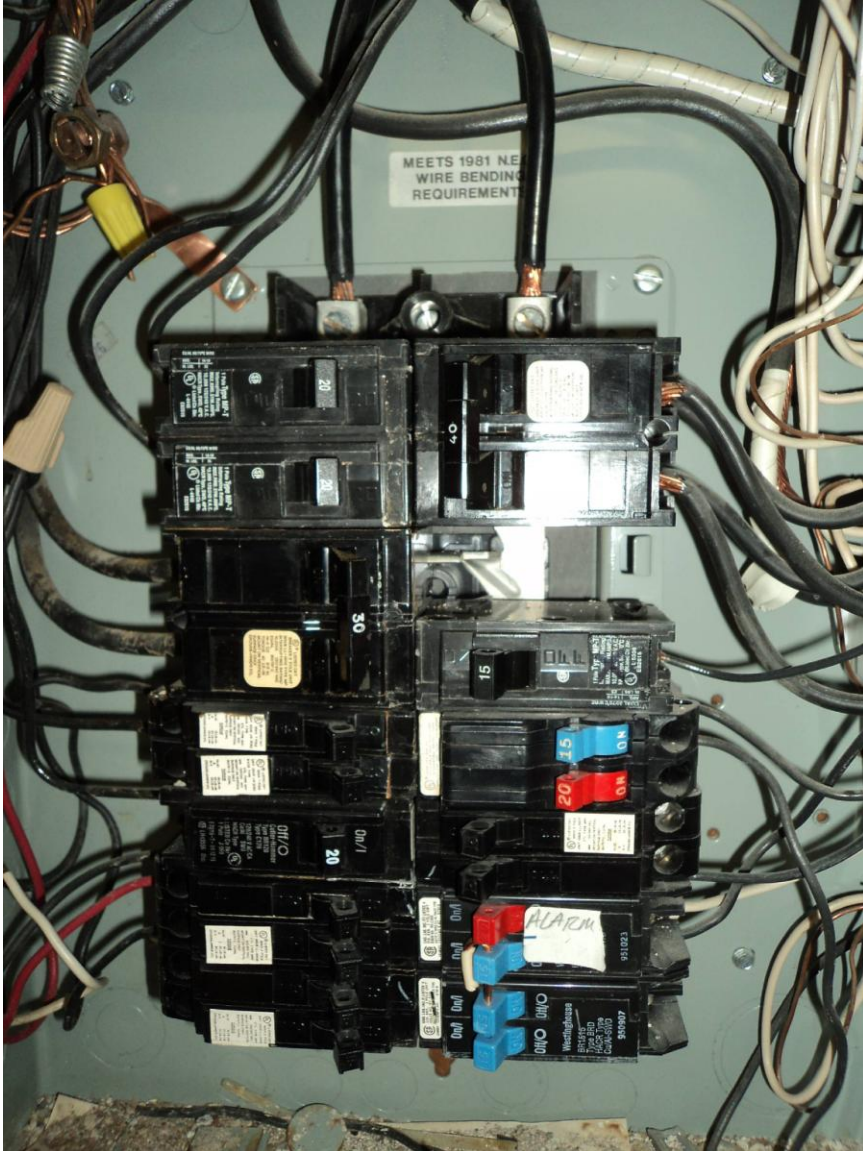
There were two wires in the sub service panel near the basement door that were doubled up on one breaker. The wires should come off at this time and go on their own breakers.

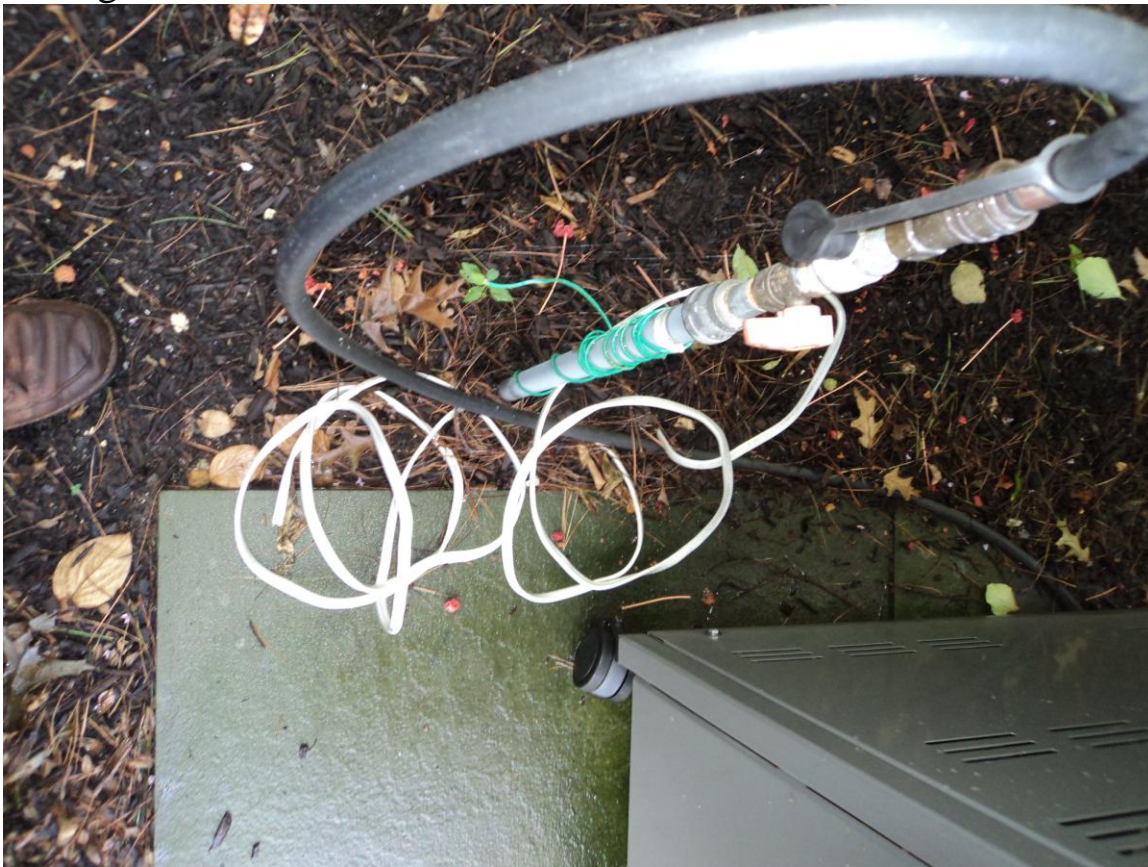
Recommend capping the open electric wire near the BBQ at the pool house or having an outlet installed in this location.

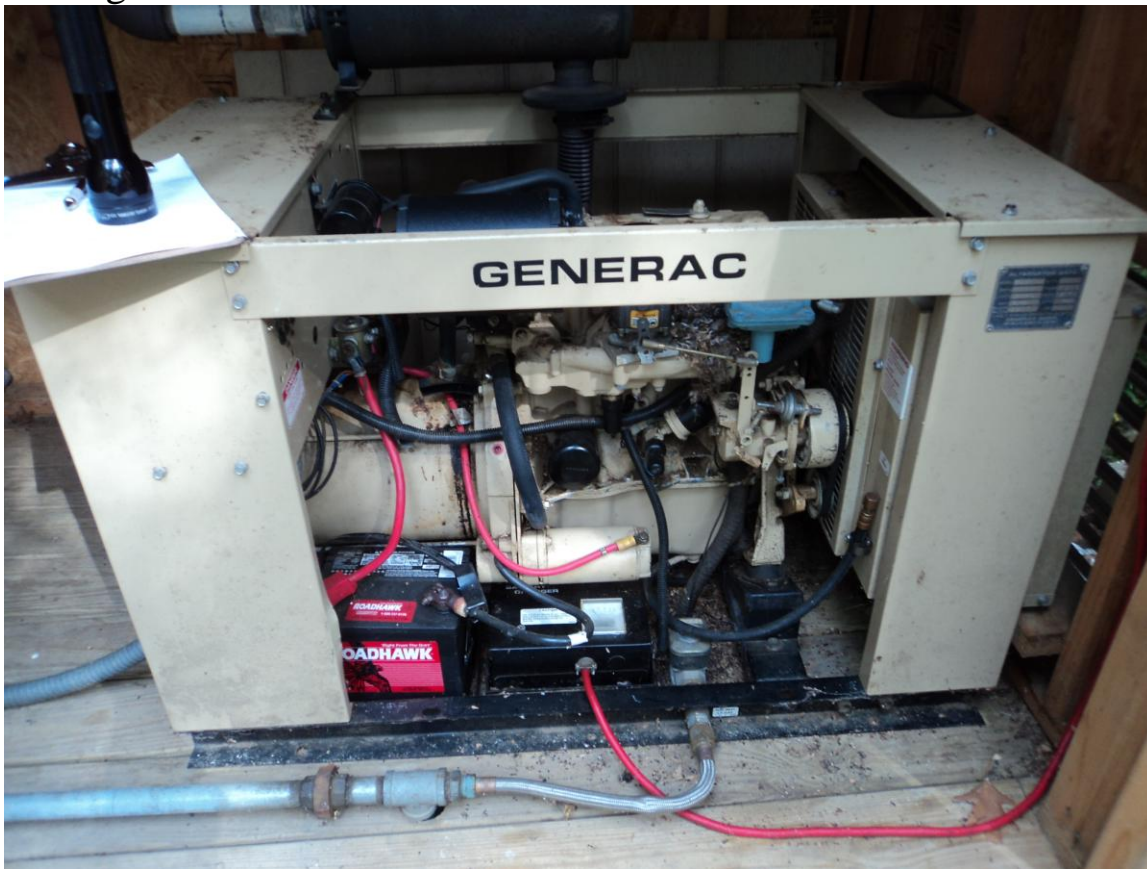
At the time of the inspection the house had a back up gas generator. The unit did not have a recent service tag. Recommend having the unit tested and serviced prior to closing on the house.

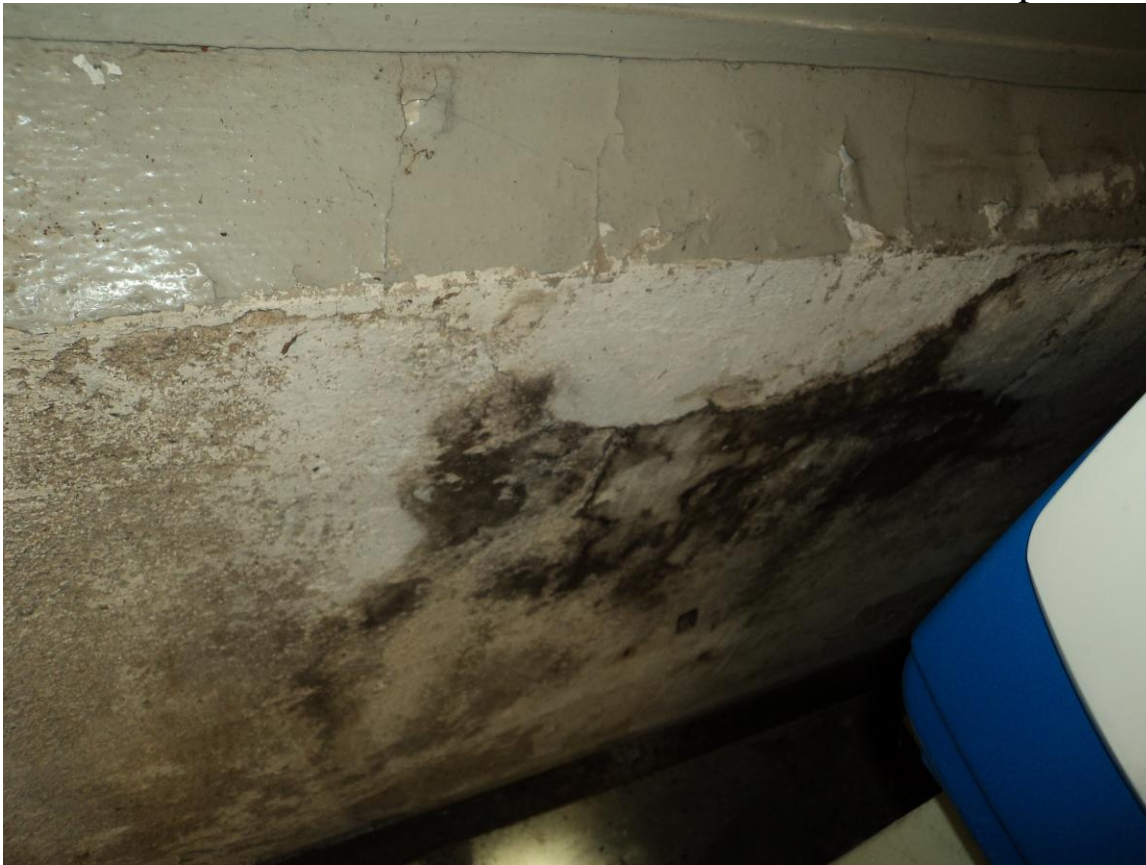
At the time of the inspection the house had some settling cracks. Due to the very nature of cracks water may seep through at certain times. Recommend checking with the current homeowner as to whether the house has had any water problems in the past and if it has, recommend consulting a water proofing company. Water seepage was noted near the basement windows at the time of the inspection.

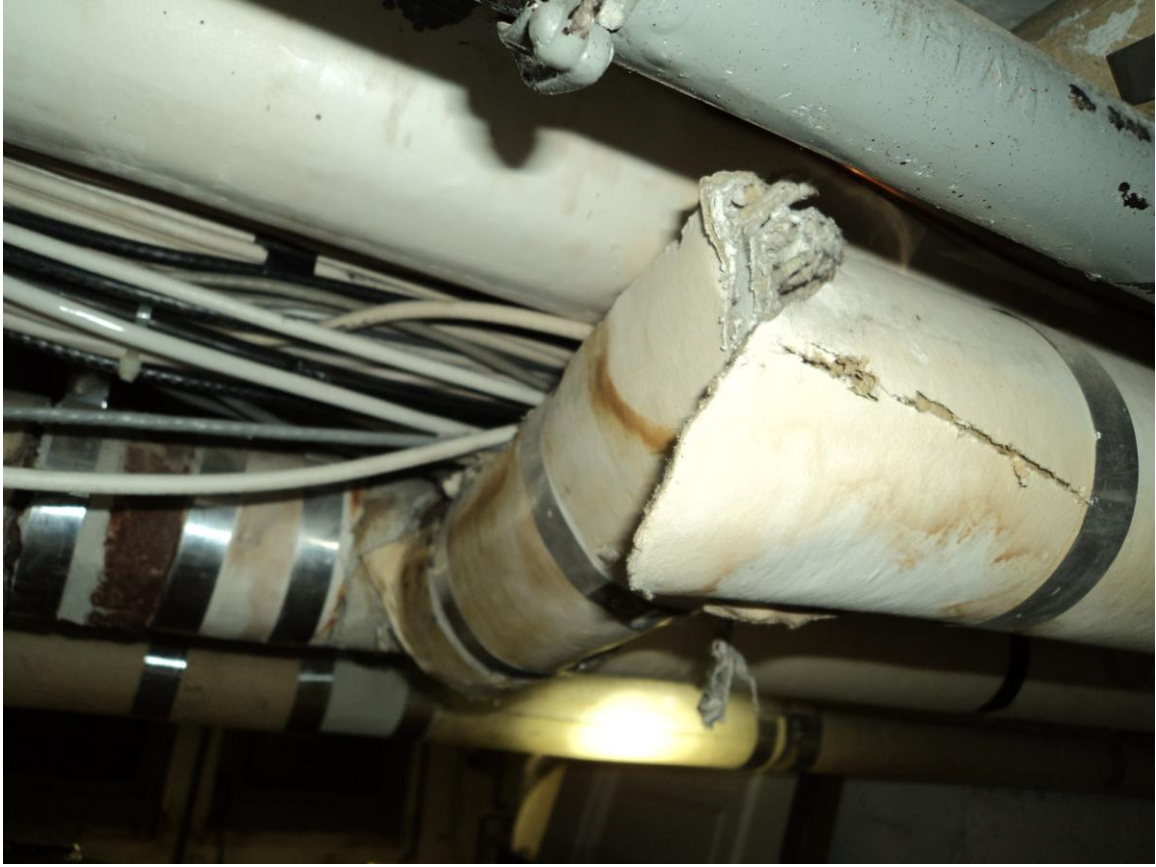
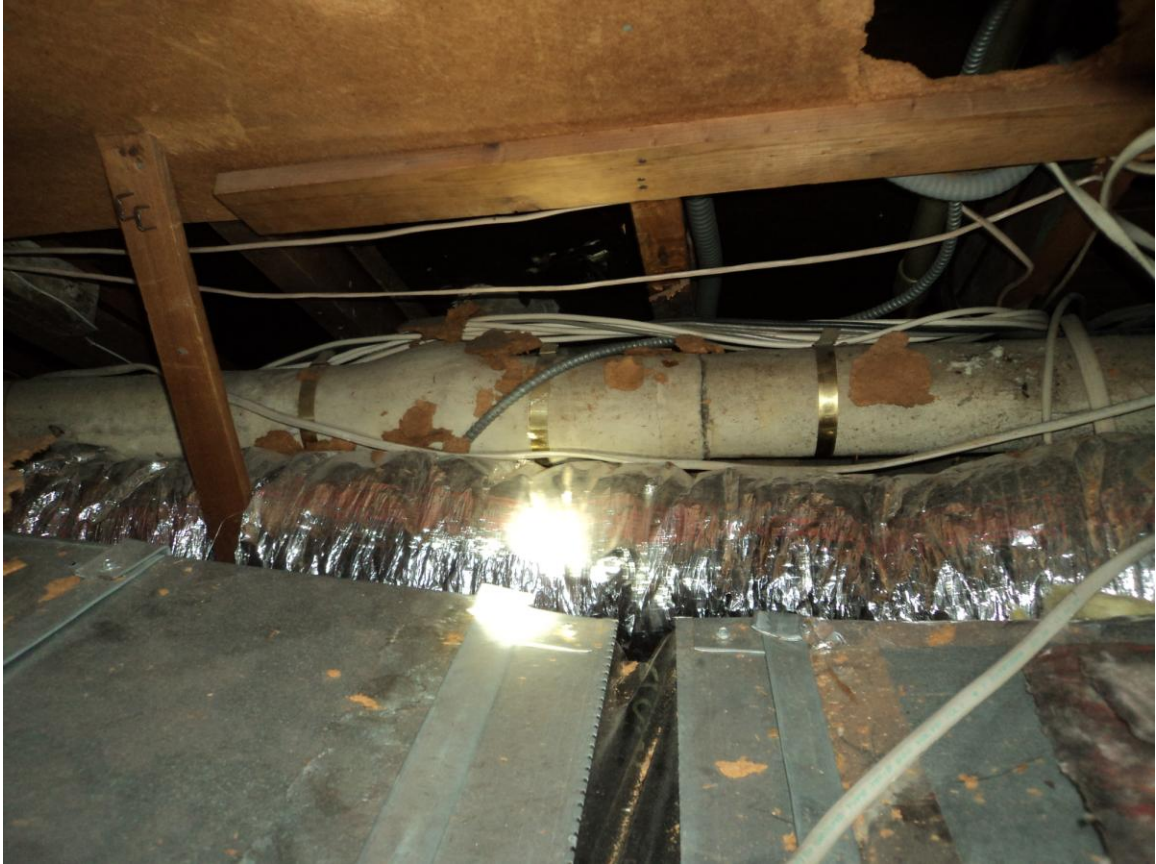
Recommend having the asbestos pipe wrap properly removed off the pipes in the house, asbestos was found in the basement and in the attic. Additional asbestos may be in the walls of the house.

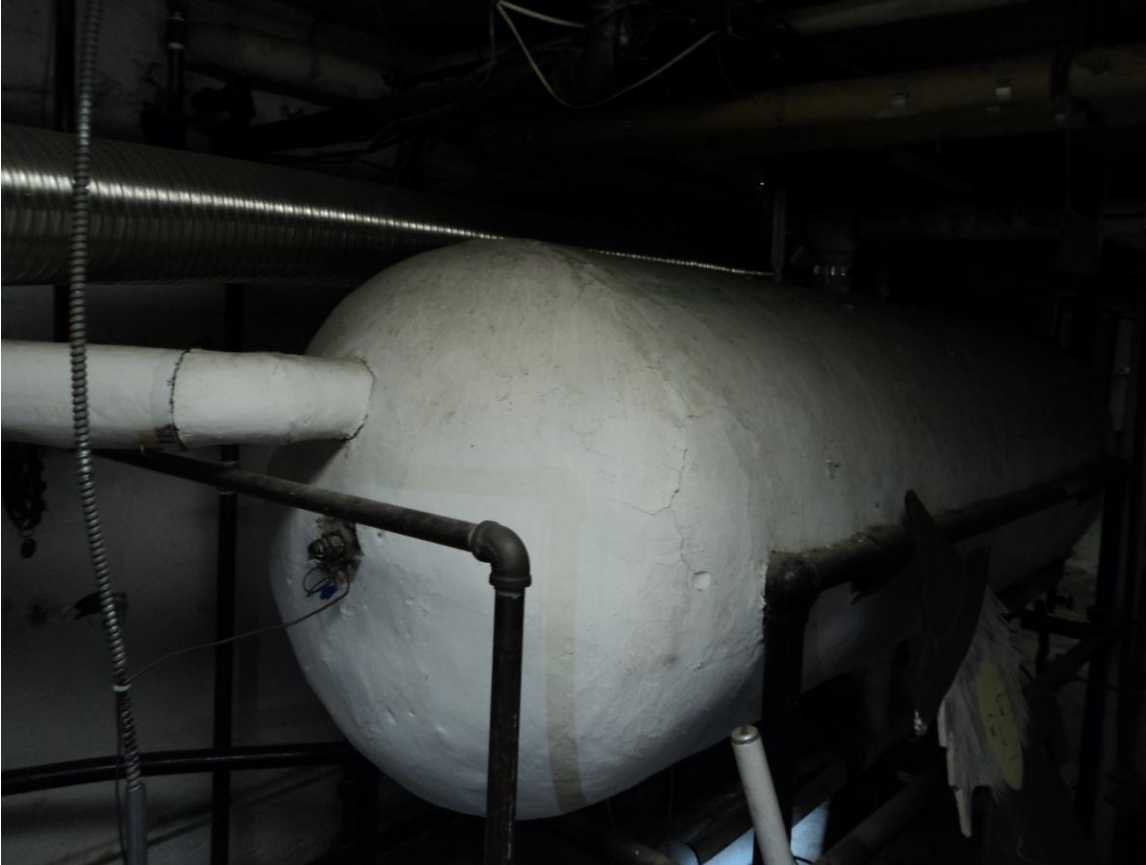
Asbestos was also noted around the hot water tank in the basement of the house.

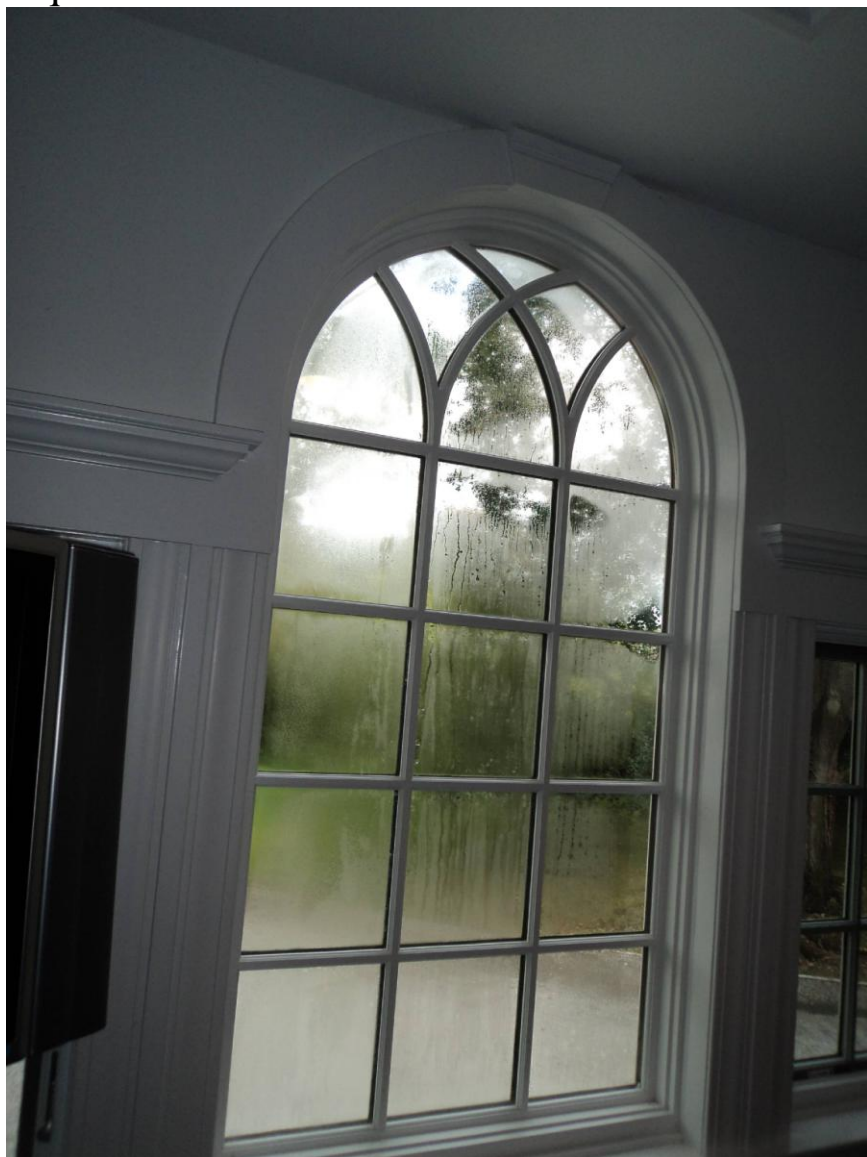
The window in the garage gym in the center had some condensation/staining between the panes. Recommend repairing the window and replacing the hermetic seal as required.

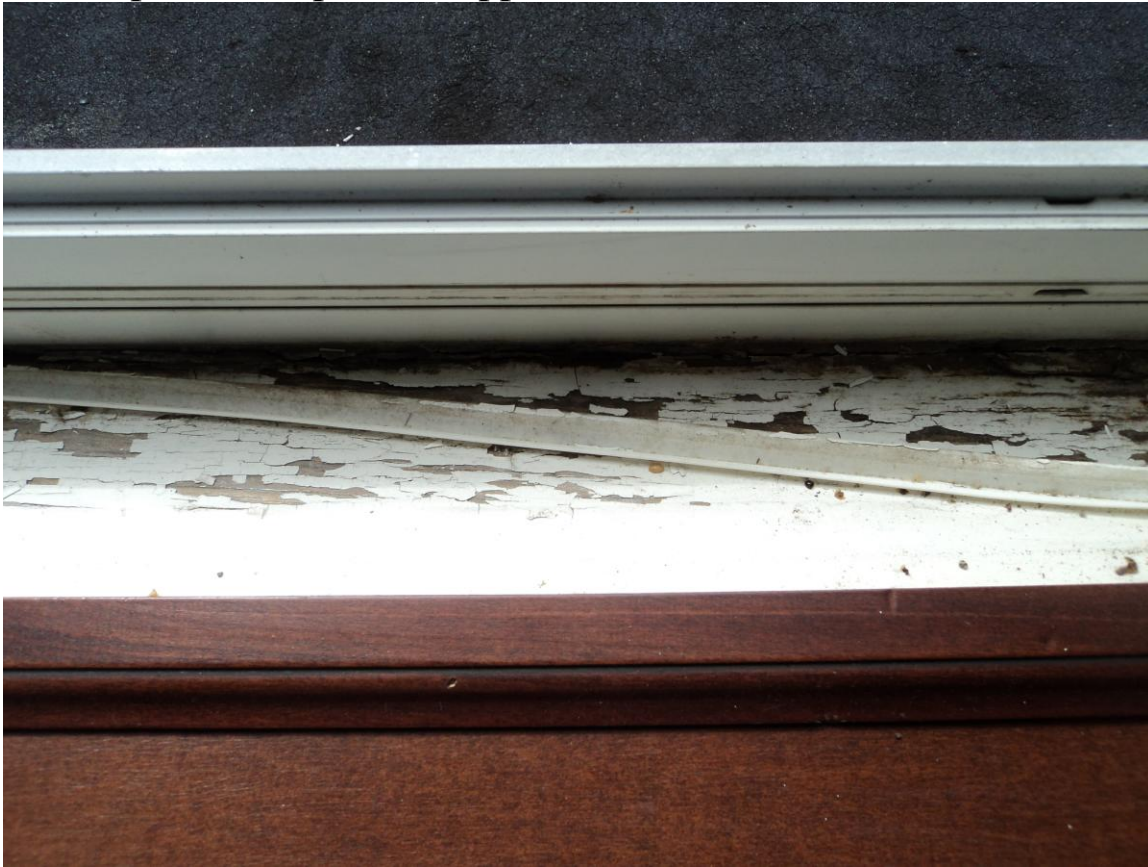
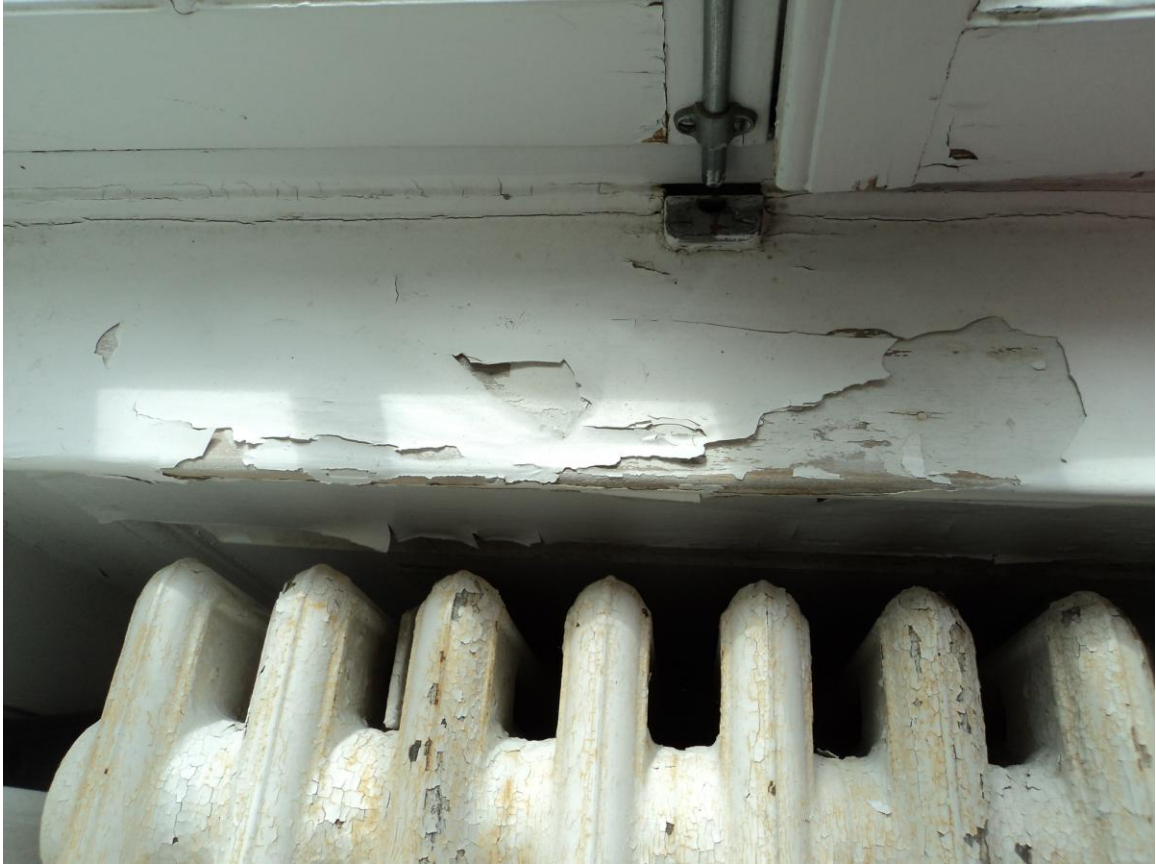
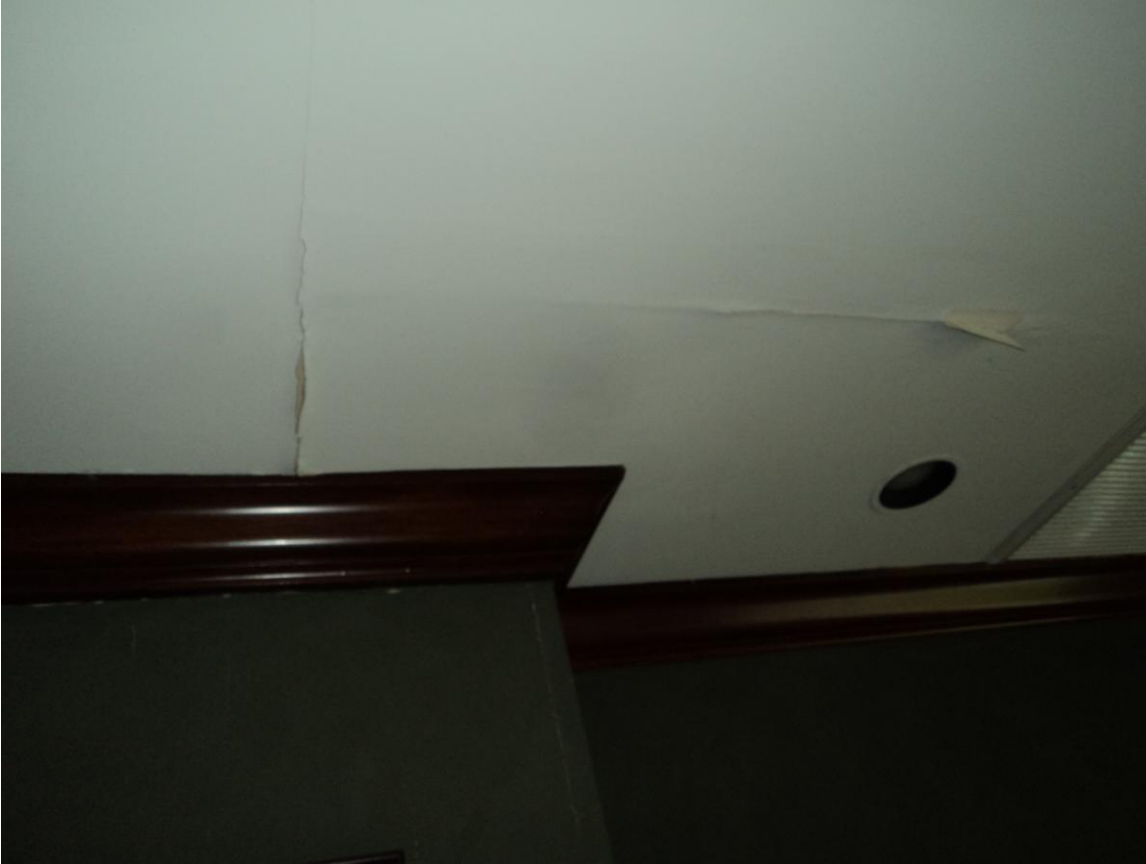
Peeling paint was observed in a number of interior locations around the house. As the house predates 1978, the potential exists that the paint may contain lead. To minimize the potential for any adverse health effects, I recommend that the paint be properly scraped off and disposed of. Subsequent to that, I recommend that a fresh coat of primer and paint be applied.
