AC & E HOME INSPECTION CORP.

CONCLUSION

Cold Spring Harbor NY
09/21/2011

DESCRIPTION OF HOUSE: Manor house

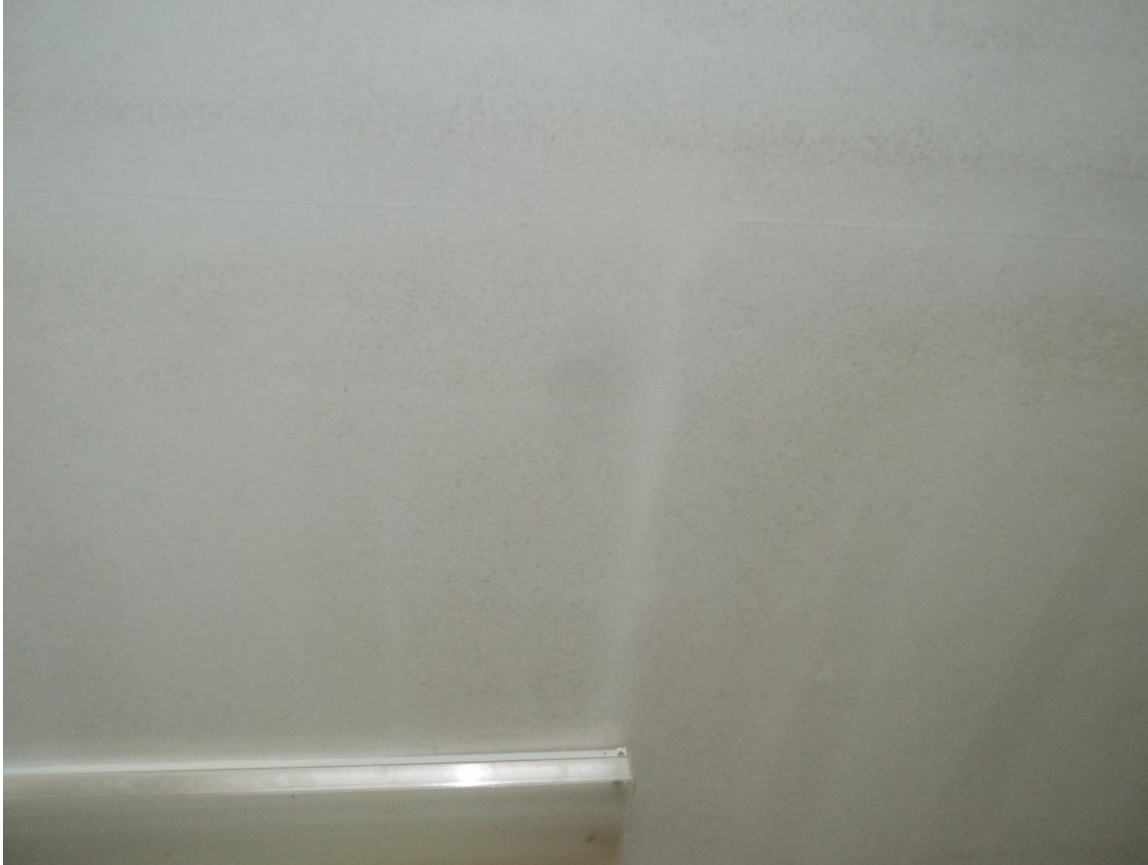
At the time of the inspection there was mold noted on the ceiling in the garage. Recommend having the mold in this location properly removed at this time.

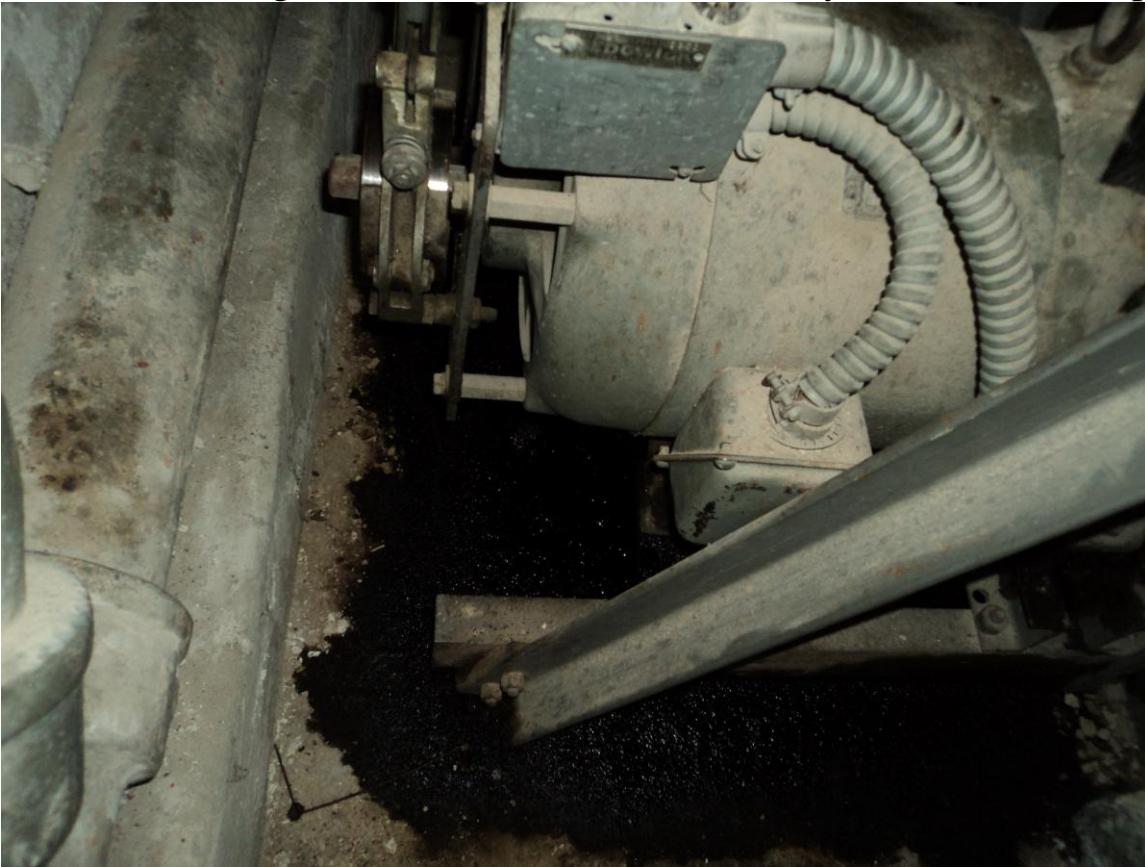
At the time of the inspection the house had an elevator system that was not working and oil or hydraulic fluid was noted under the motor. An elevator repair company needs to be brought in at this time and have the system serviced, repaired and tested.

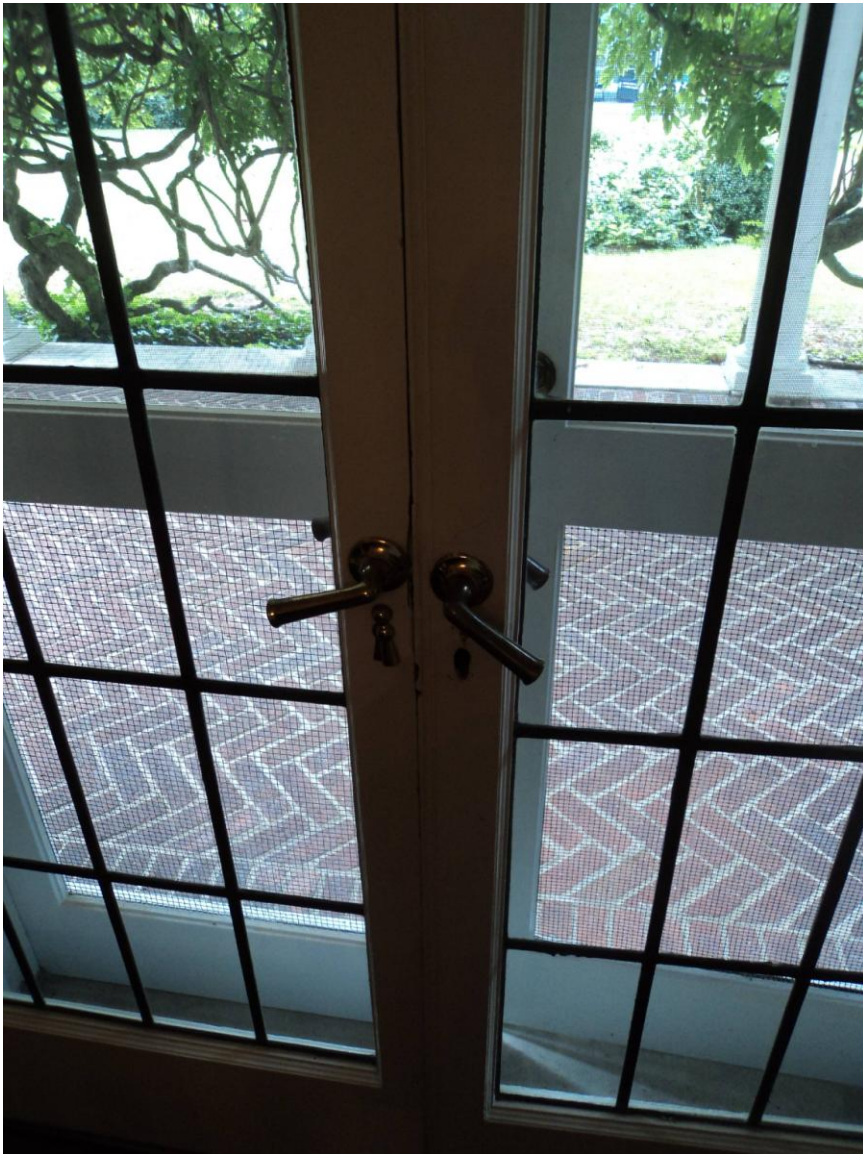
Recommend repairing the door in the 1st floor that leads to the center patio as the door was stuck closed.

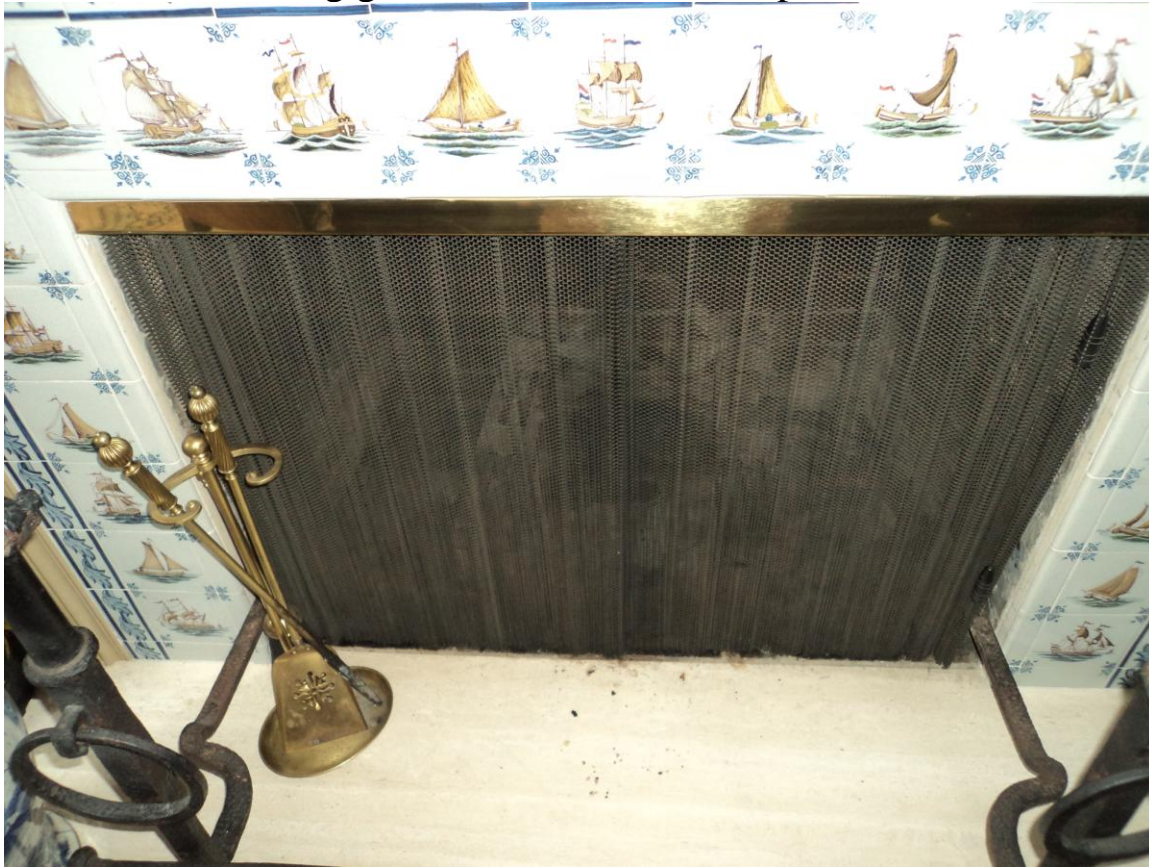
Recommend adding glass doors to all the fireplaces in the house.

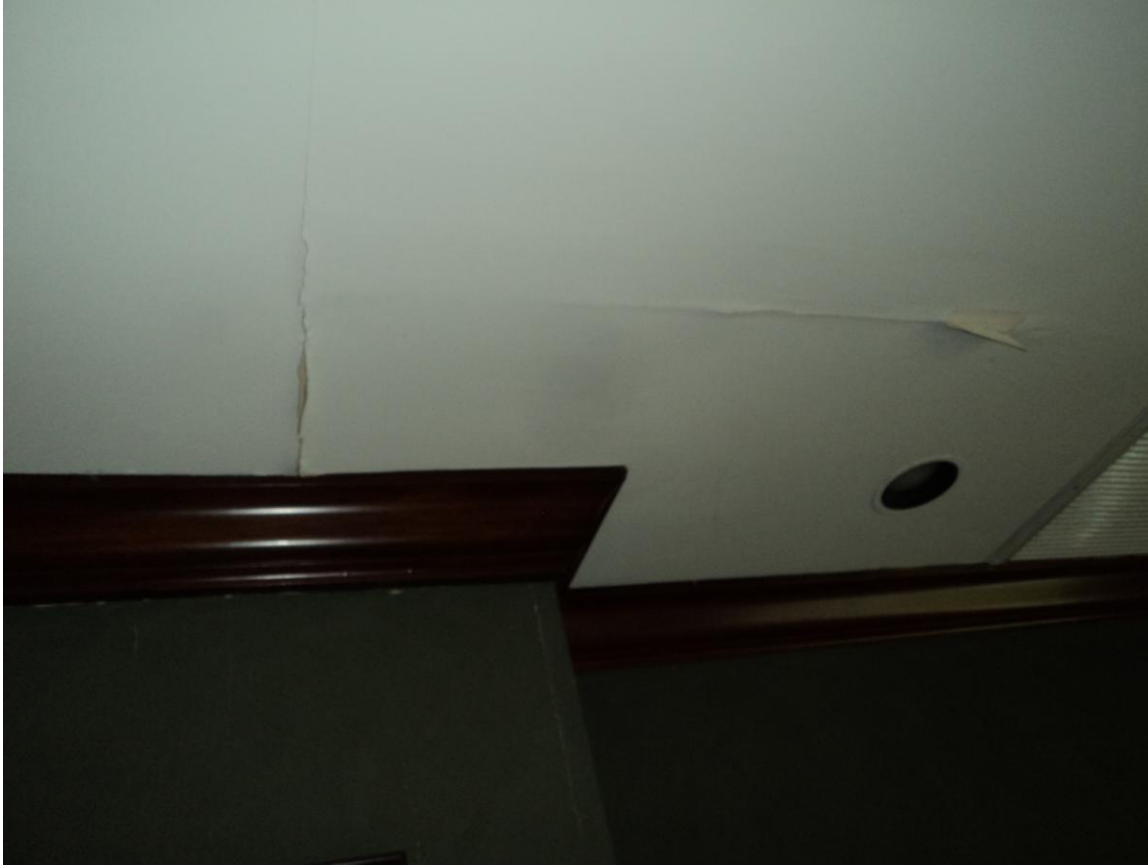
Recommend repairing the damaged sheet rock on the 2nd floor far left room as the air handler above had a past leak in this location.

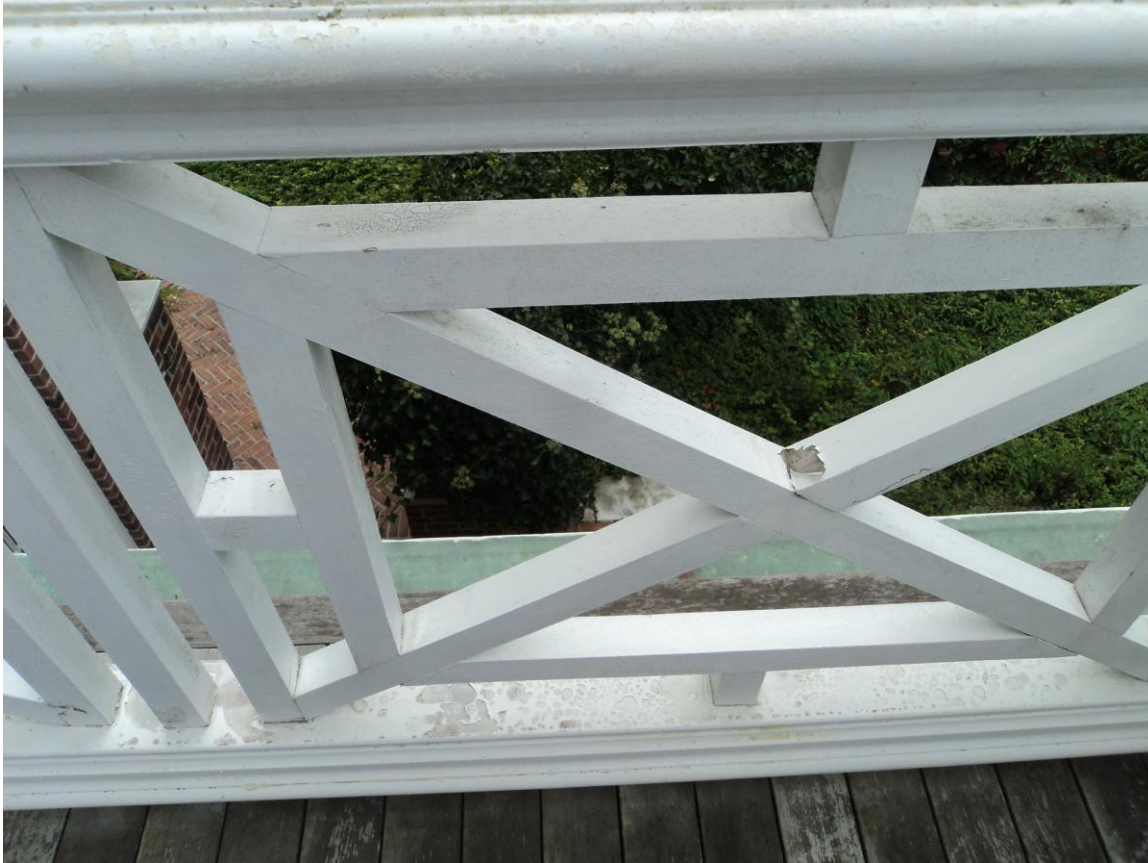
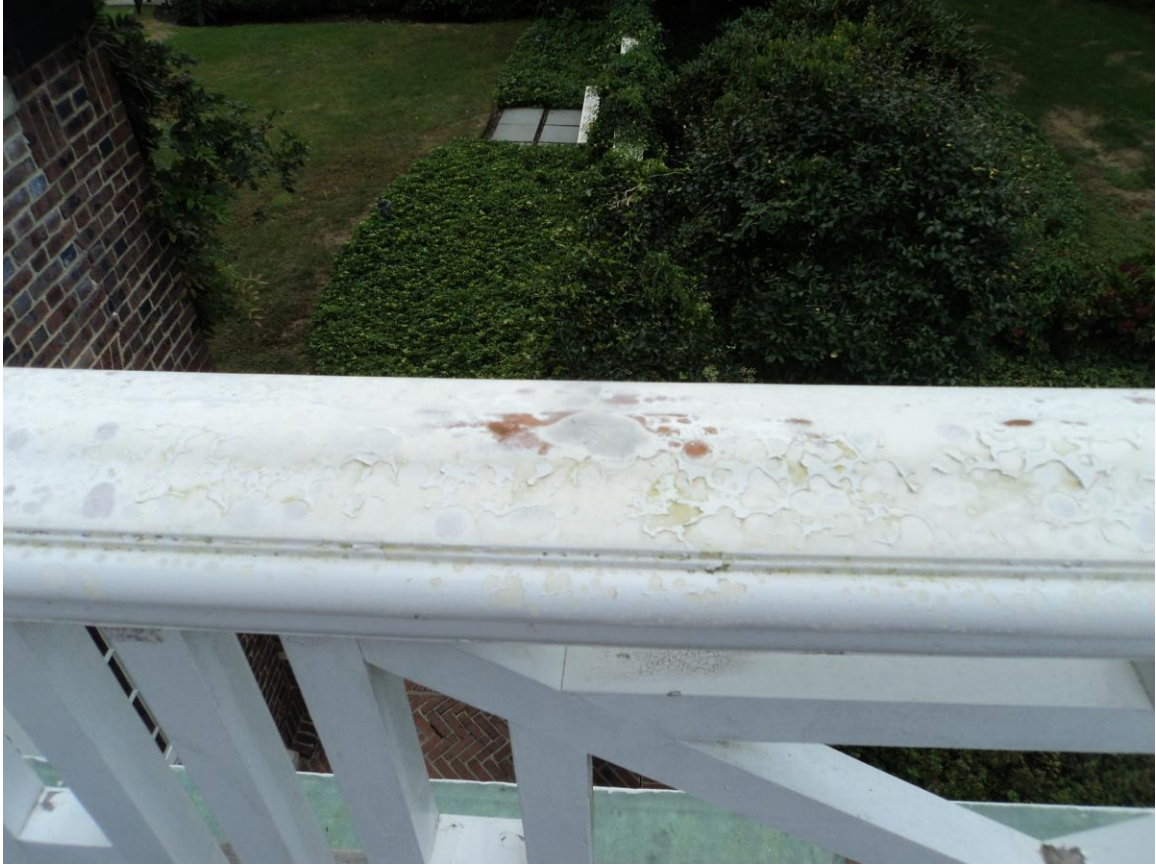
Recommend closing the gap on the deck rails on the 2nd floor master bedroom deck. The rails also need to be painted in this location.

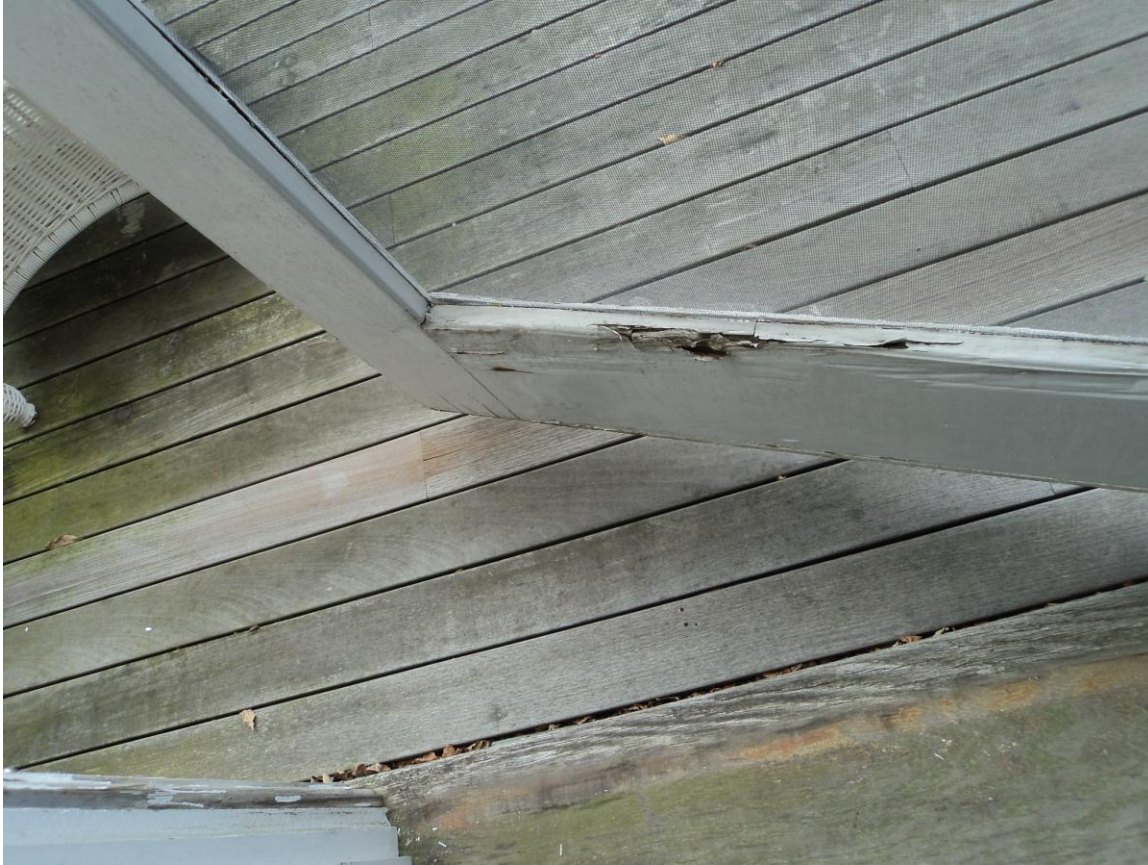
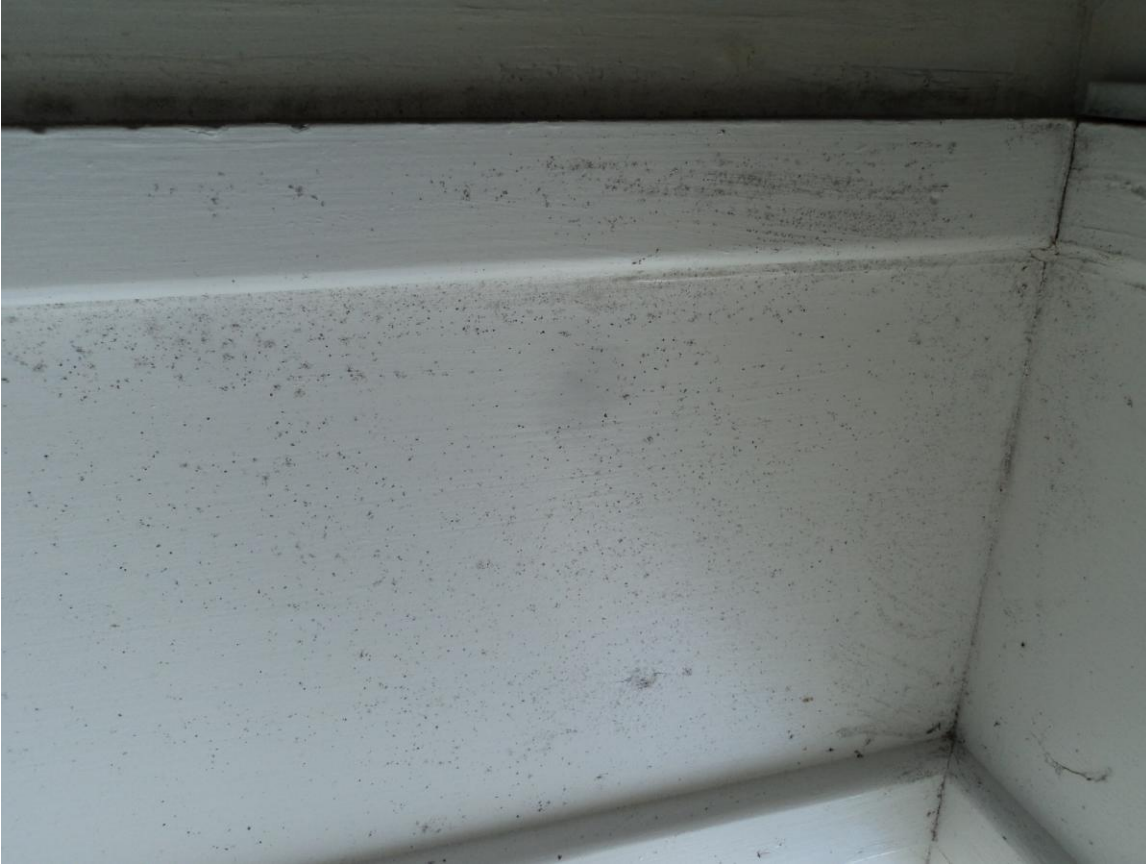
Recommend replacing the rotted screen door and remove the mold from the door frame in the 2nd floor bedroom screen door leading to the deck.

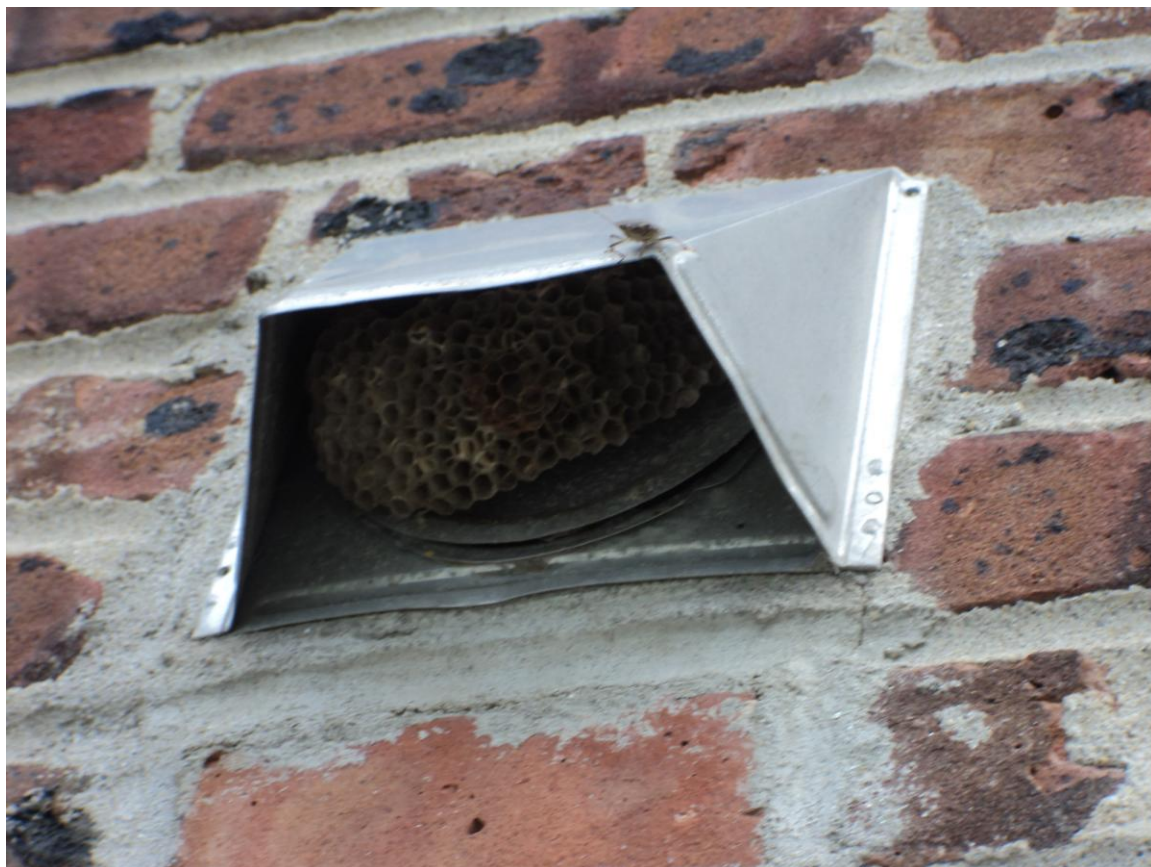
Recommend removing the bees nest from the vent on the 2nd floor master bedroom deck area.

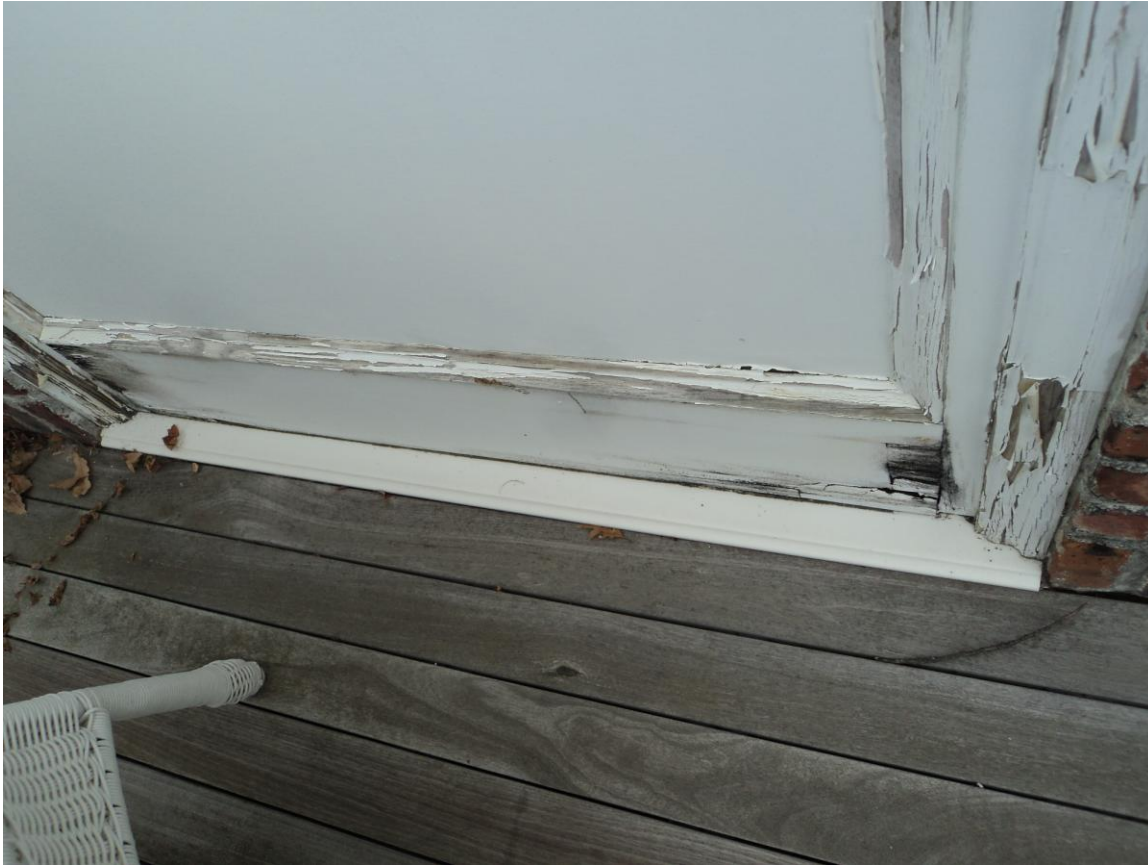
Recommend replacing the rotted wood around the window noted from the 2nd floor master bedroom deck.

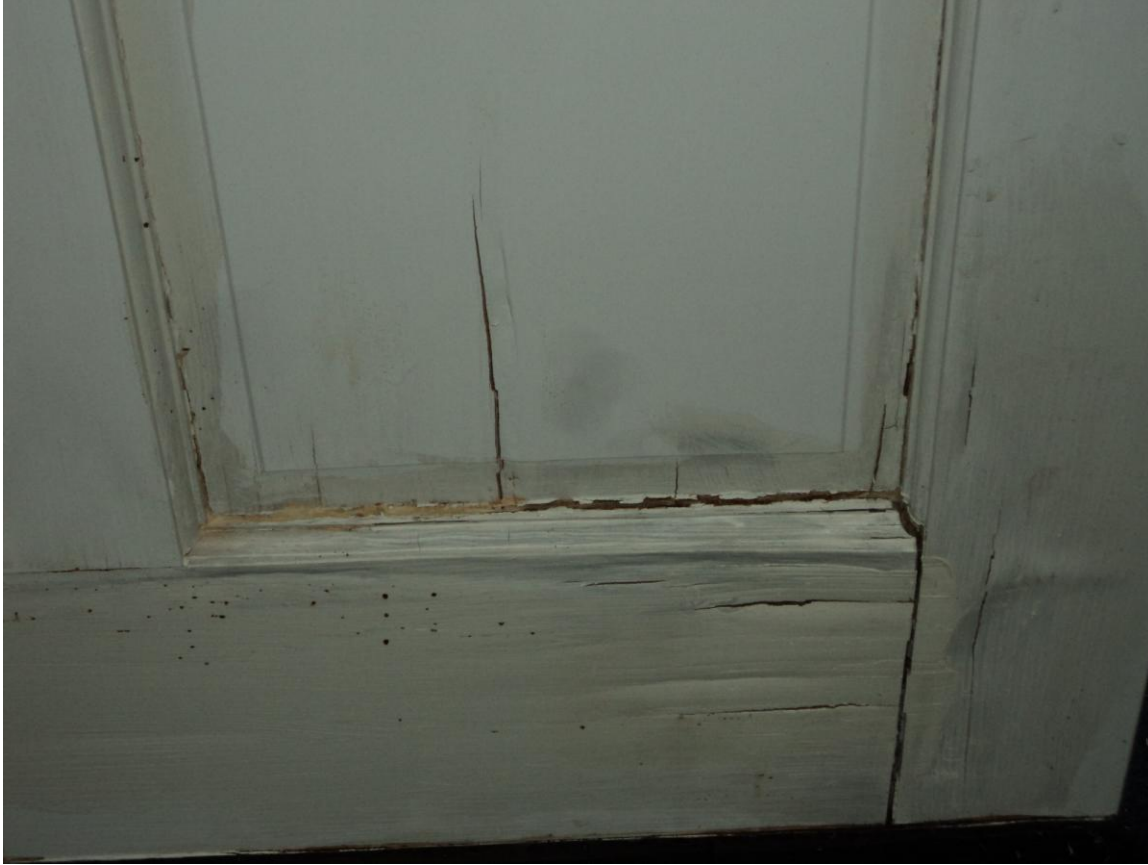
Recommend replacing the rotted door leading to the 2nd floor of the garage.
