# **AC & E HOME INSPECTION CORP.**

## **CONCLUSION**

12/10/2011

DESCRIPTION OF HOUSE: Two Story

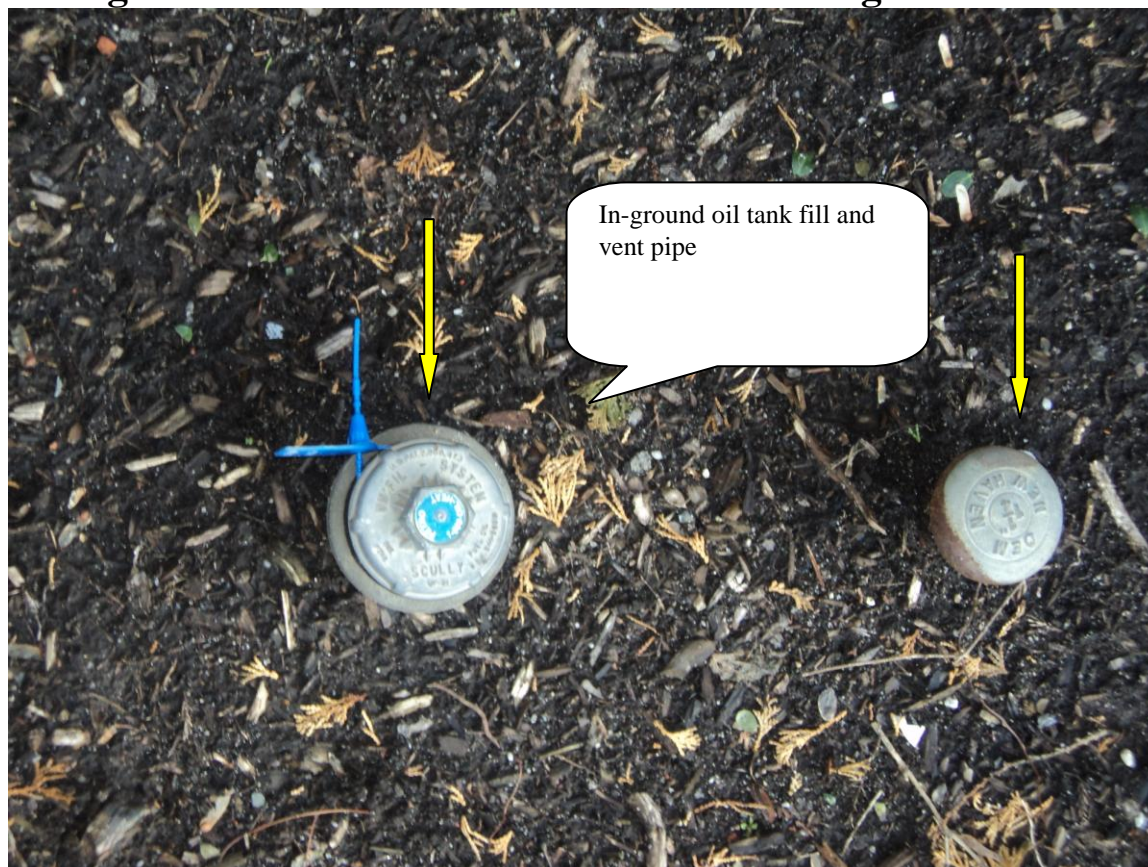
**At the time of the inspection there was an in-ground xxx gallon oil tank at xx years of age. It is our highest recommendation to accomplish a leak check at this time due to possible contamination to the soil. Soil and/or tank testing is the only way you can be sure you do not have an environmental problem. If needed, at AC&E we can accomplish an EPA approved, NON-pressure test and/or soil testing. Please see the enclosed literature on in-ground tanks.**

**4) Recommend having the tank properly inspected at this time. Please call if you would like to set this up.**

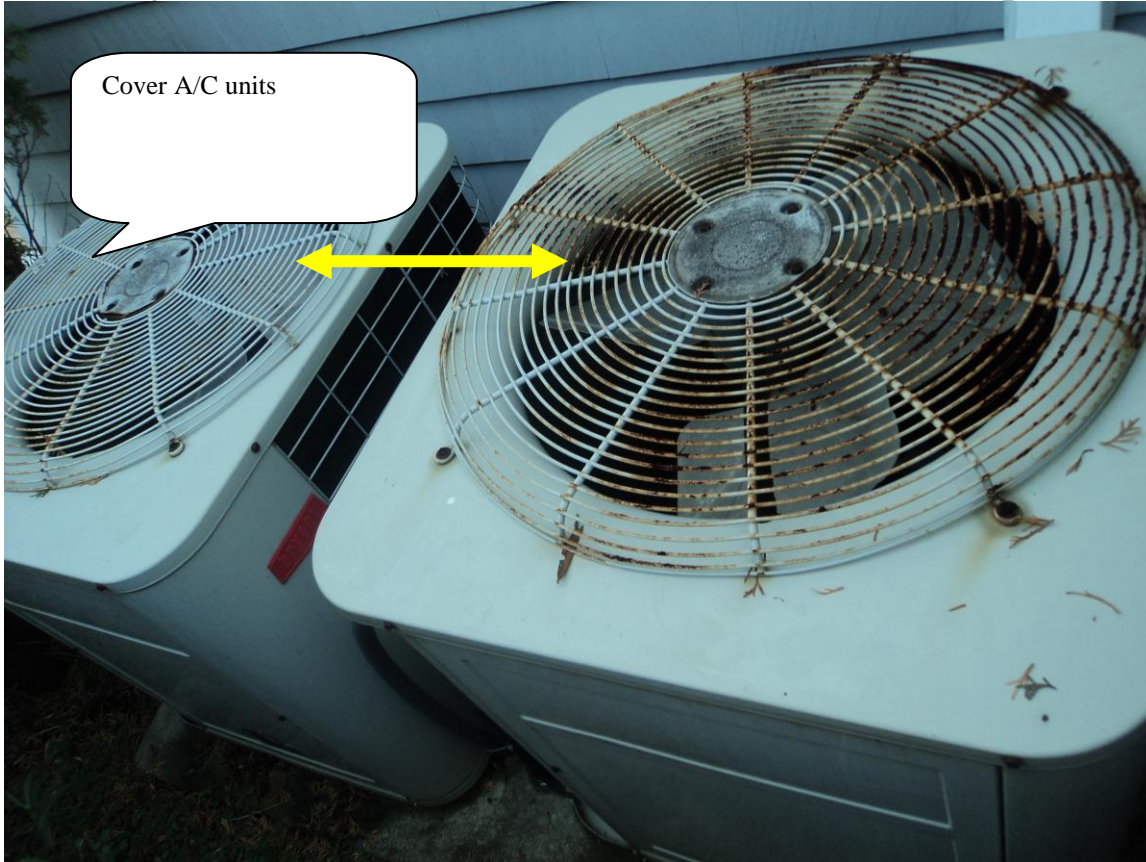
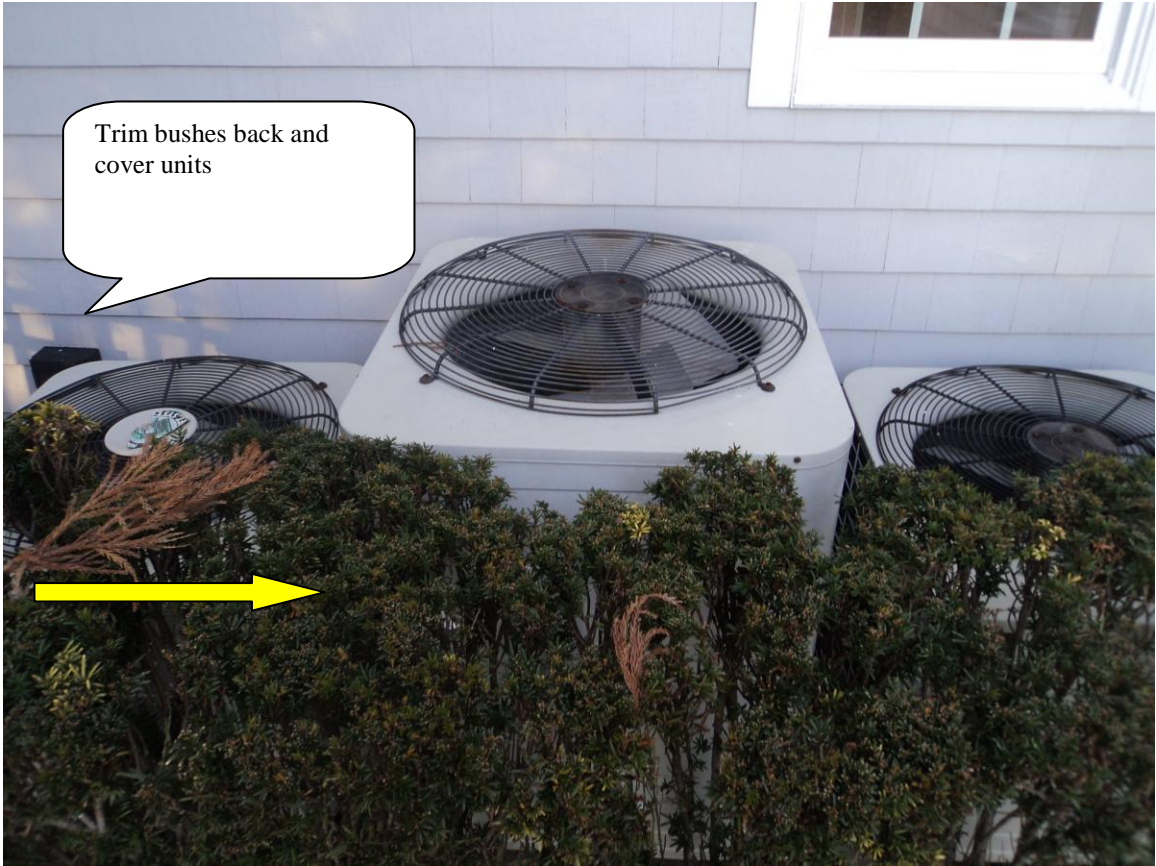
Recommend removing the leaves from the air conditioning condensing units and covering them while they are out of service for the season to prevent further debris from getting in. due to the location of the systems(on the water the life of the units will be shorter)

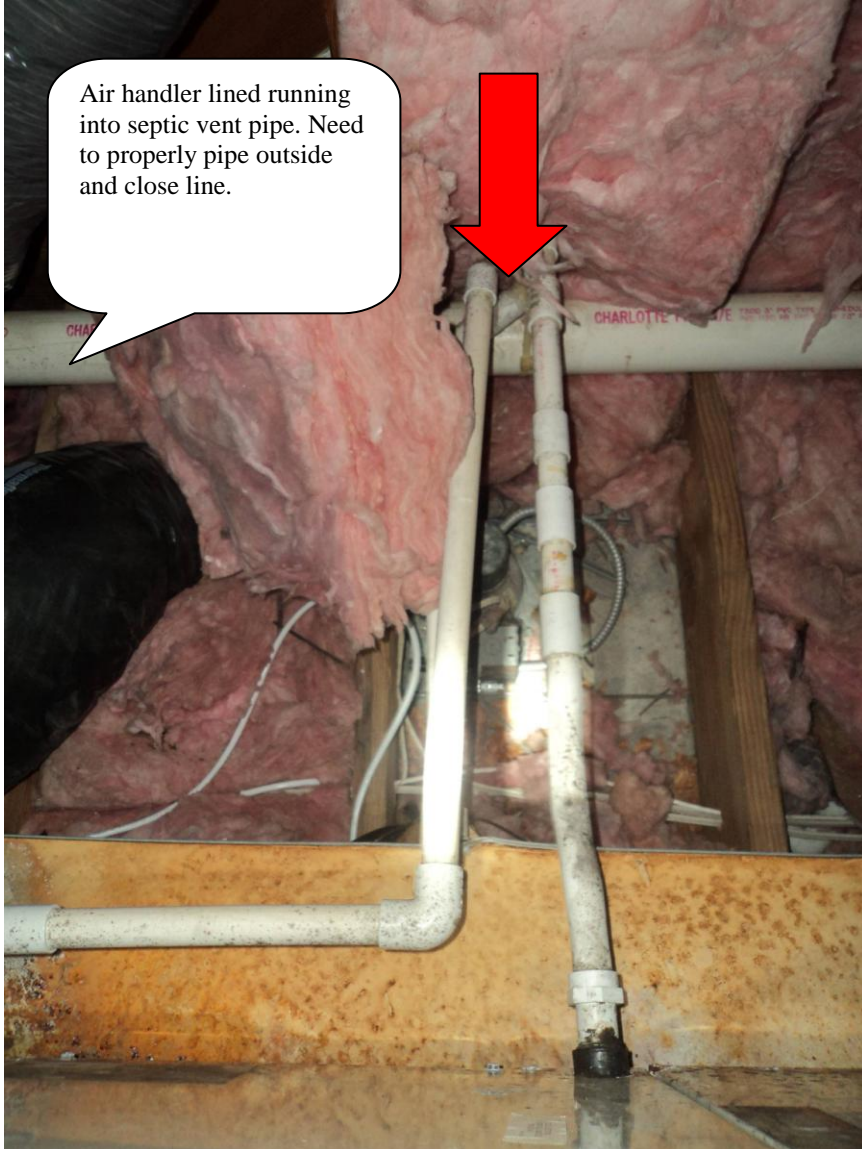
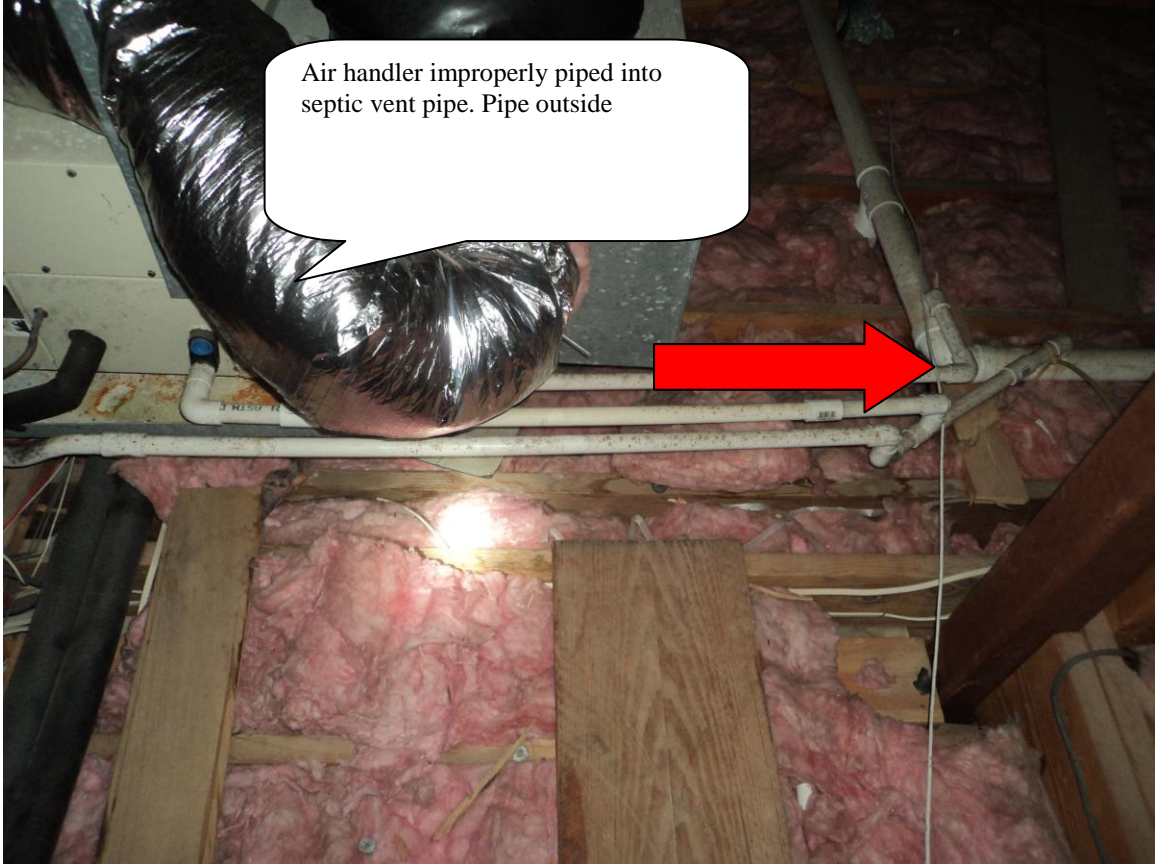
At the time of the inspection there was two air handlers located in the attic. Both units were found to be improperly piped into the septic venting system of the house. This needs to be properly piped outside to prevent septic gasses to migrate out into the air handlers and into the living space of the house.

Air handler improperly piped into septic vent pipe. Pipe outside

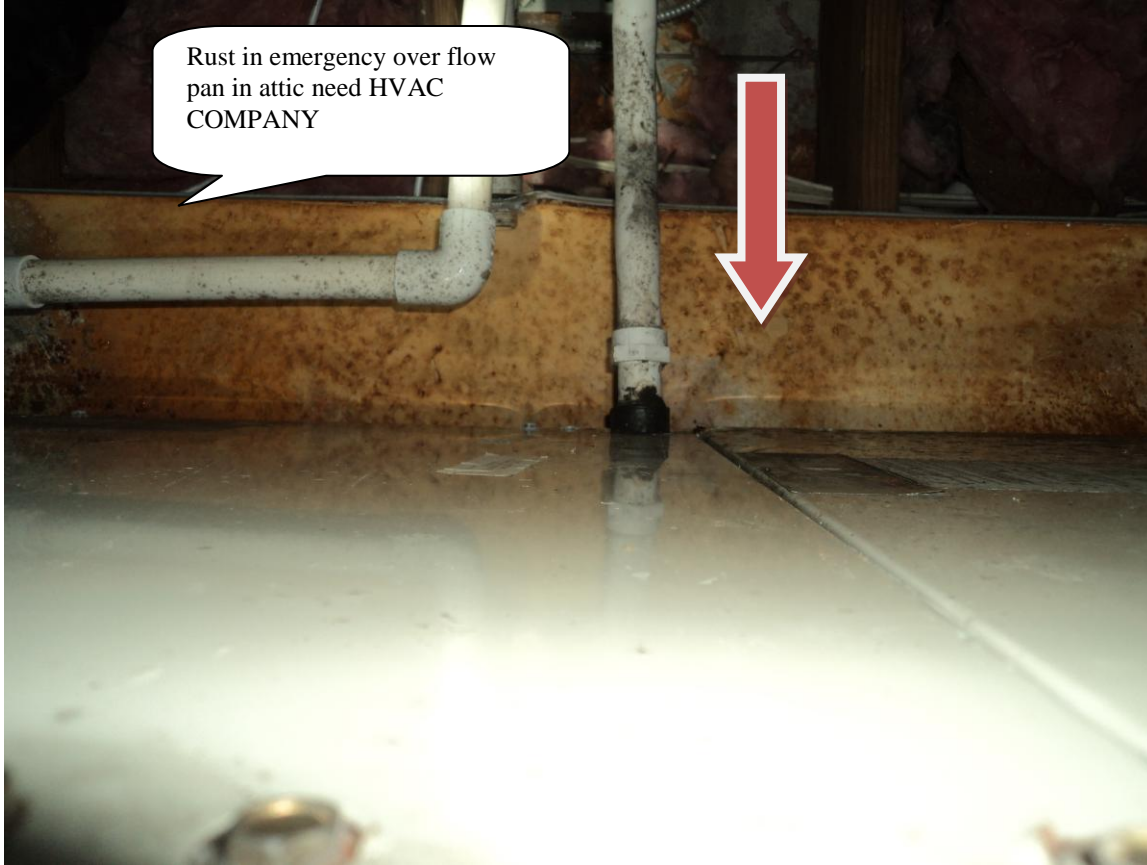
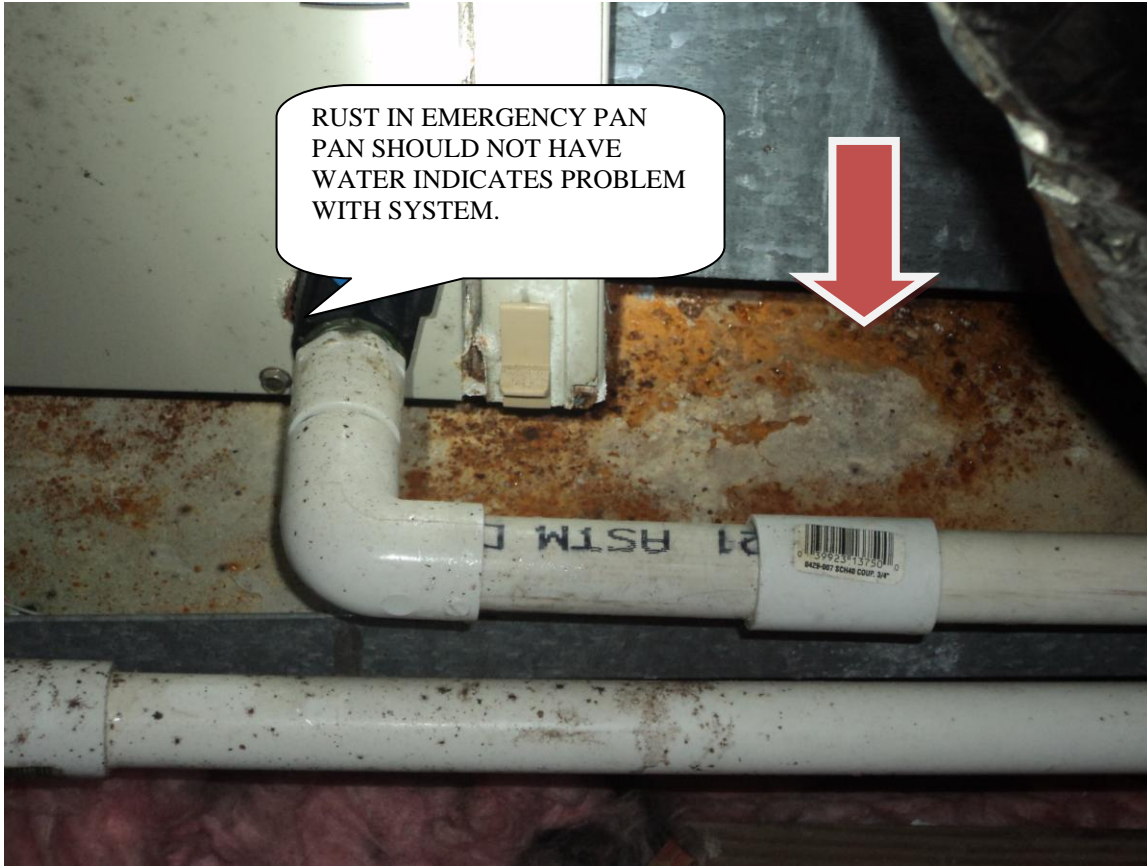
At the time of the inspection both air handlers in the attic were found to be leaking into the emergency over flow pans as high rust marks were noted on the pans. Water should never be in the pan as this is used for emergency only. Recommend having an HVAC company come out at this time to repair or replace the air handlers as needed.

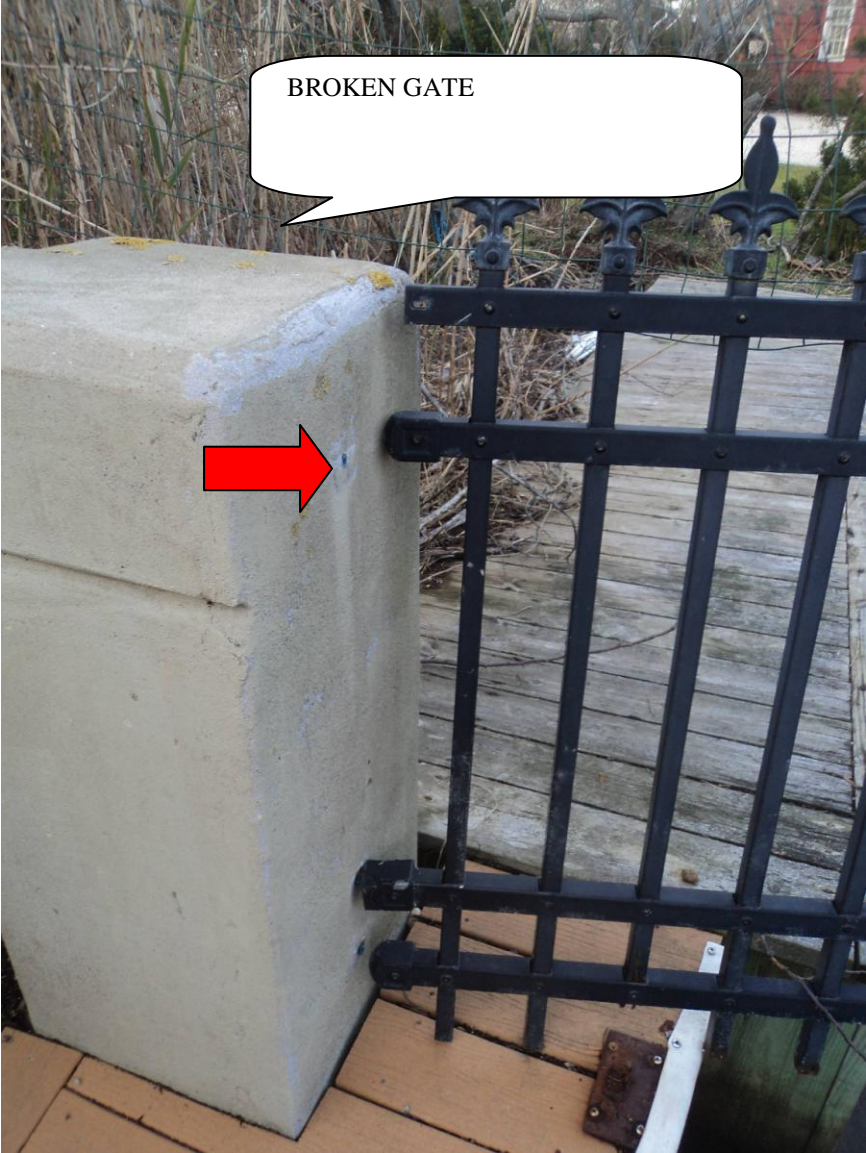
Recommend repairing the broken gate on the left rear of the property.

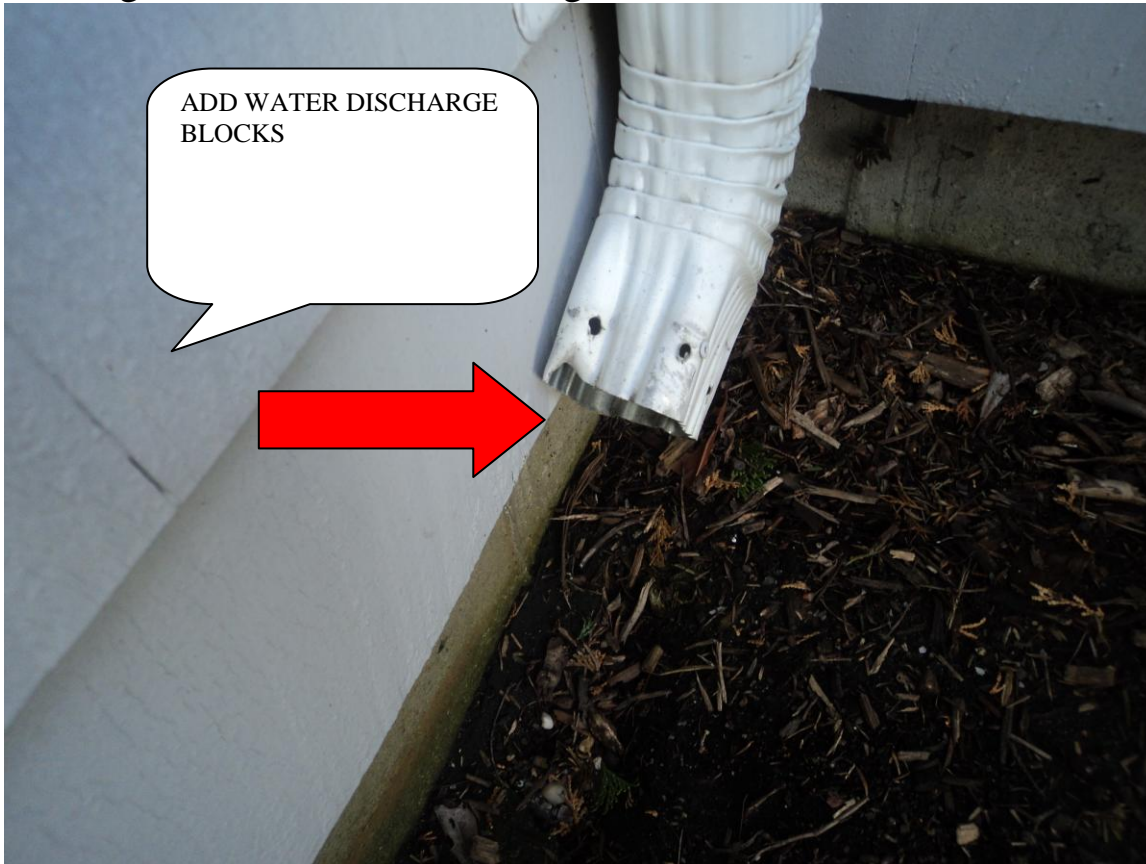
Recommend that gutter extensions be added to downspouts in a couple of locations to channel water away from the foundation during rain events. Additionally, I recommend that roof gutters be cleaned out as part of a regular maintenance program. The present configuration of the gutters allows water to seep into the ground around the foundation creating added stress on the structure and possibly creating a condition for water migration into the house.

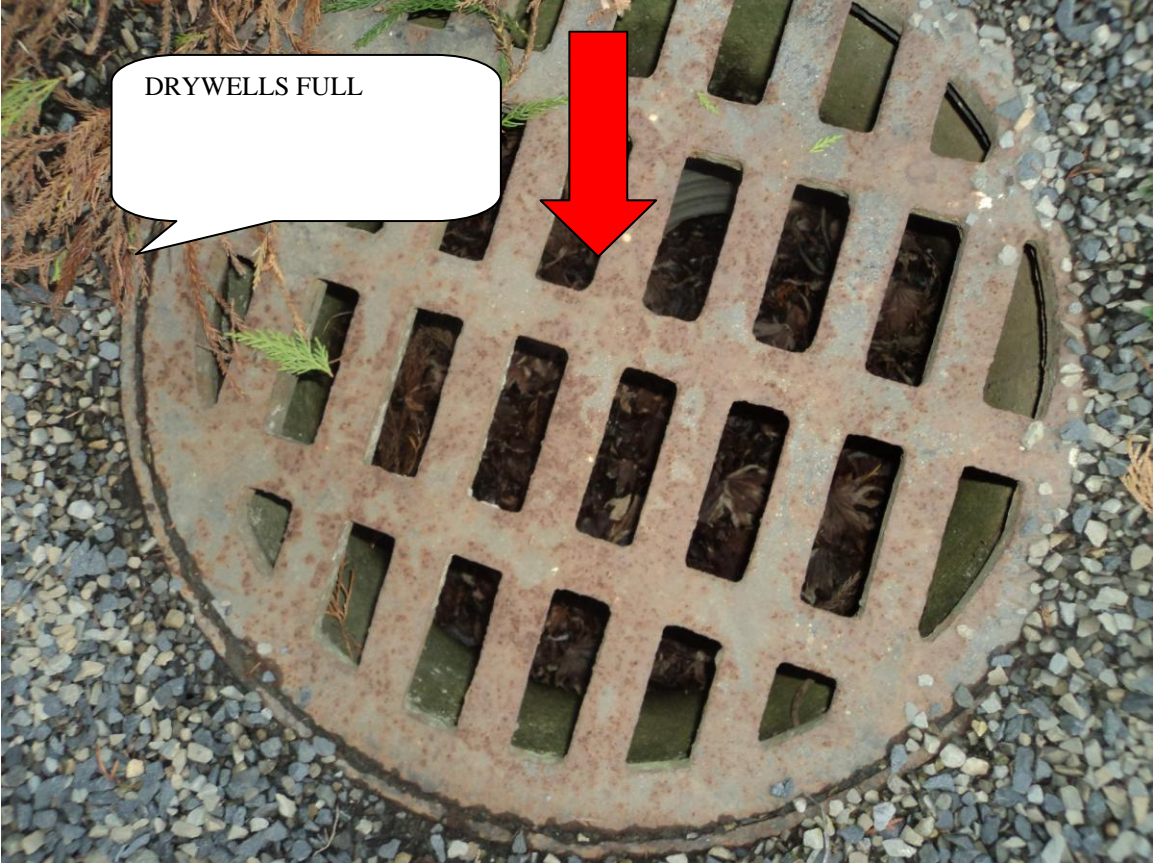
The home has two drywells located in the driveway. Both drywells appear to be full and should be cleaned out with a pump truck at this time.

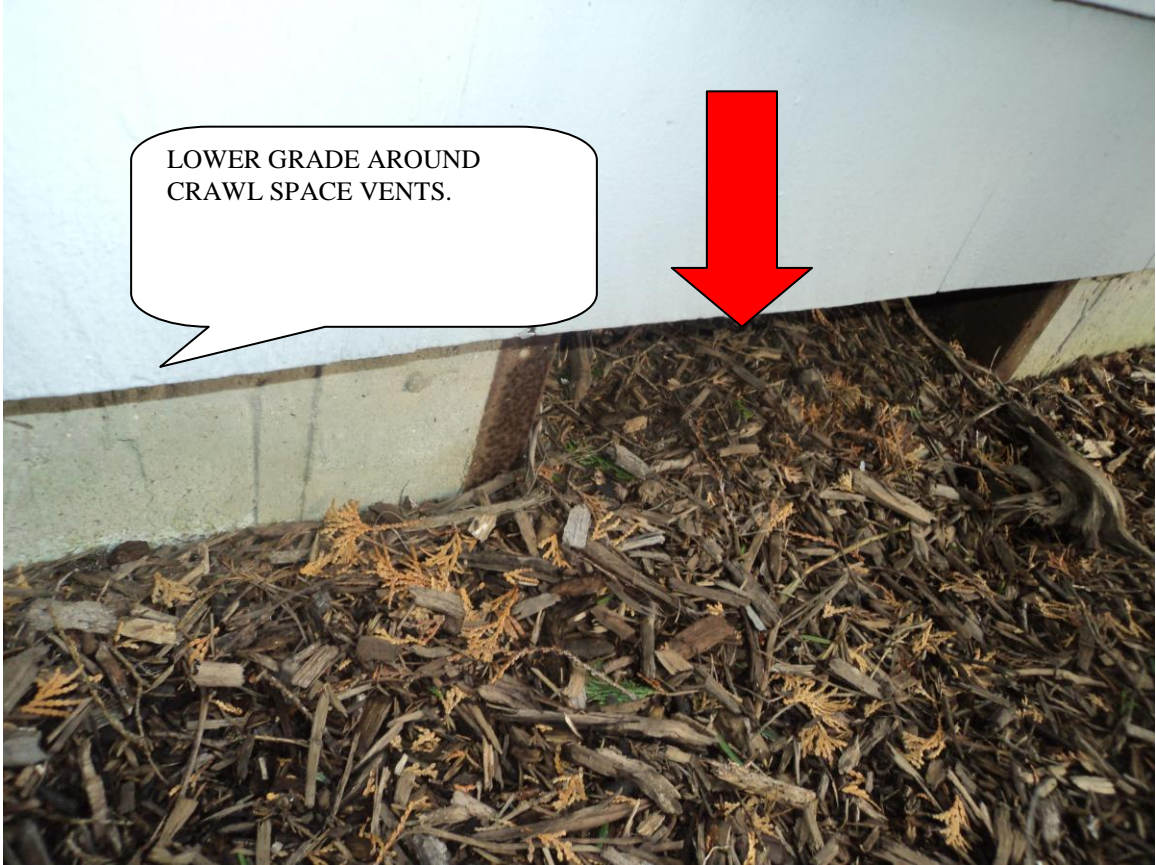
Recommend lowering the grade around the crawl space vents as snow and water can enter the crawl space in these locations.

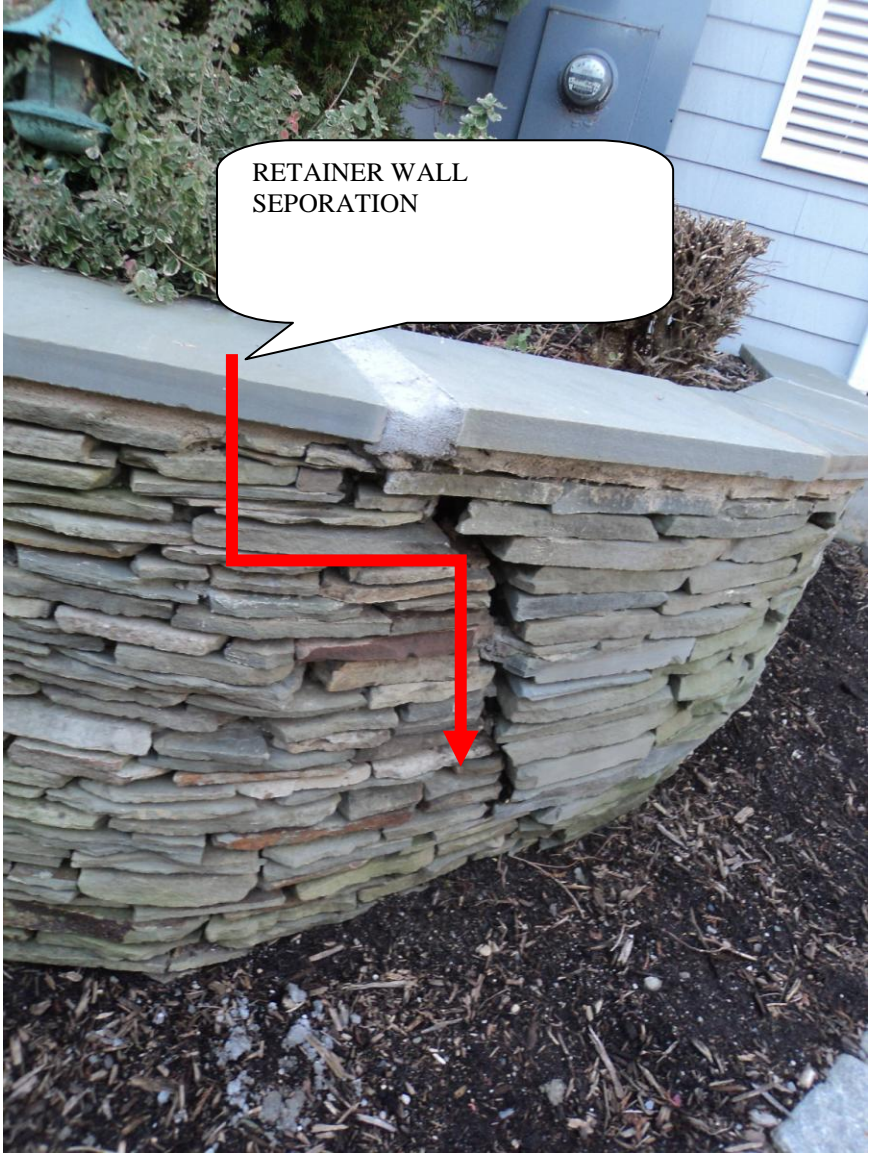
Recommend monitor or re-build of the slate wall that has shifter on the left side of the house near the garage.

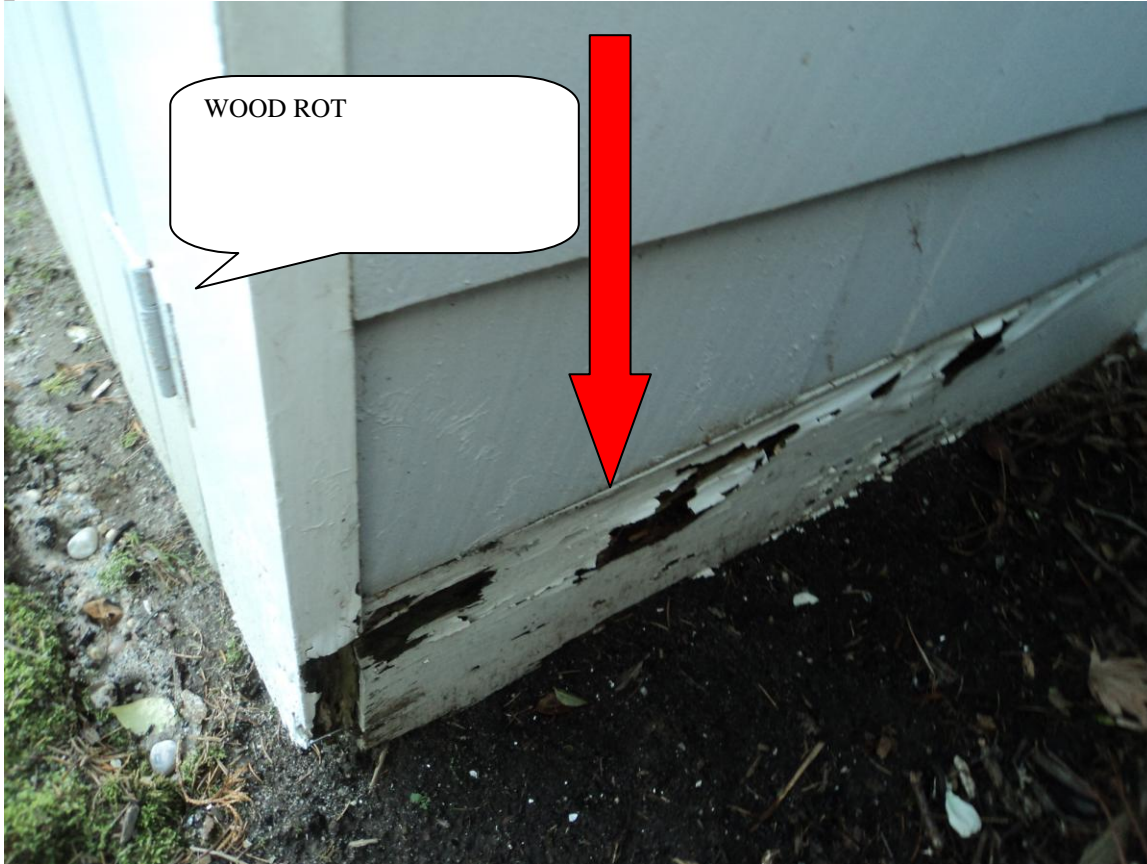
Recommend replacing the rotted wood around the wood storage shed for the garbage pails.

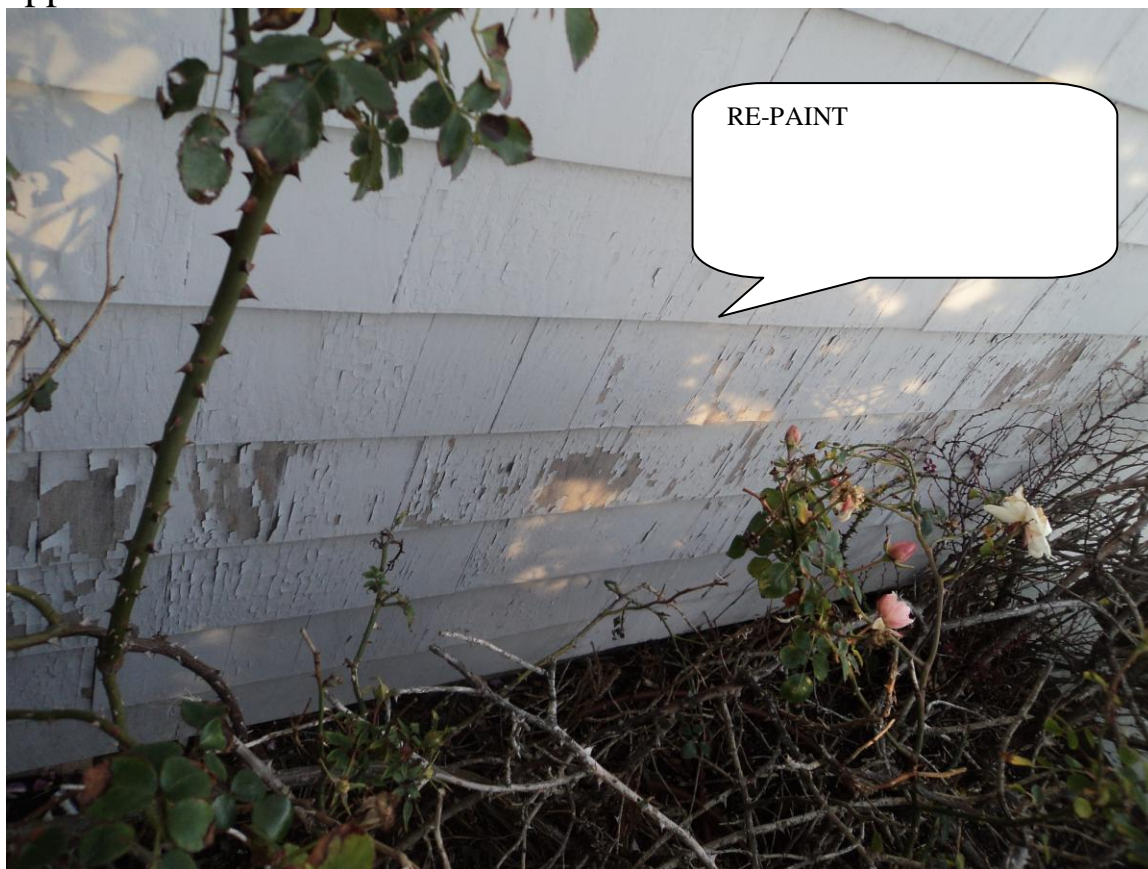
RECOMMENDATIONS: Peeling paint was observed in a number of exterior locations around the house. I recommend that the paint be properly scraped off and disposed of. Subsequent to that, I recommend that a fresh coat of prime and paint be applied.

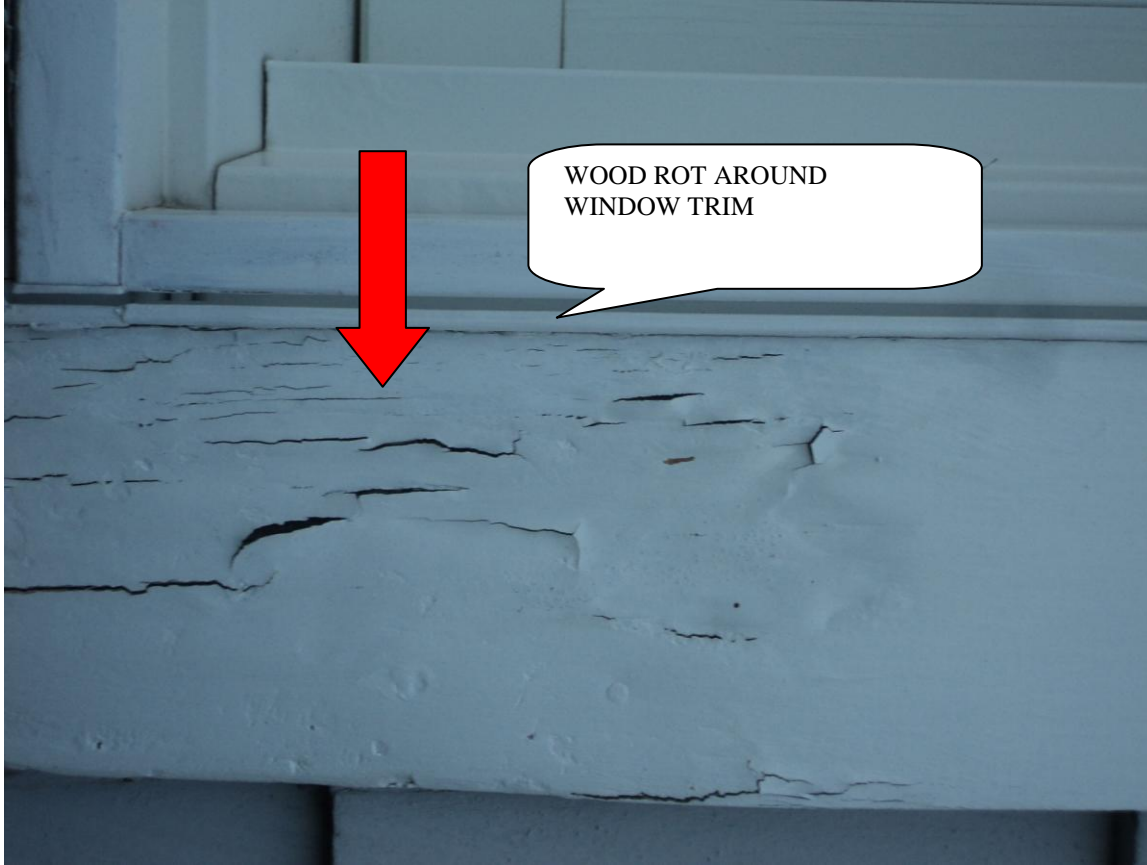
Some wood rot was observed in exterior wood pieces (i.e. wood window trim on the left side of the house near the garage, etc.). I recommend that all affected wood pieces be replaced.

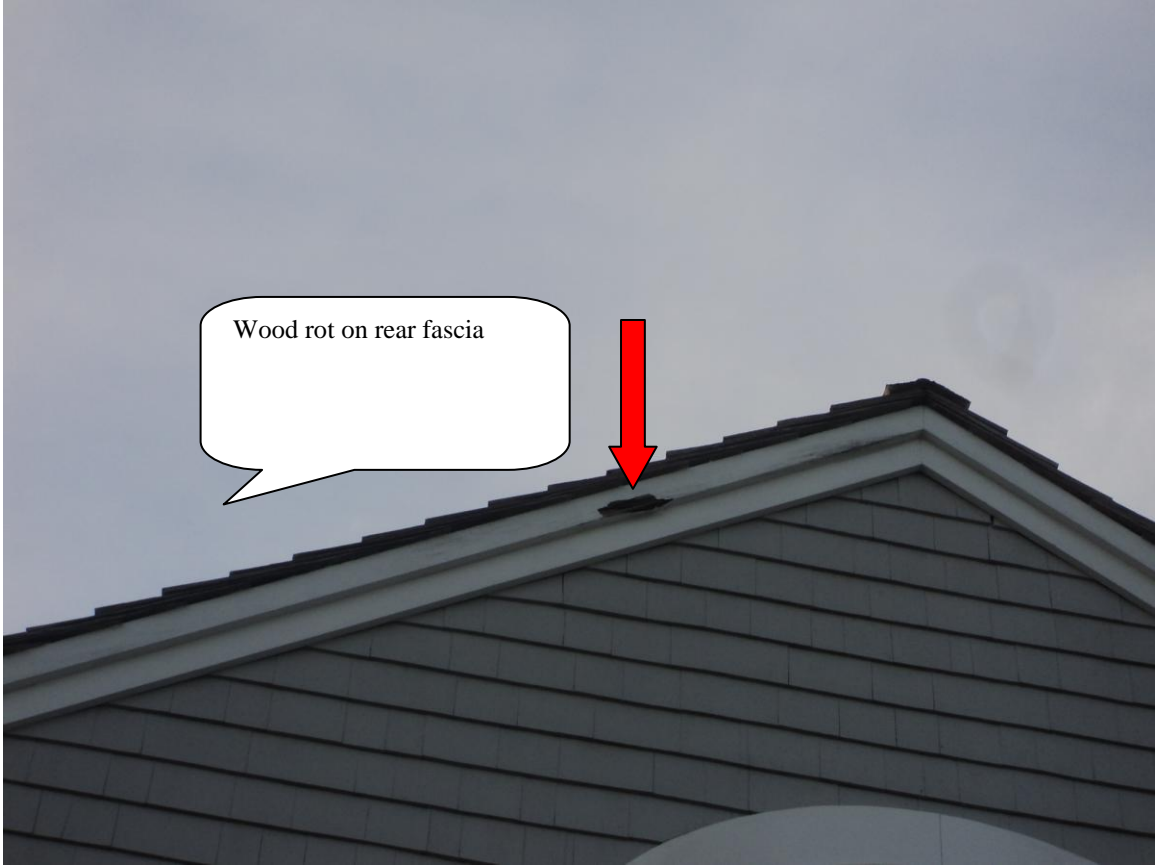
Recommend replacing the rotted wood fascia on the rear of the house.

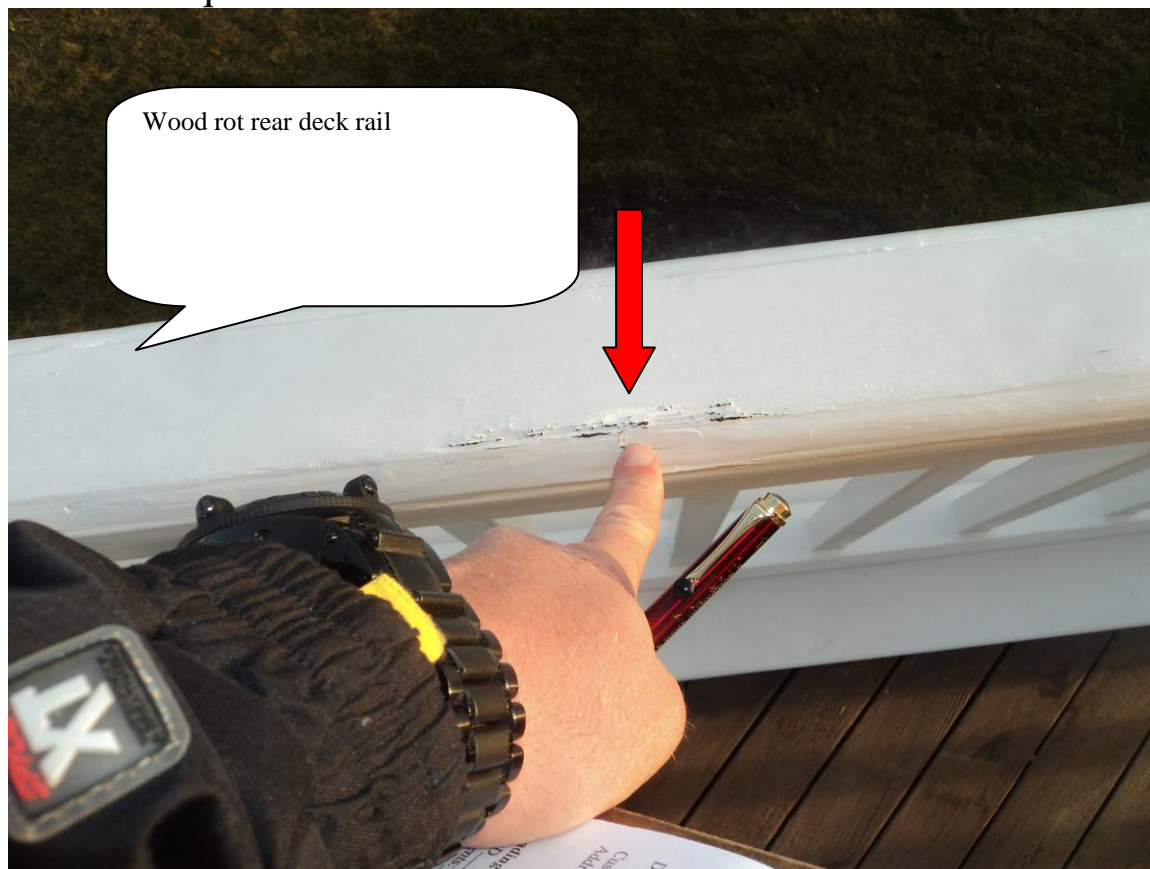
Wood rot was noted to the 2<sup>nd</sup> floor back right deck rails. Recommend replacing wood as required.

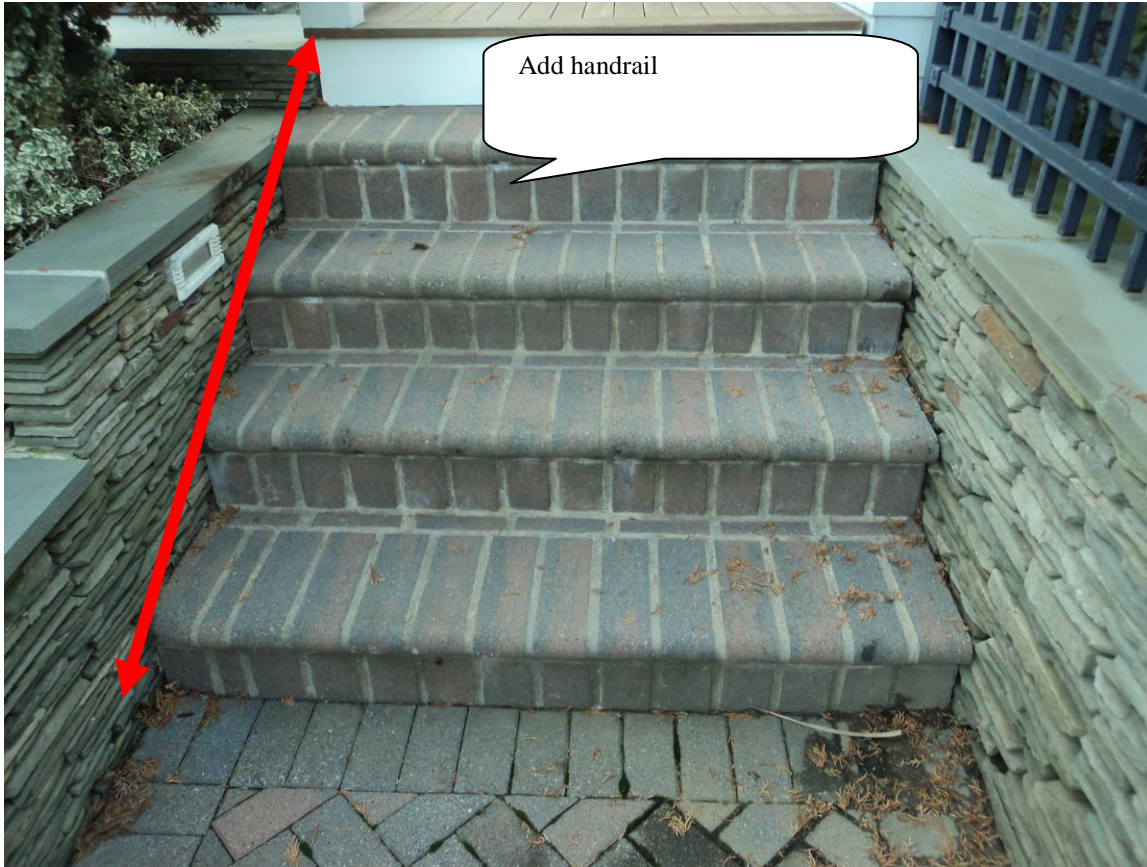
Recommend adding a handrail to the steps leading to the deck on the left side of the house.

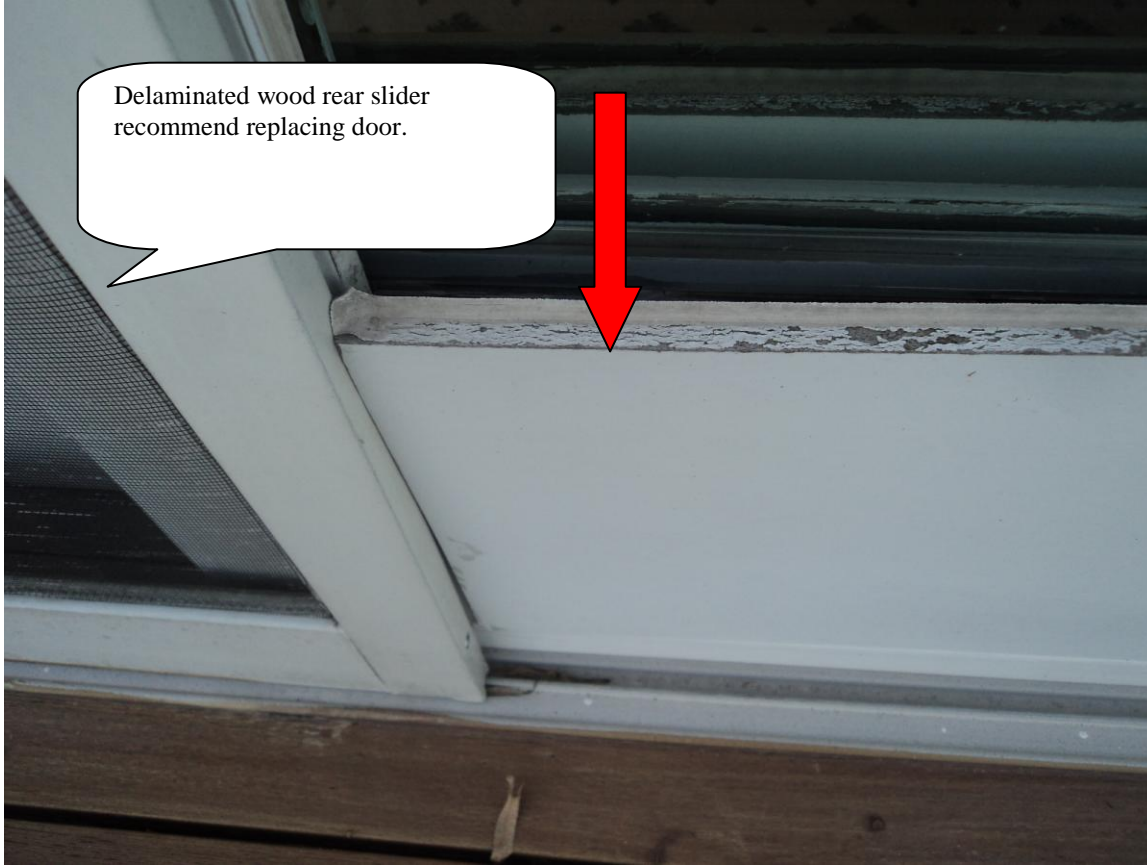
Note the 2<sup>nd</sup> floor sliding door on the back left side of the house had wood delaminating. Recommend replacing the door.

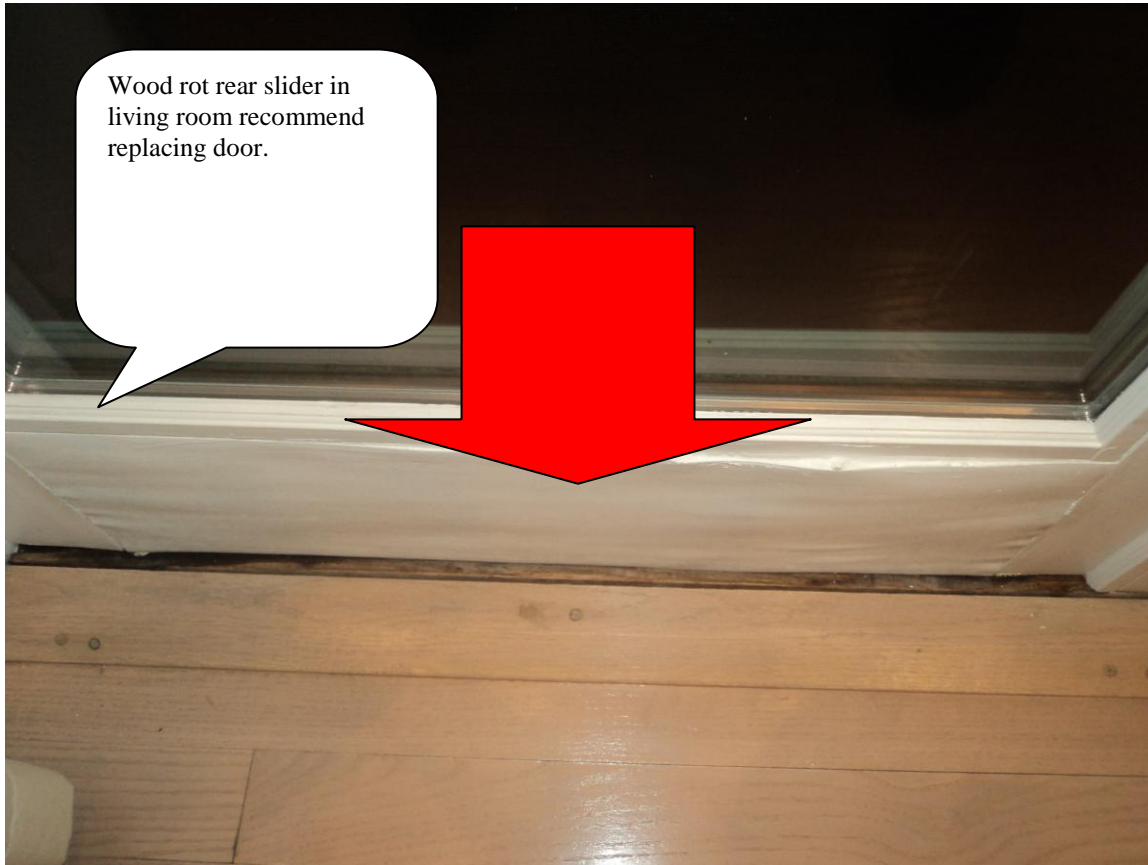
Note the 1<sup>st</sup> floor center sliding door in the living room had wood rot and was delaminating recommend replacing the door.

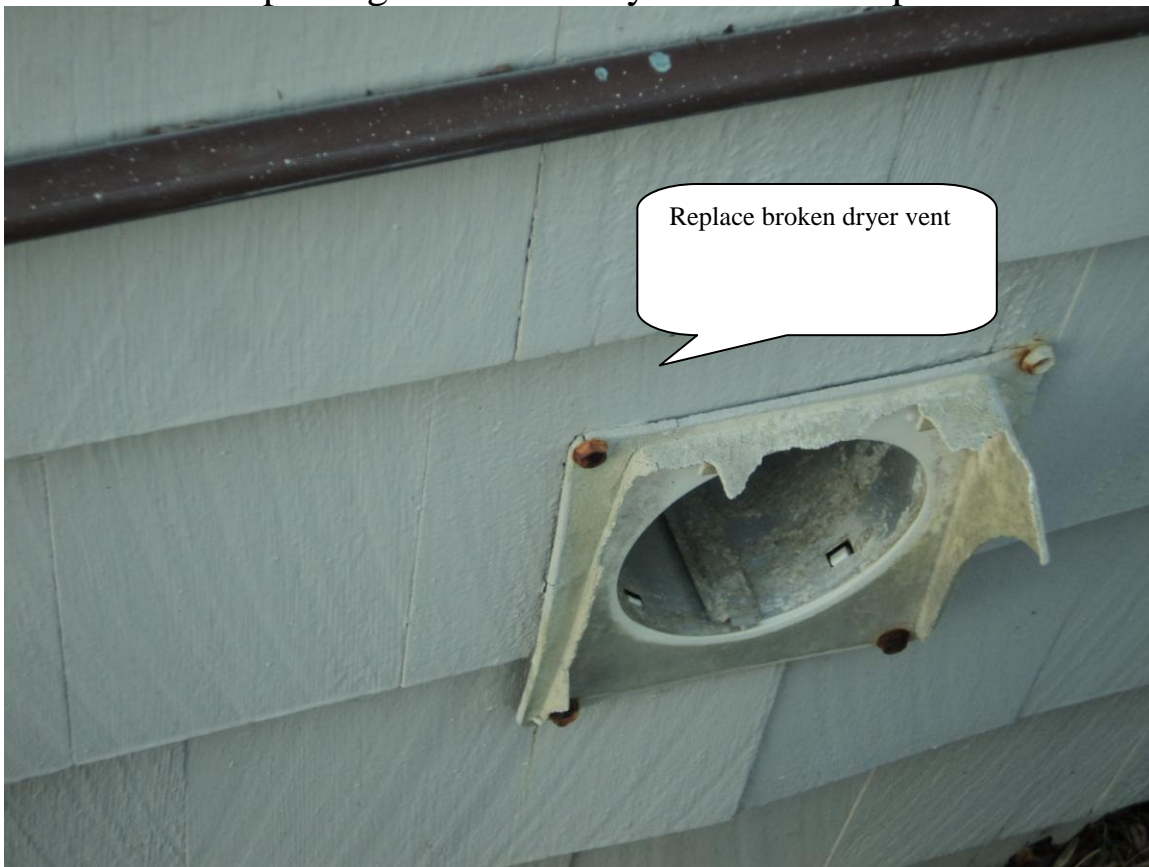
Recommend replacing the broken dryer vent on the pool house.

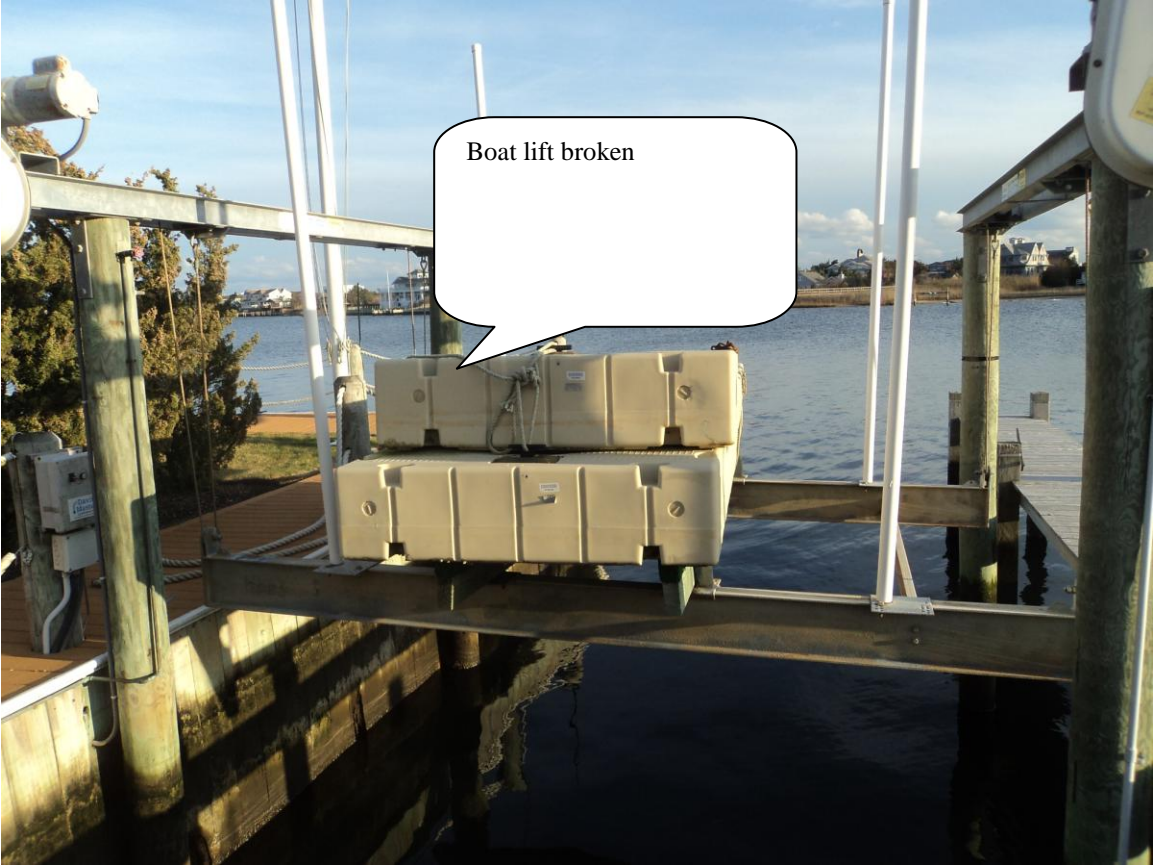
Recommend repairing the broken boat lift as this unit was not working at this time.
