# **AC & E HOME INSPECTION CORP.**

## **CONCLUSION**

12/10/2011

DESCRIPTION OF HOUSE: Two Story

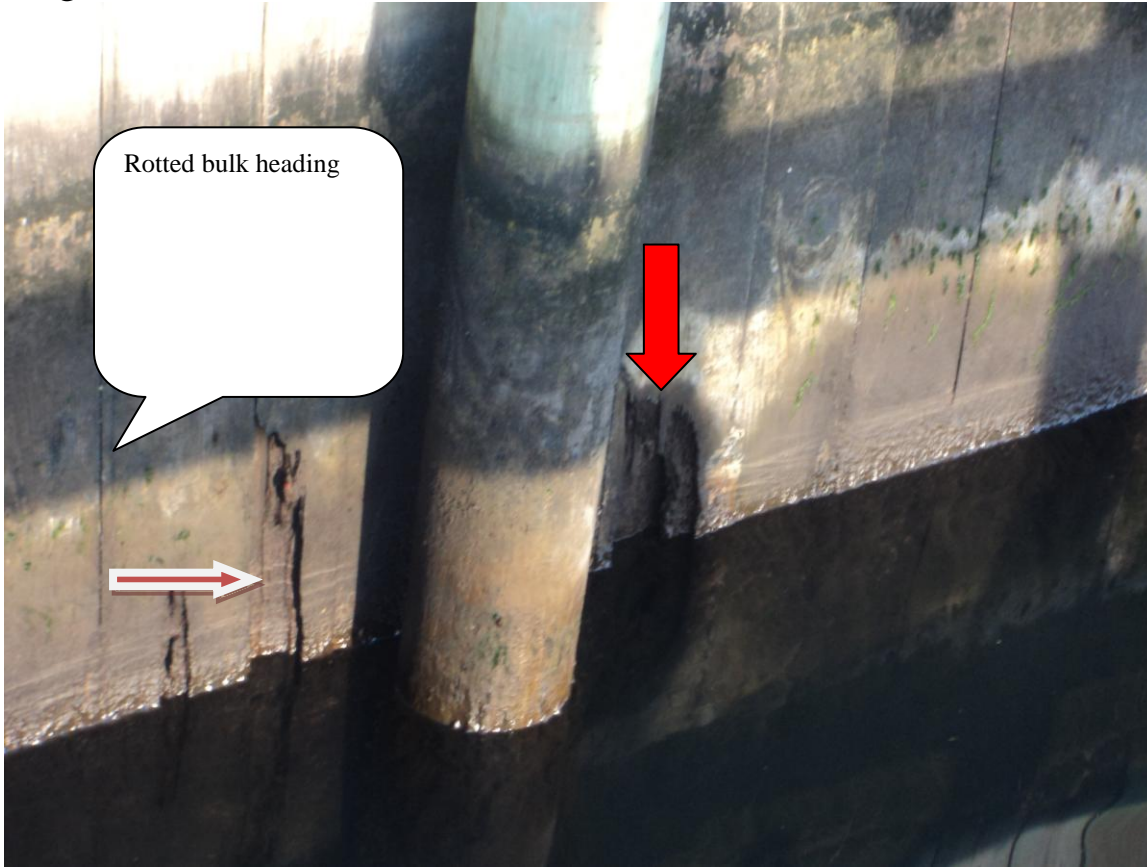
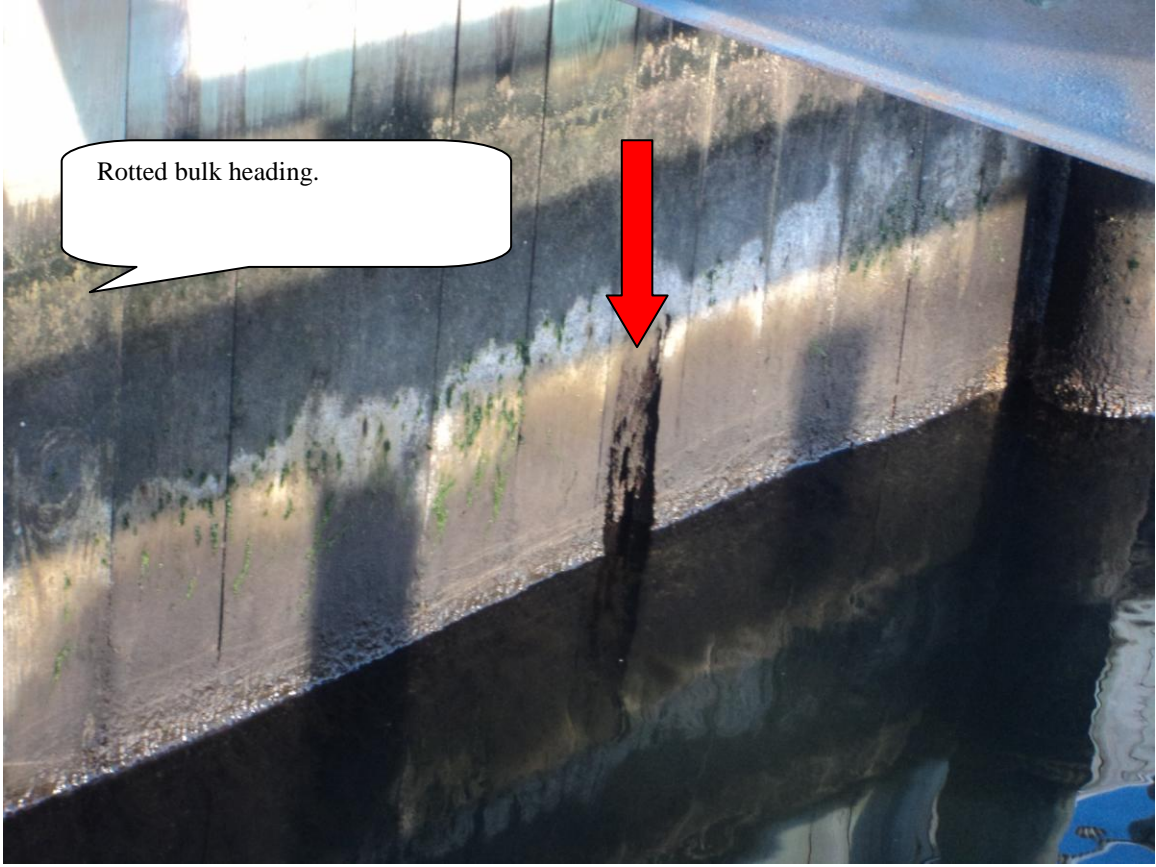
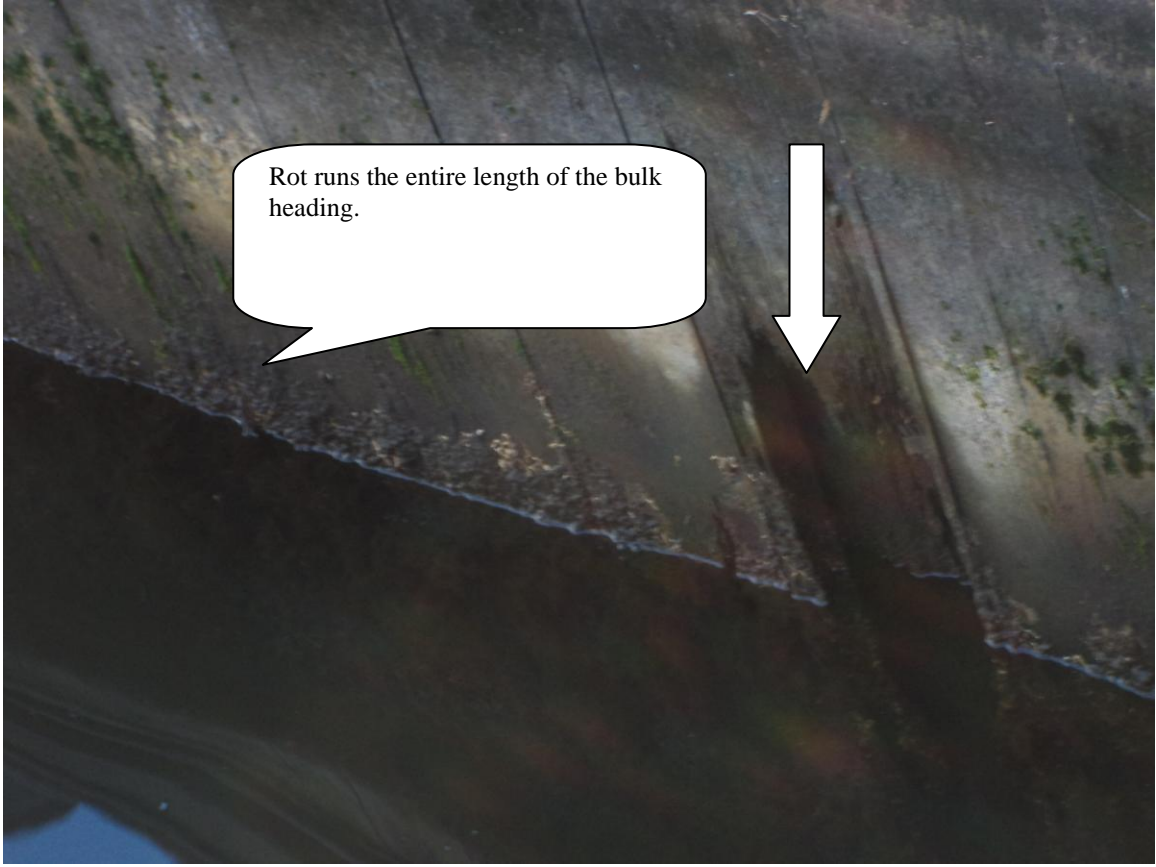
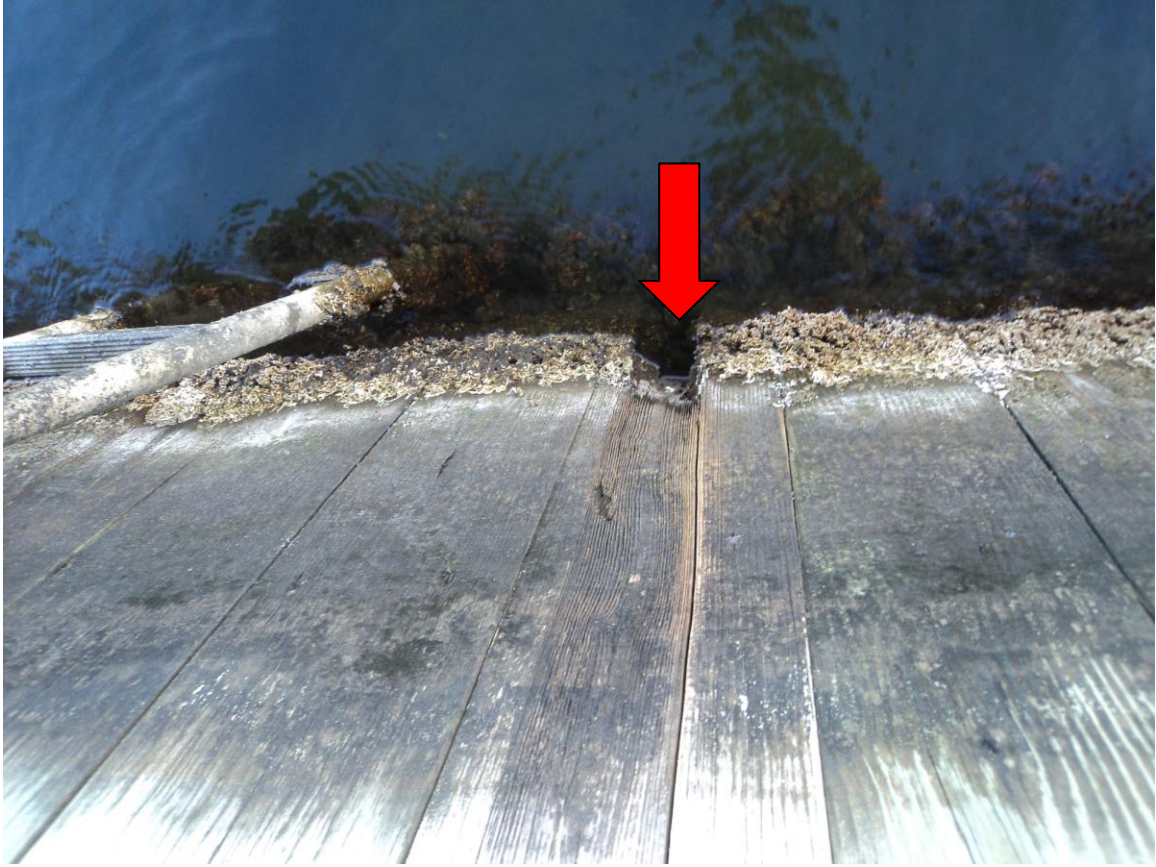
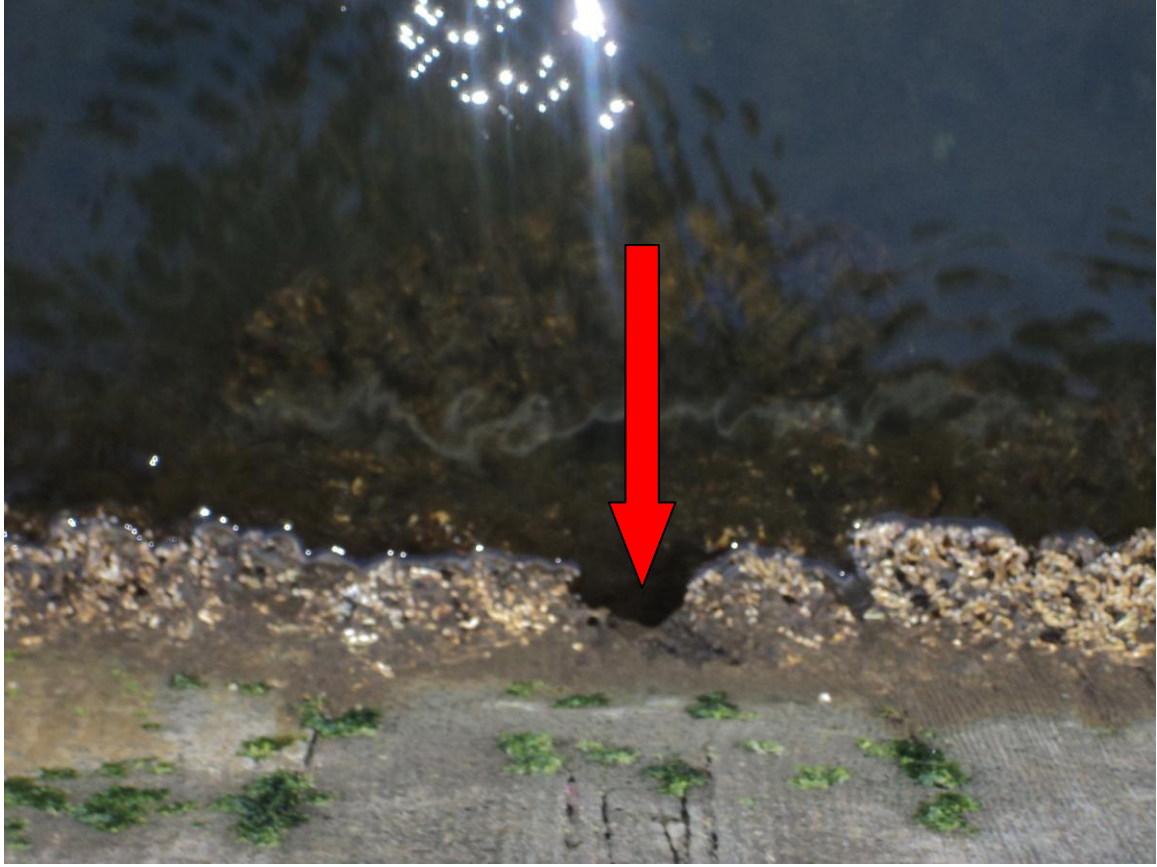
At the time of the inspection the bulk heading was worn and damaged in many areas on the front face boards. Recommend having a bulk heading company come out and give you cost estimates for replacing the bulk heading as this may run in the 250k range.

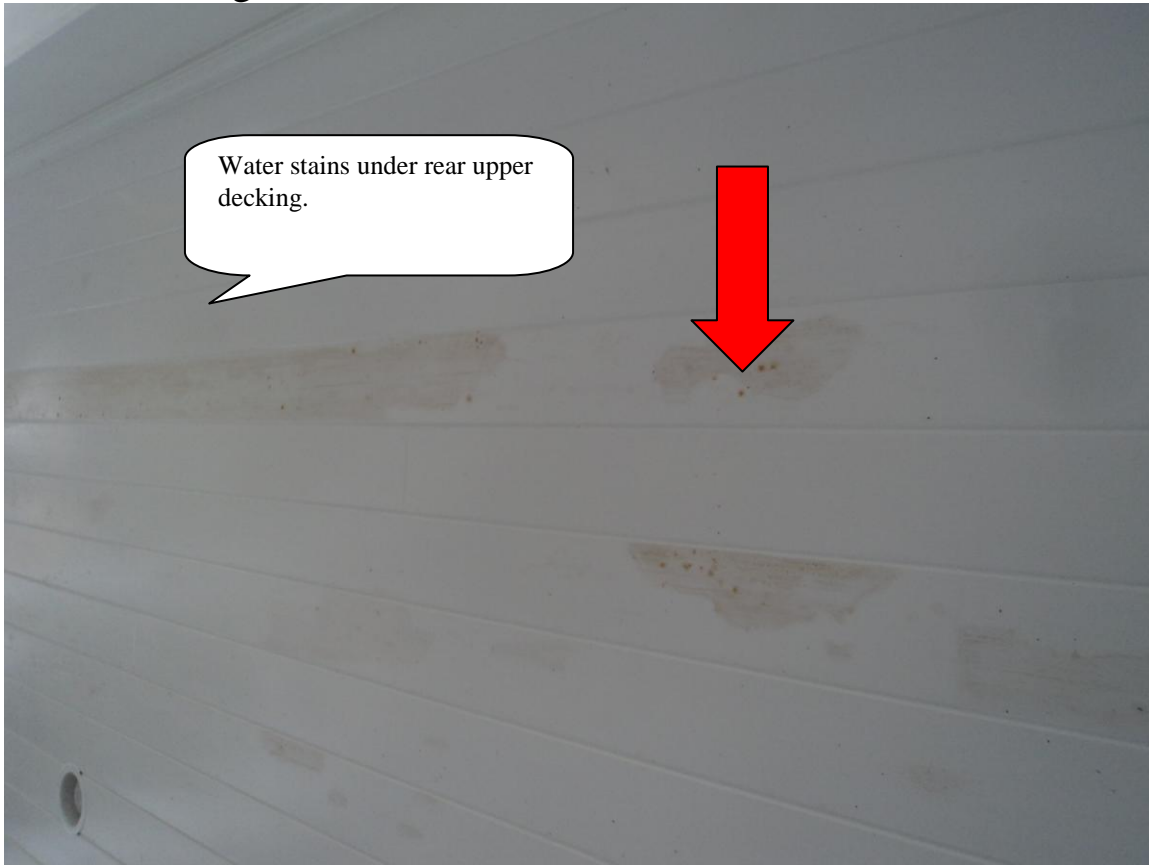
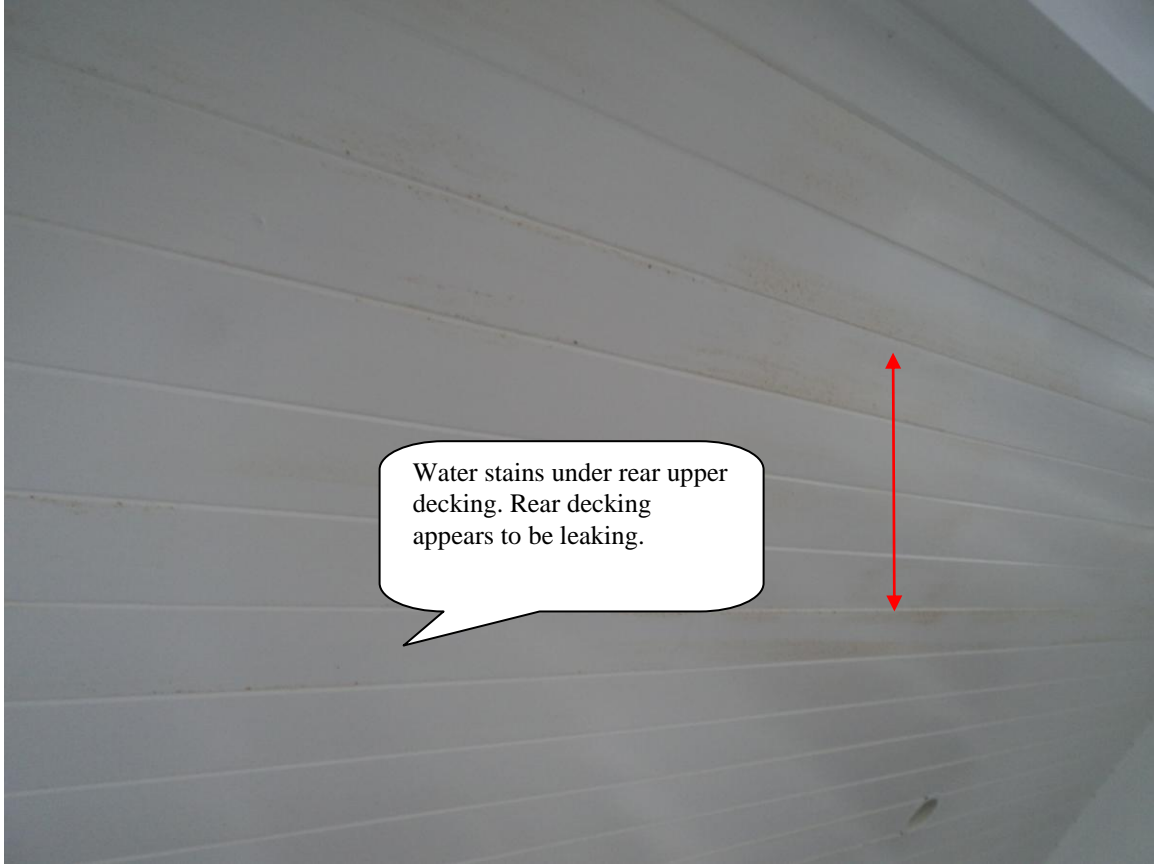
- 1) Roof leaks were noted to the wood under the decks in the rear of the house on both the left and right sides.

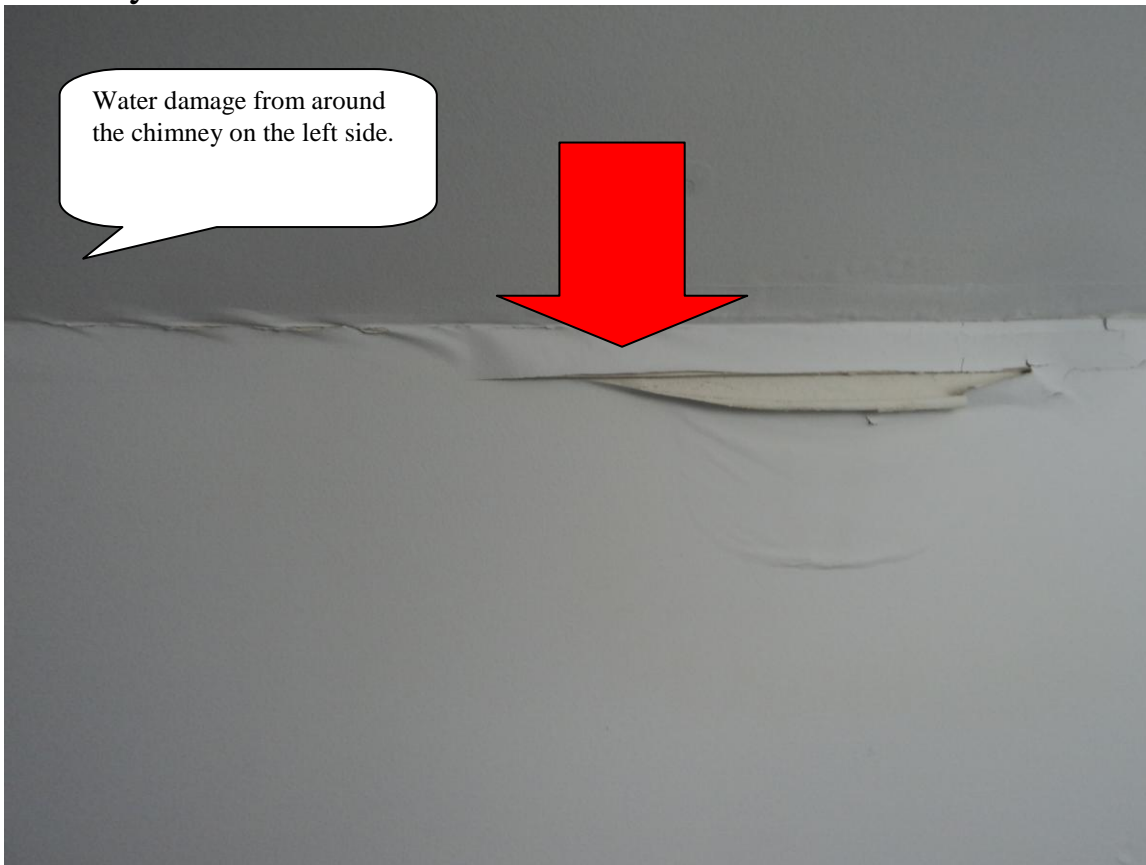
2) Roof leaks were noted in the 2<sup>nd</sup> floor closet on the back left side around the chimney area.

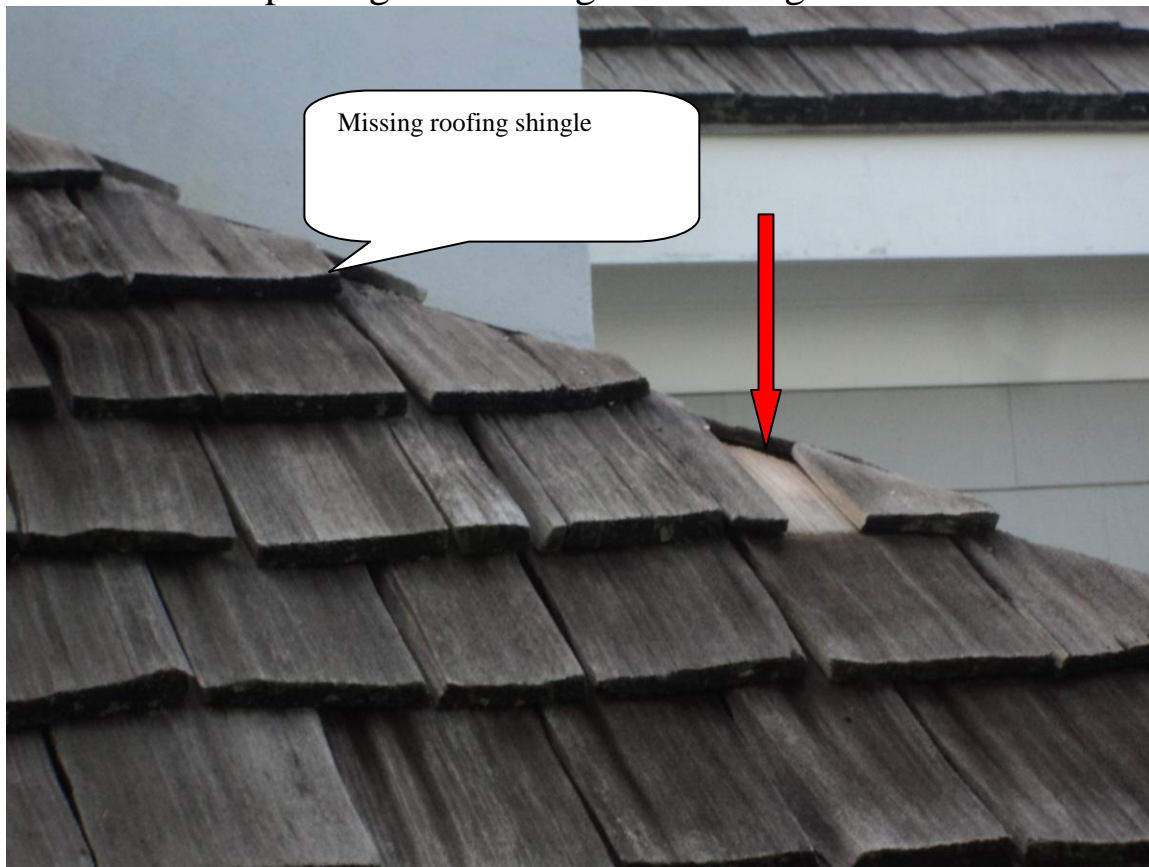
Recommend replacing the missing wood shingle on the back left side of the house.

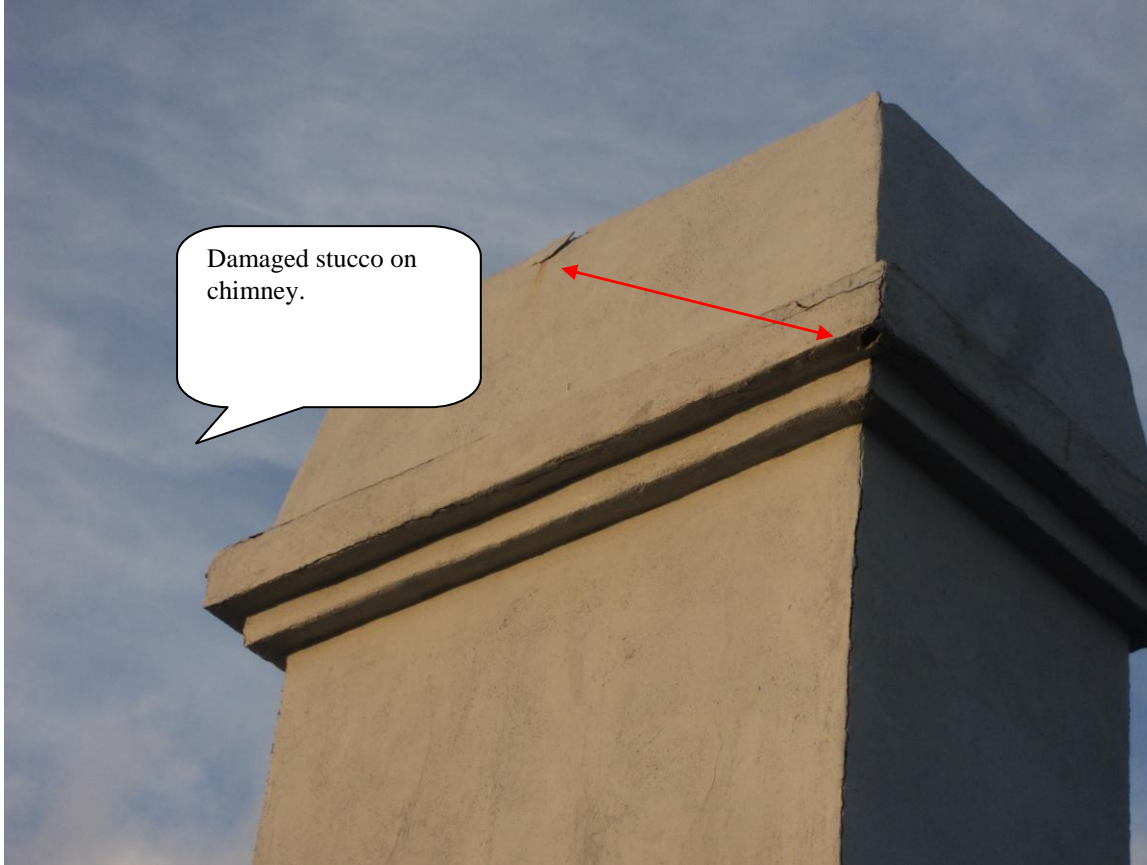
The chimney on the back right side of the house has some damaged stucco around the outside. Recommend repair to the chimney at this time.

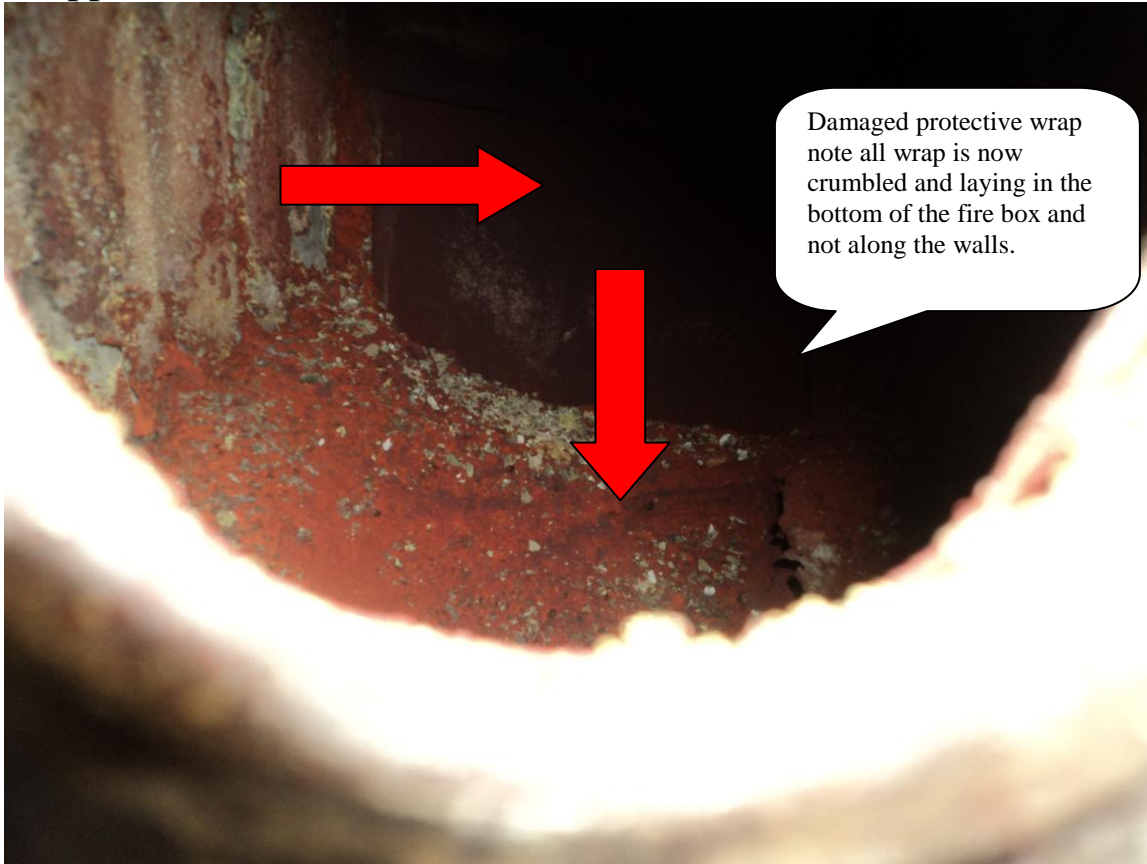
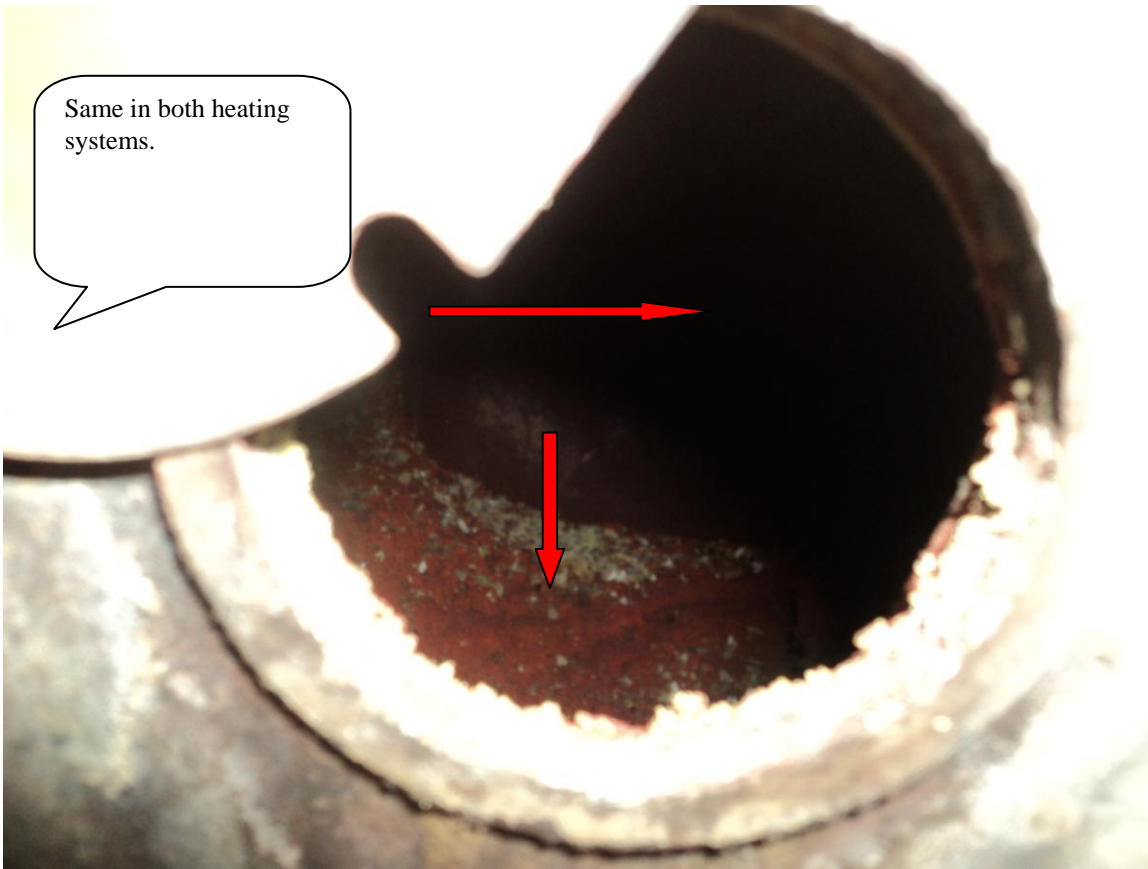
Inspection of the heating systems shows damage to both internal firebox protective wraps on the heating systems. Recommend having both heating system fireboxes re-wrapped at this time. Failure of this can cause the boiler cores to crack.

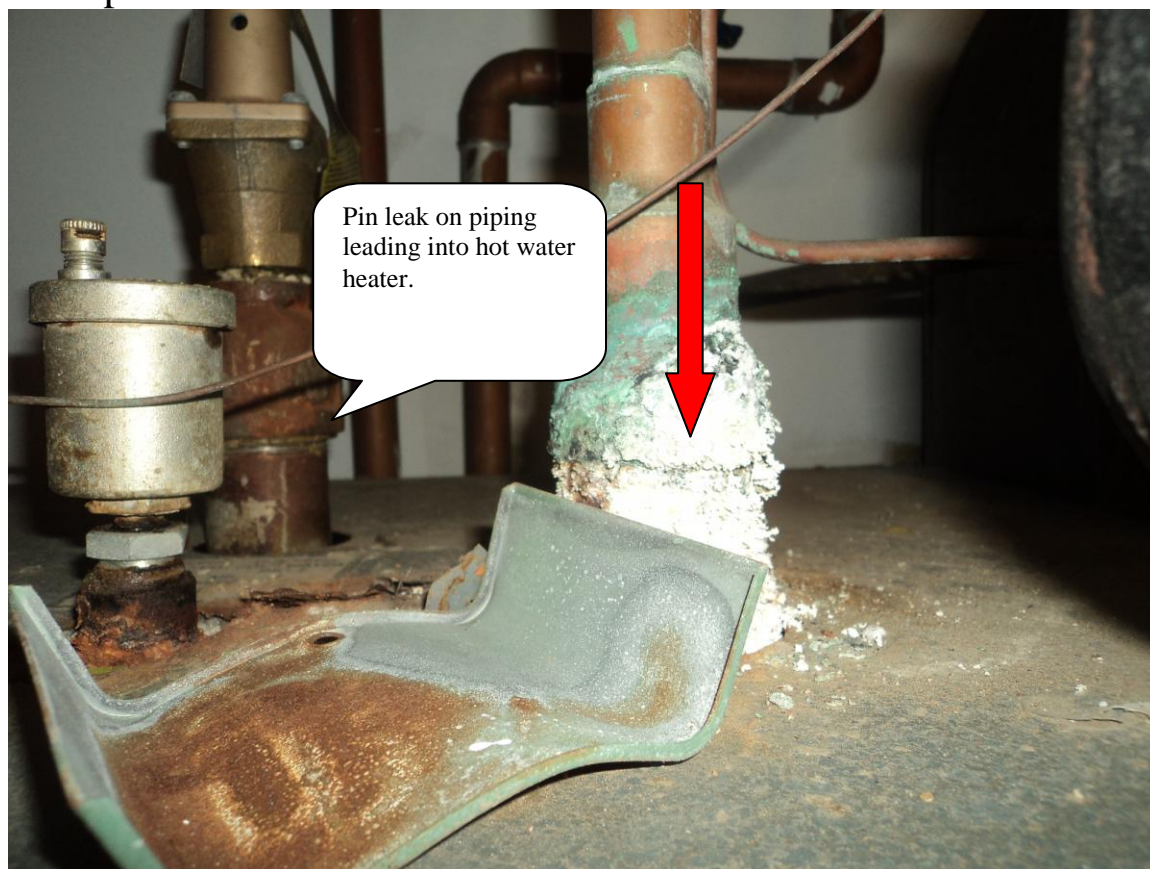
Recommend repairing the pin leak on the pipes leading into the hot water heater at the top.

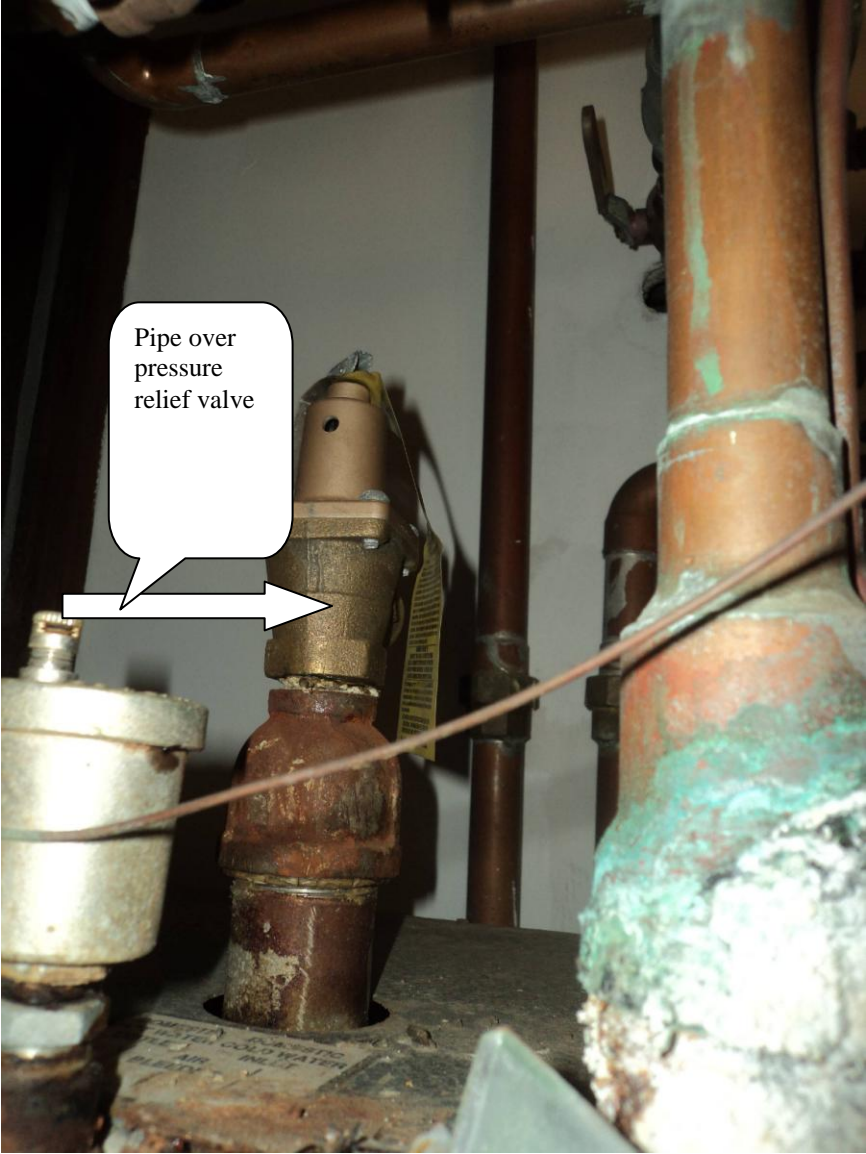
Recommend installing a safety extension for the relief valve on the hot water heater.

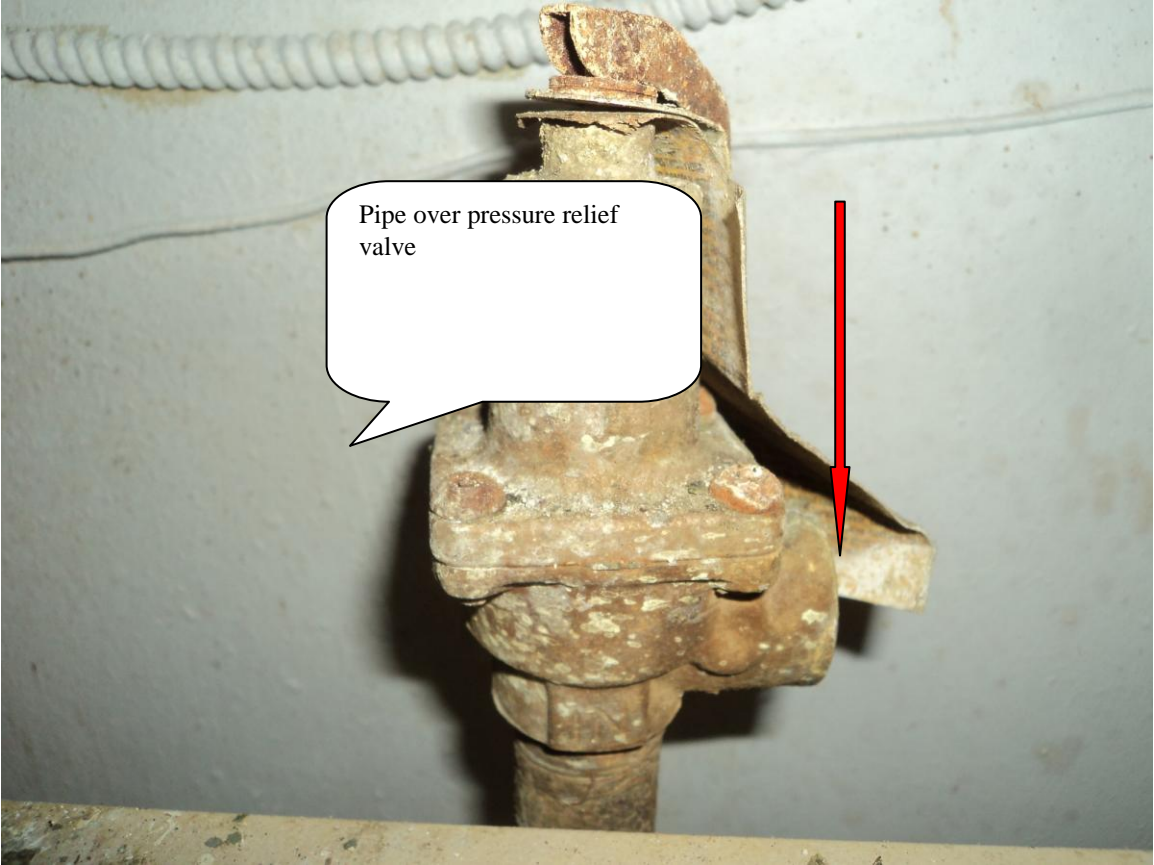
Recommend installing a safety extension for the relief valve on the boilers.

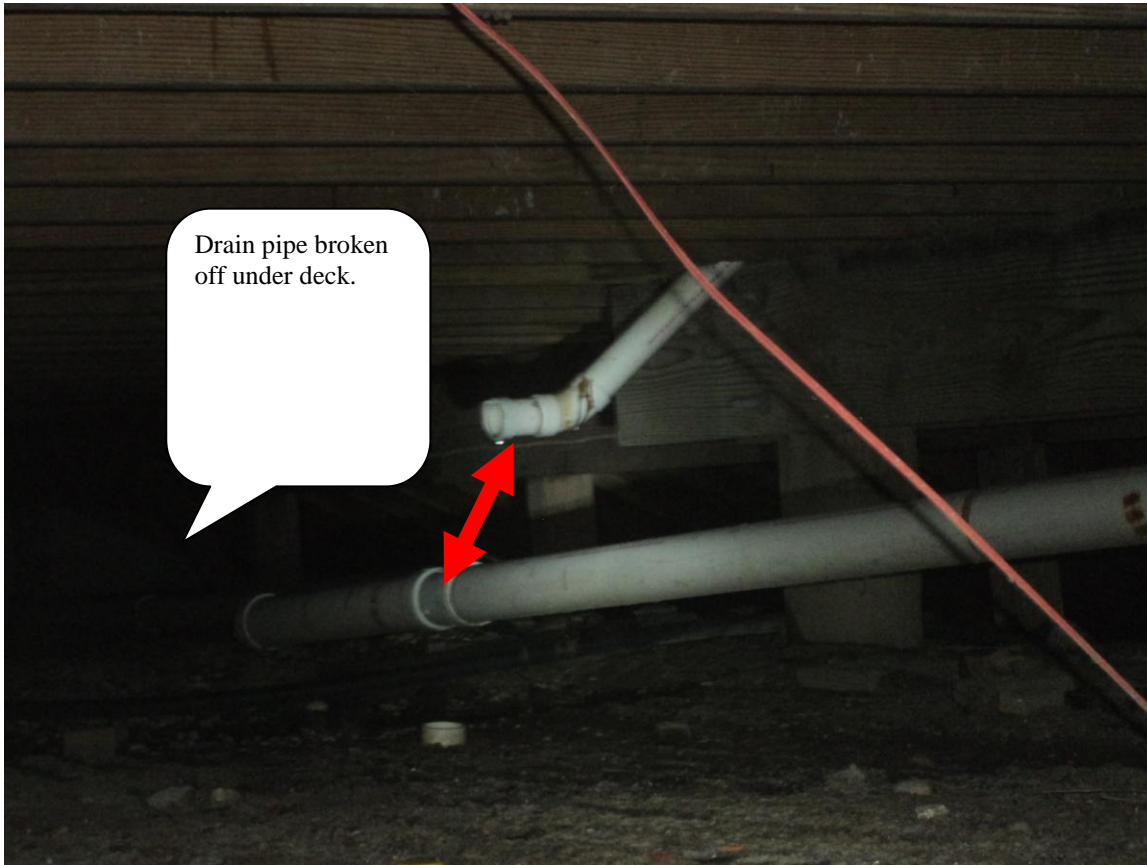
RECOMMENDATIONS: Recommend replacing the broken PVC roof drain pipe under the deck.

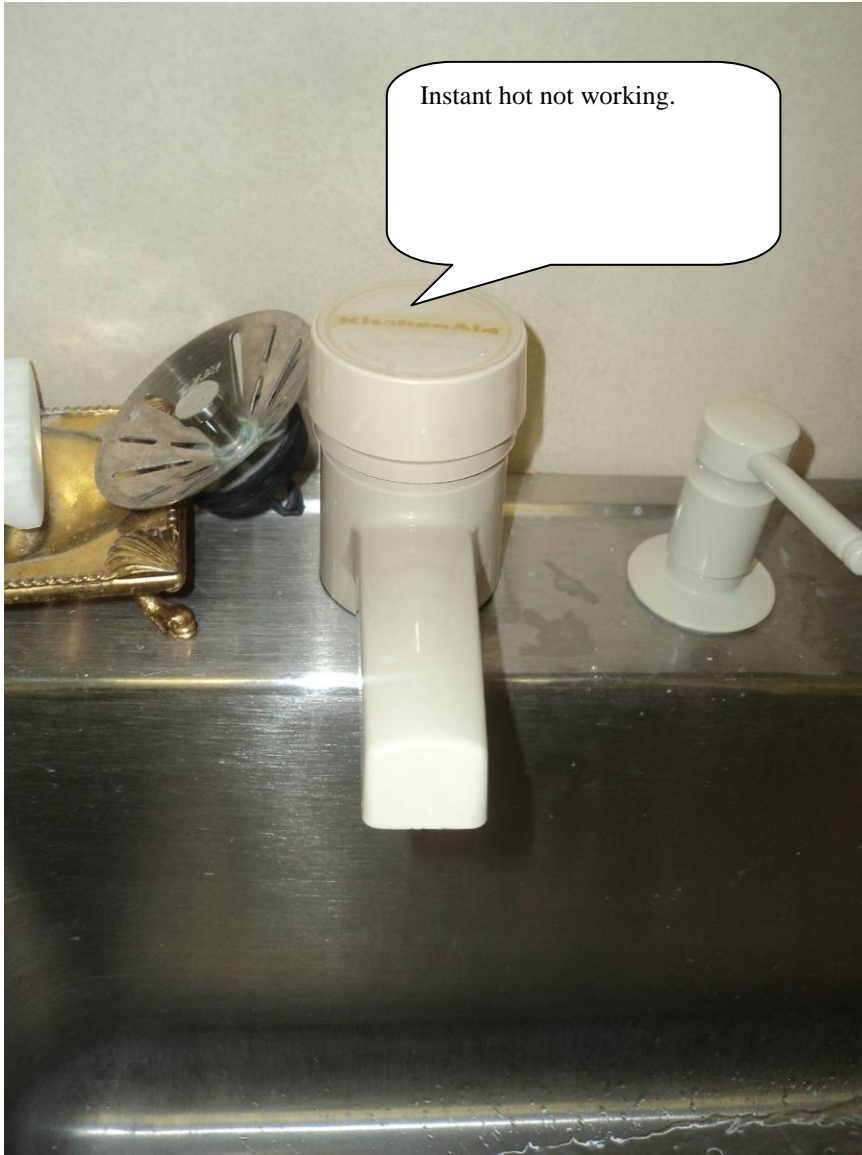
Recommend replacing the non-working instant hot water dispenser on the laundry room off the kitchen.

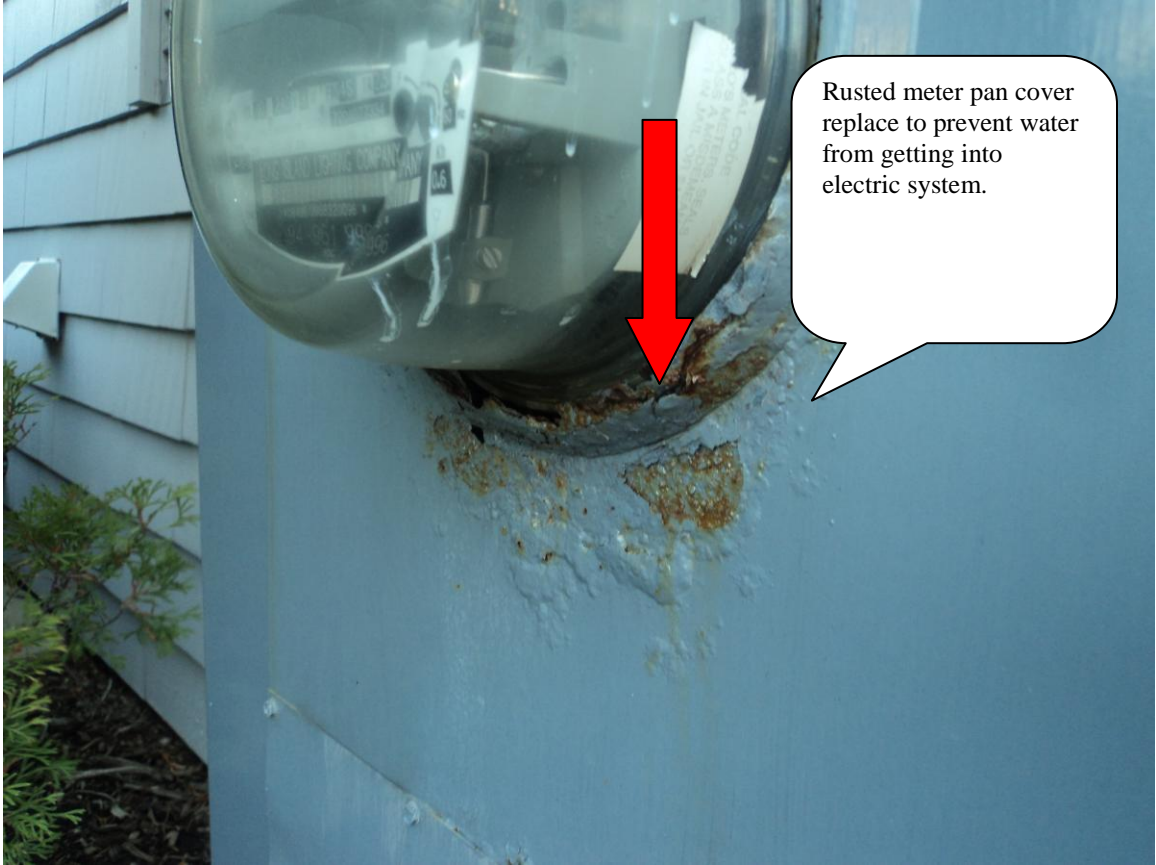
Recommend replacing the rusted meter pan cover to prevent water from entering the electric meter pan on the house.

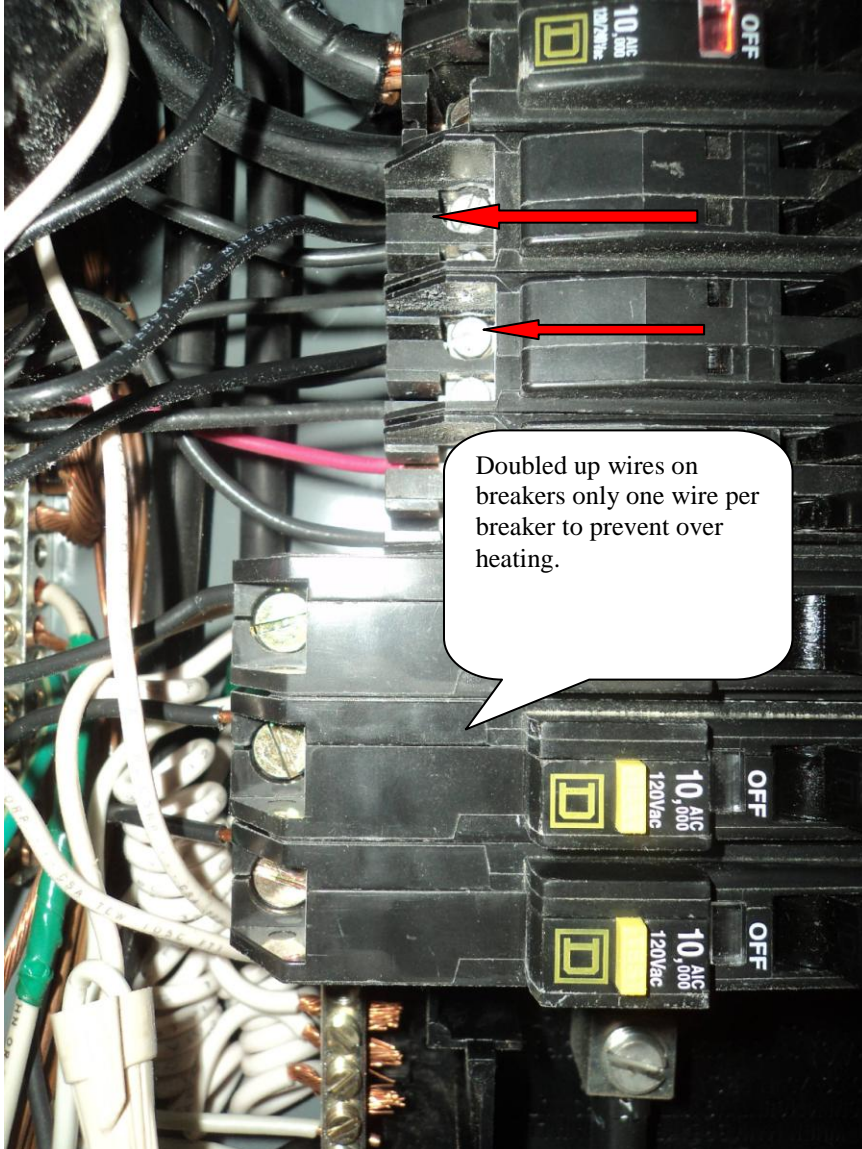
There were two wires in the service panel that were doubled up on three breakers. In the pool house electric panel. The wires should come off at this time and go on their own breakers.

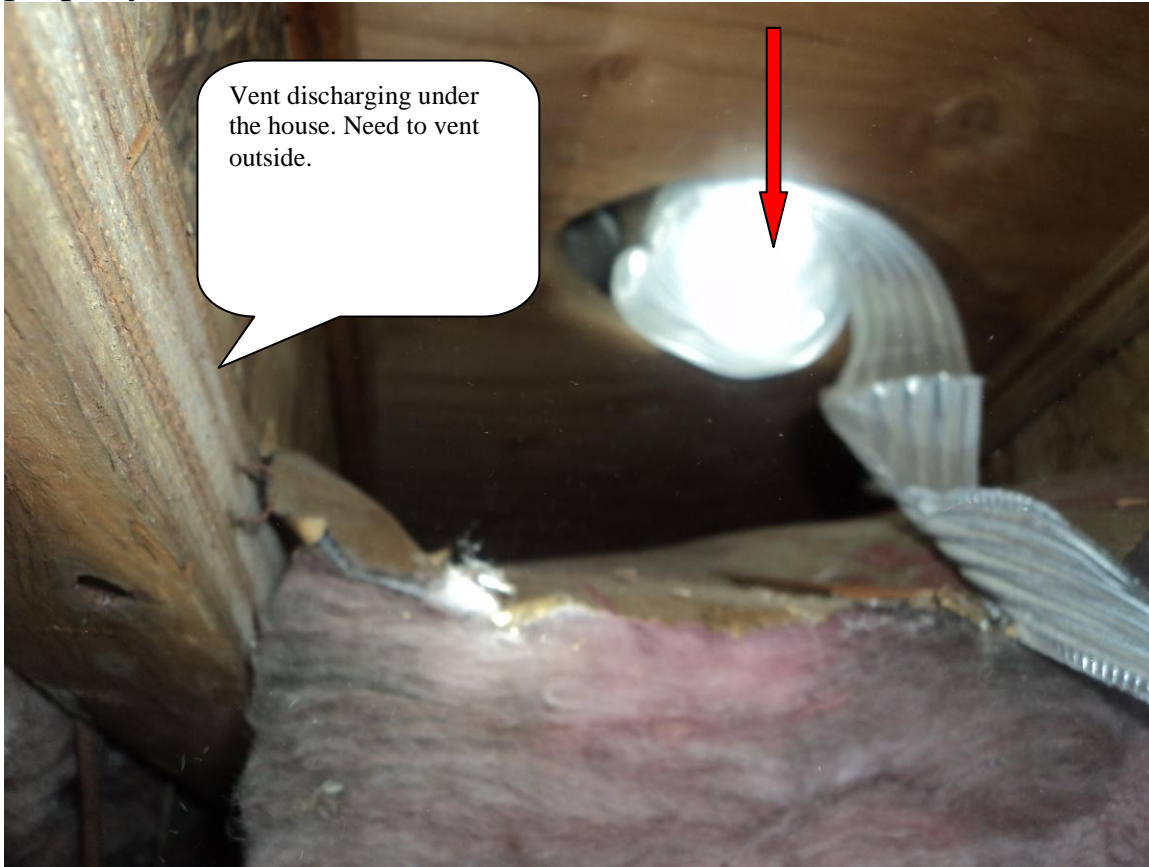
Recommend having the open bathroom fan vent that is discharging under the house properly vented to the outside of the house.

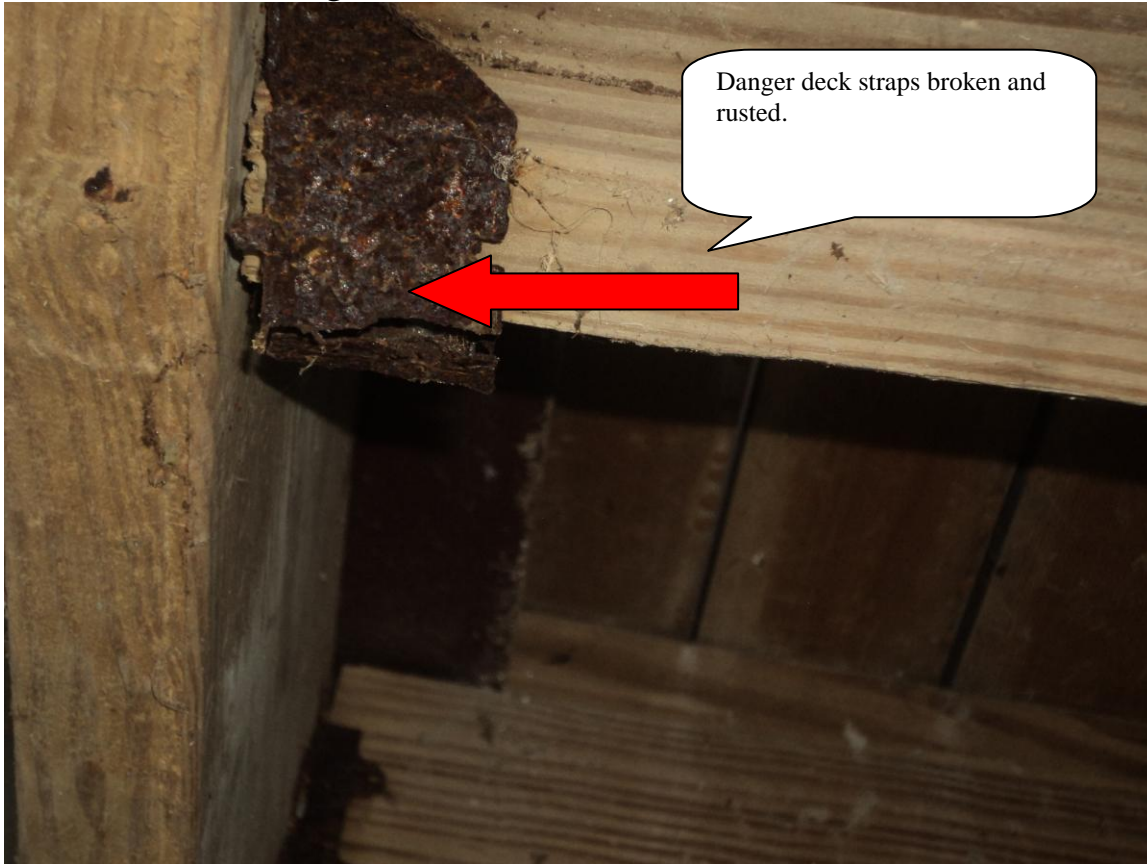
Recommend replacing all rusted out and broken deck hanger straps. Broken deck straps can cause serious injury to people on the deck above due to deck failure. Recommend having this corrected at this time.

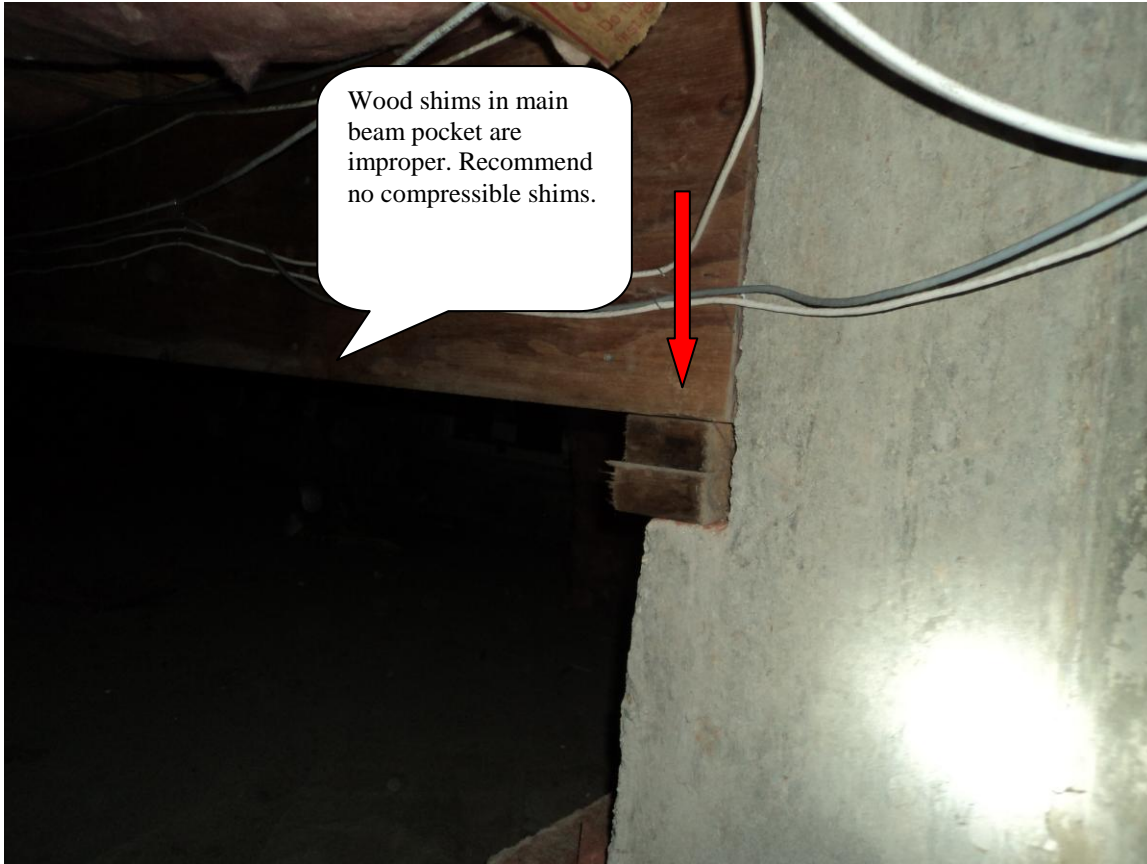
At the time of the inspection there was the back right main beam improperly supported in the pocket of the foundation. Recommend having non-compressible shims installed in this location at this time.
