# **AC & E HOME INSPECTION CORP.**

## **CONCLUSION**

12/10/2011

DESCRIPTION OF HOUSE: Two Story

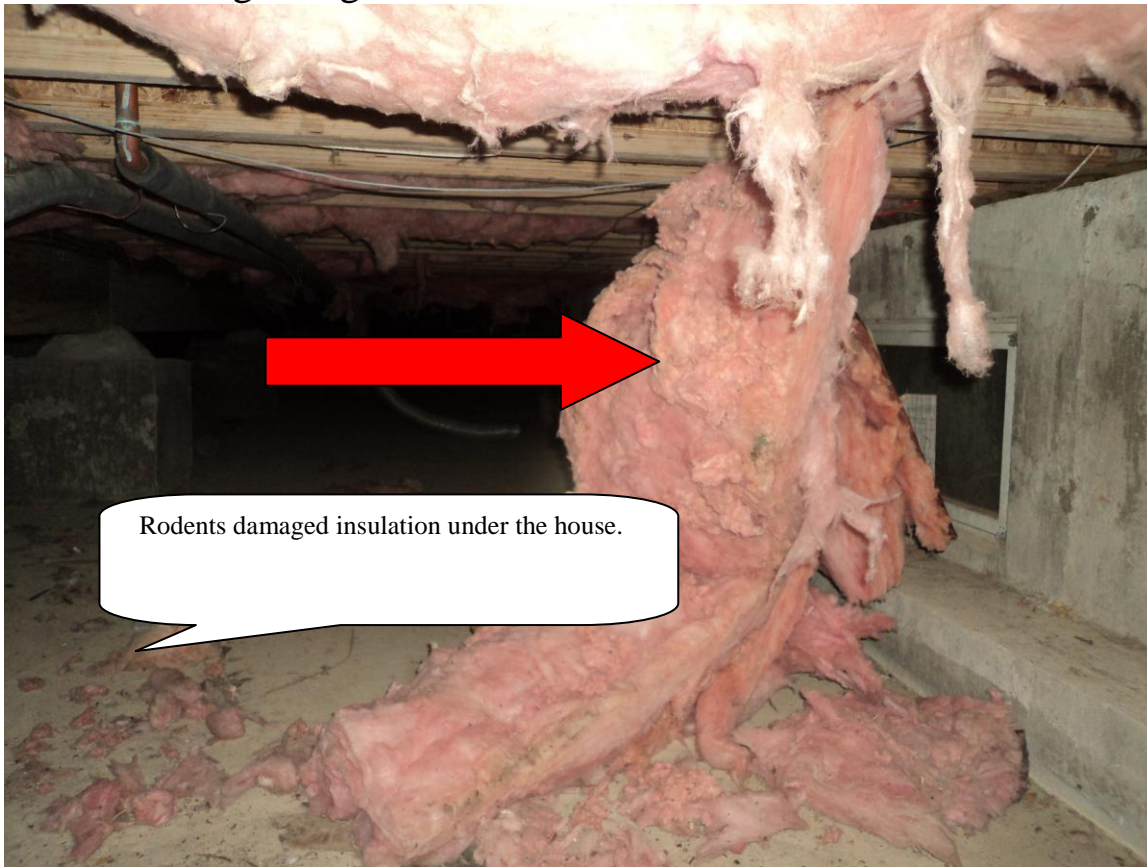
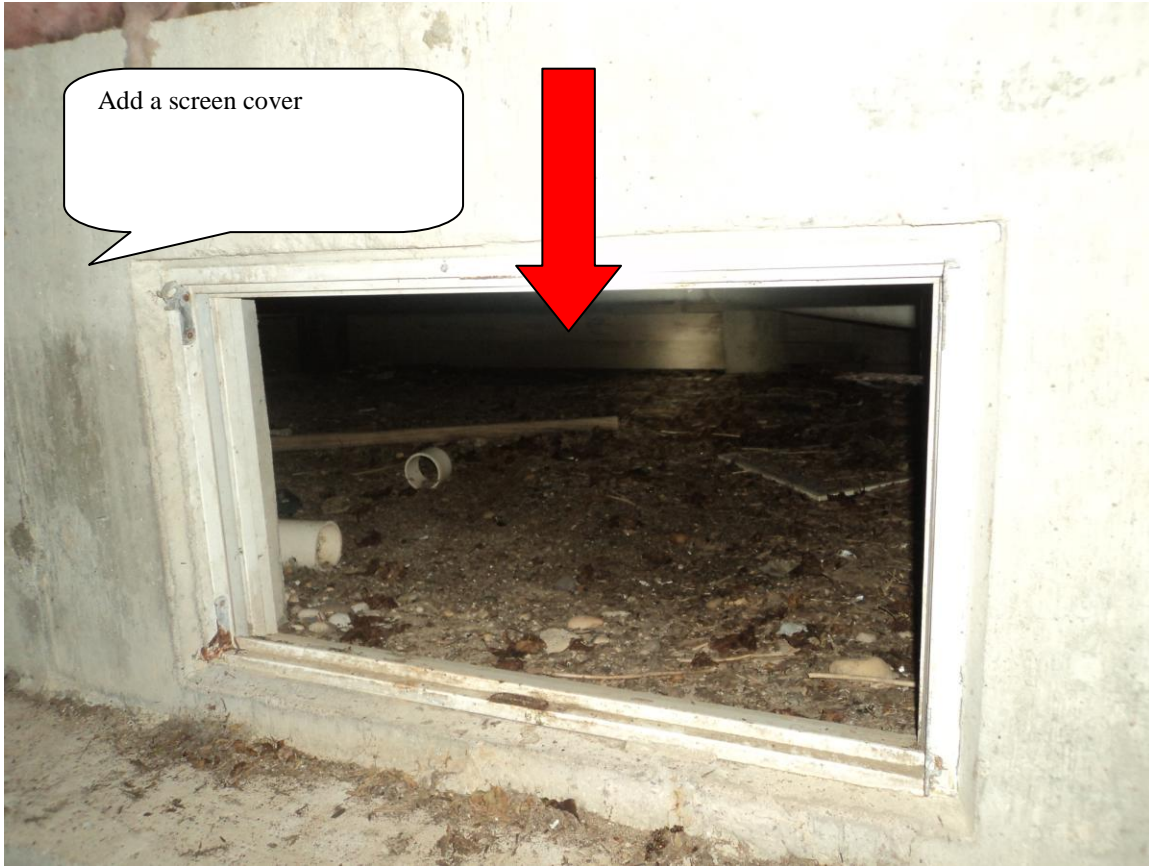
Mice droppings were noted in the crawl space of the house. The mice have damaged insulation under the house. My recommendation is to remove all the insulation under the house and have it replaced. Have a TYVEK cover installed over the insulation to then help keep rodents out. The rear crawl windows need to have screens to prevent rodents from gaining access from under the deck into the crawl.

Recommend treating the house for mice.

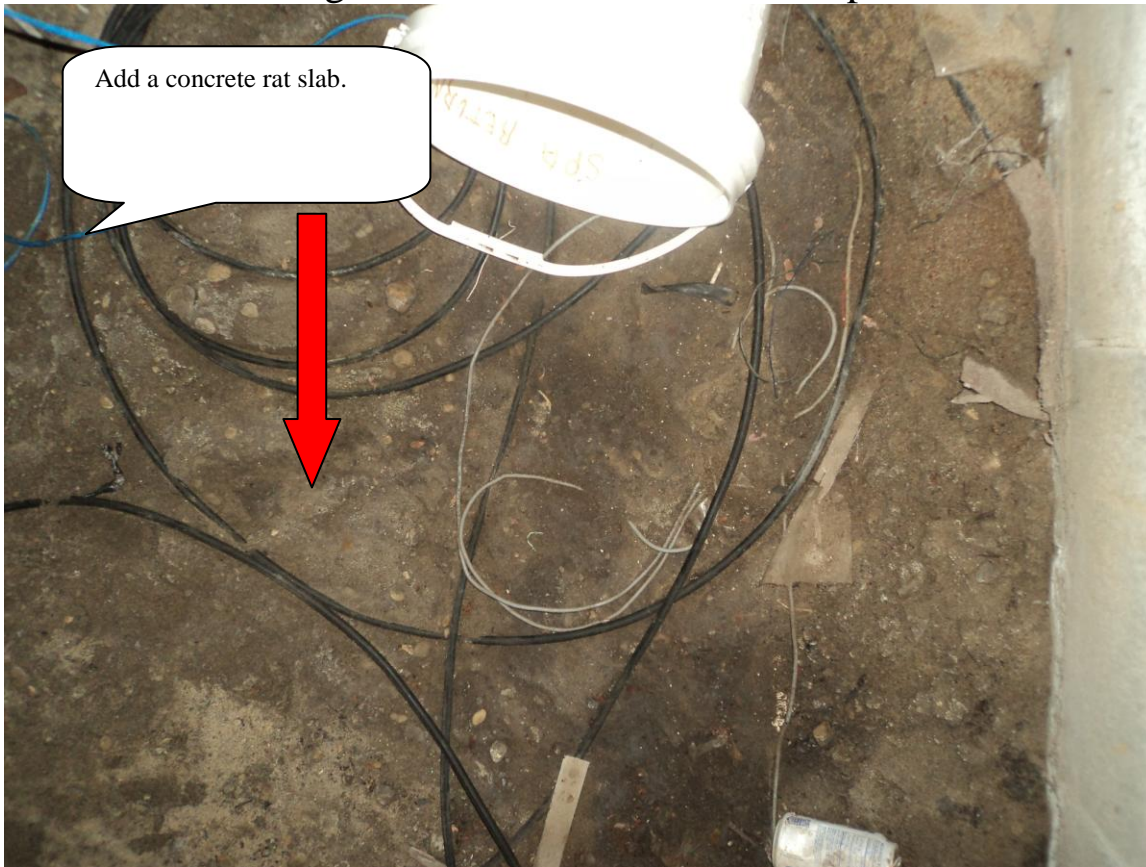
Recommend adding a concrete rat slab under the pool house.
