AC & E HOME INSPECTION CORP.

CONCLUSION

Cold Spring Harbor NY
09/21/2011

DESCRIPTION OF HOUSE: Manor house

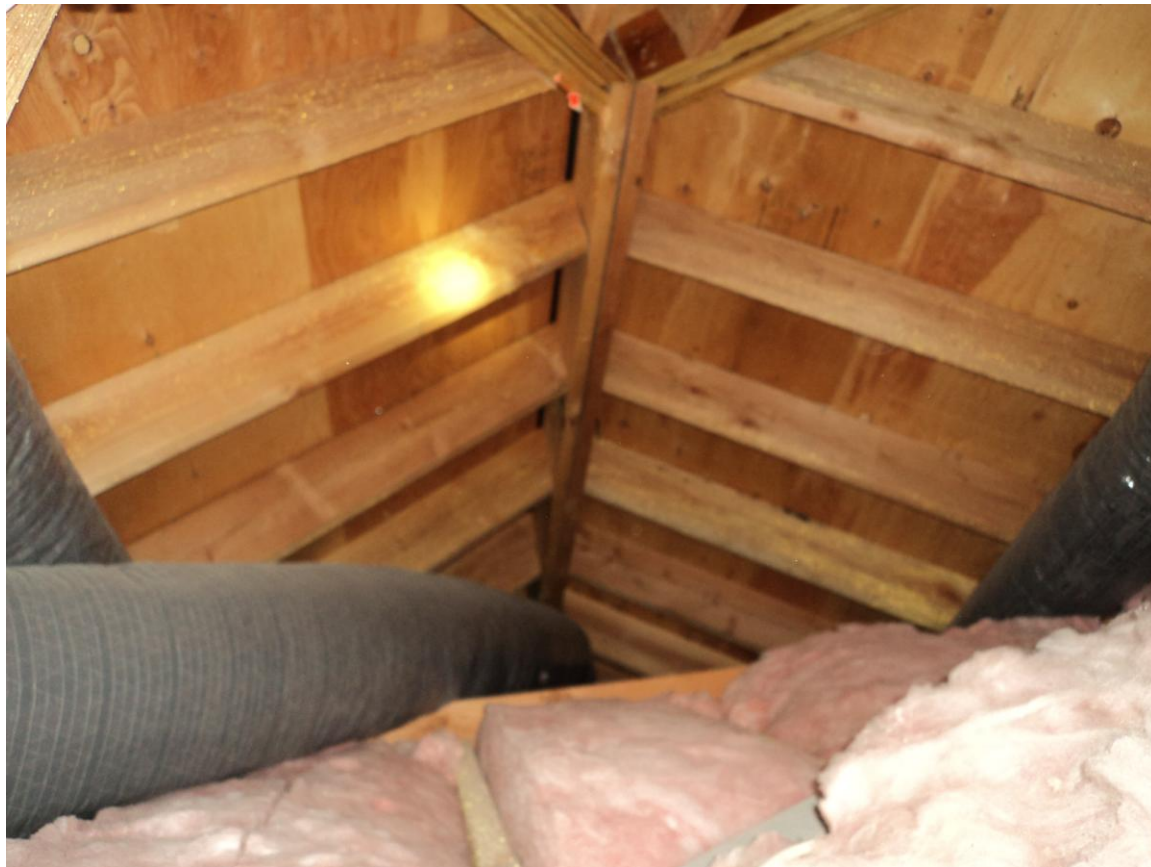
The roof on the pool house appears to be around 5 years of age and is an asphalt shingle roof. No leaks were noted in the pool house or in the attic of the pool house at this time.

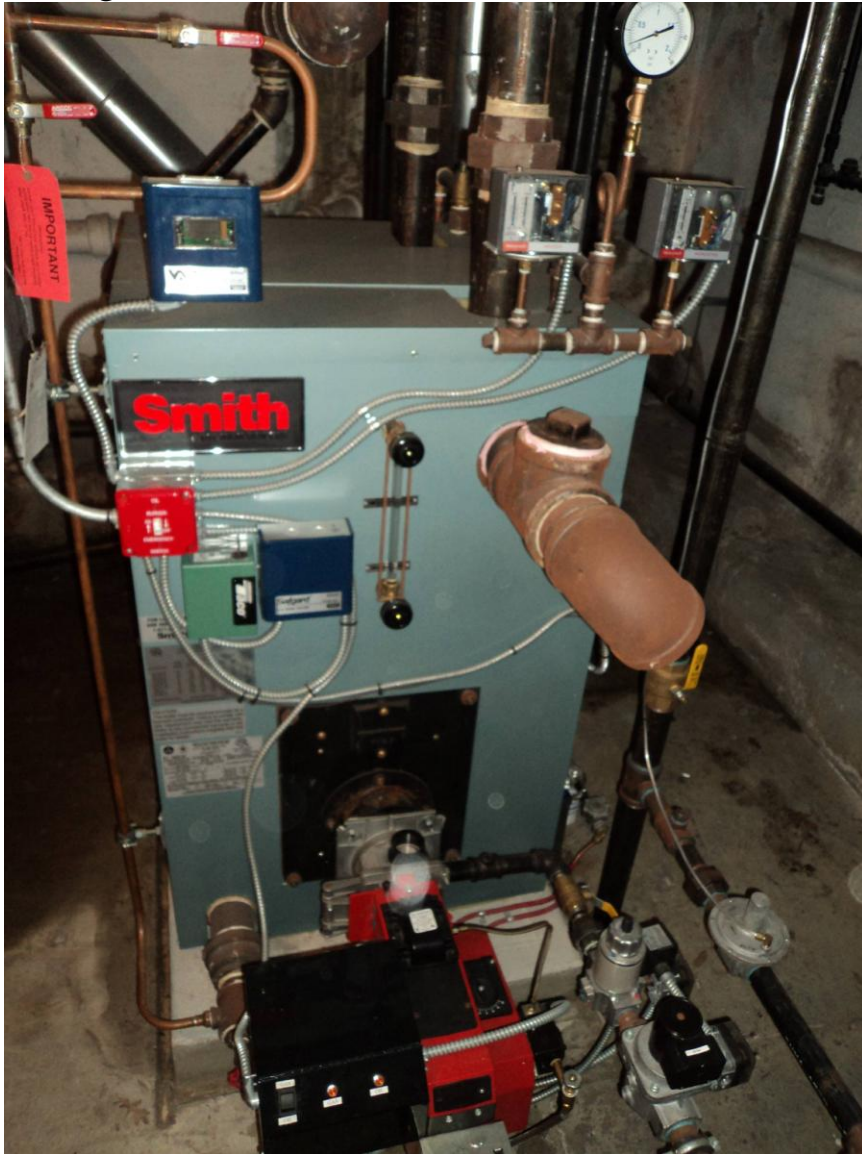
TYPE: The house is heated from a Smith dual fuel heating system (you can switch from gas or oil heat) with 375,000 btus and one zone.

RECOMMENDATIONS: Recommend having the unit serviced and maintaining a service contract. The heating system was **not** working at the time of the inspection. This system needs to be up and running and properly checked. All radiators in the house need to be tested.

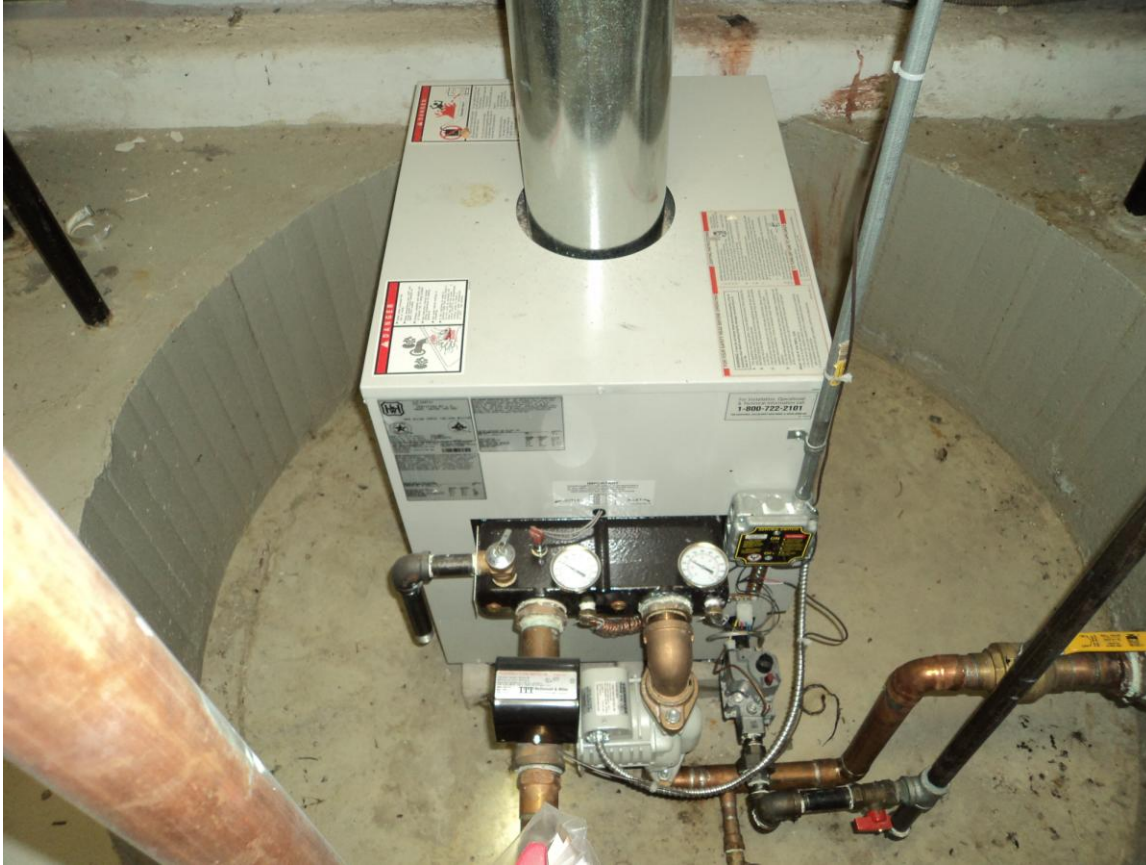
Currently, the hot water in the house is heated from a separate gas fired 180,000 btus gas fired boiler and then fed to what appears to be a 250 gallon storage tank. The system was working properly at the time of the inspection.

Recommend having the over pressure relief valve on the hot water boiler properly piped at this time as the pipe should have no threads at the discharge.

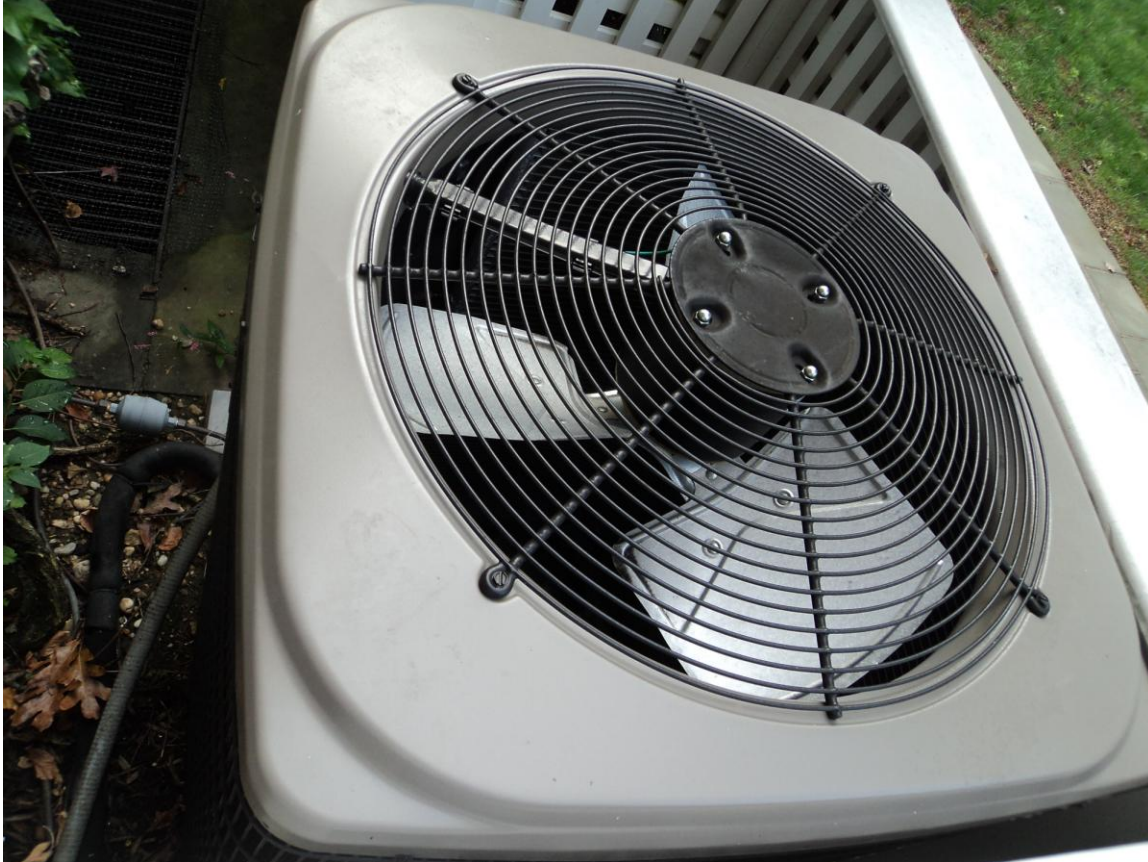
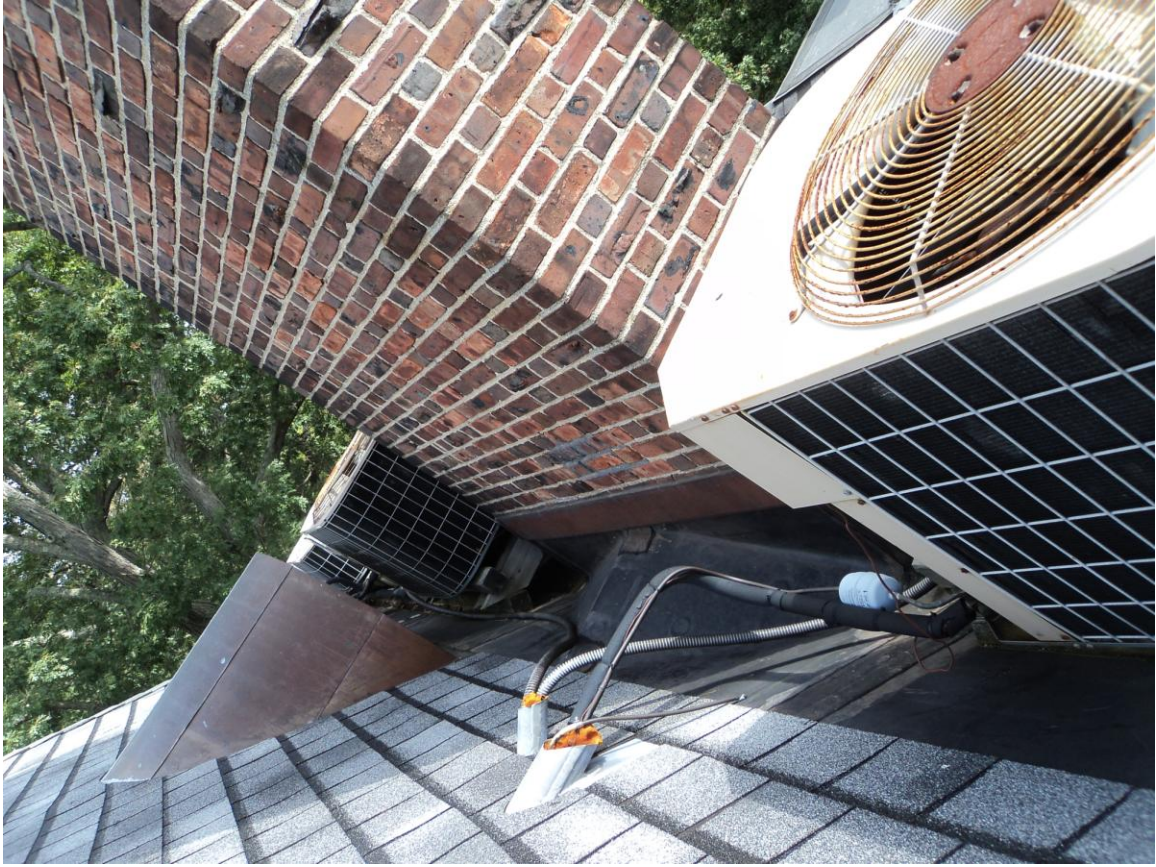
The air conditioning units were inspected and produced cool air with an average delta of 11 degrees at every register indicating that the unit is operating efficiently. The main house has a total of 4 air condition units. There is one unit in the rear of the house and 3 units on the roof.

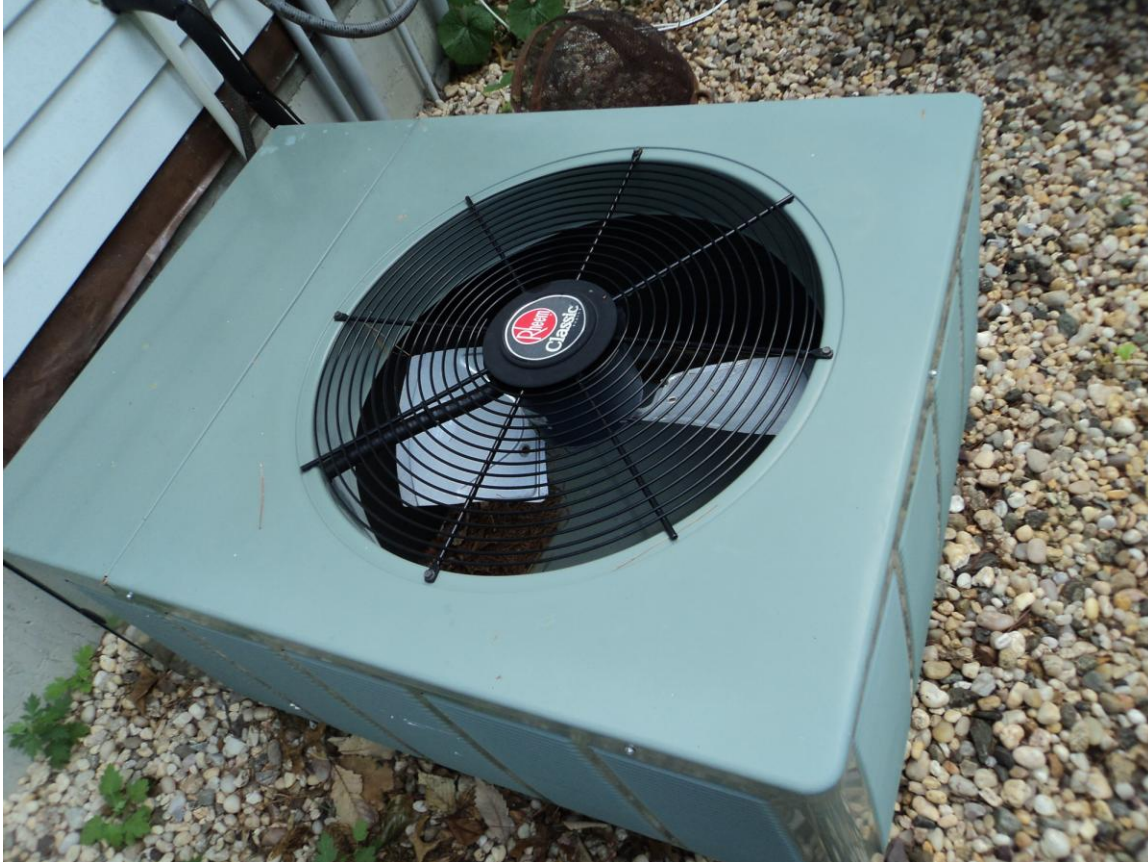
The Heat in the pool house was supplied from a Rheem electric heat pump the unit was found to be working properly at the time of the inspection. The air condition in this location was tested as well and found to be producing an 11 degree delta and working properly.

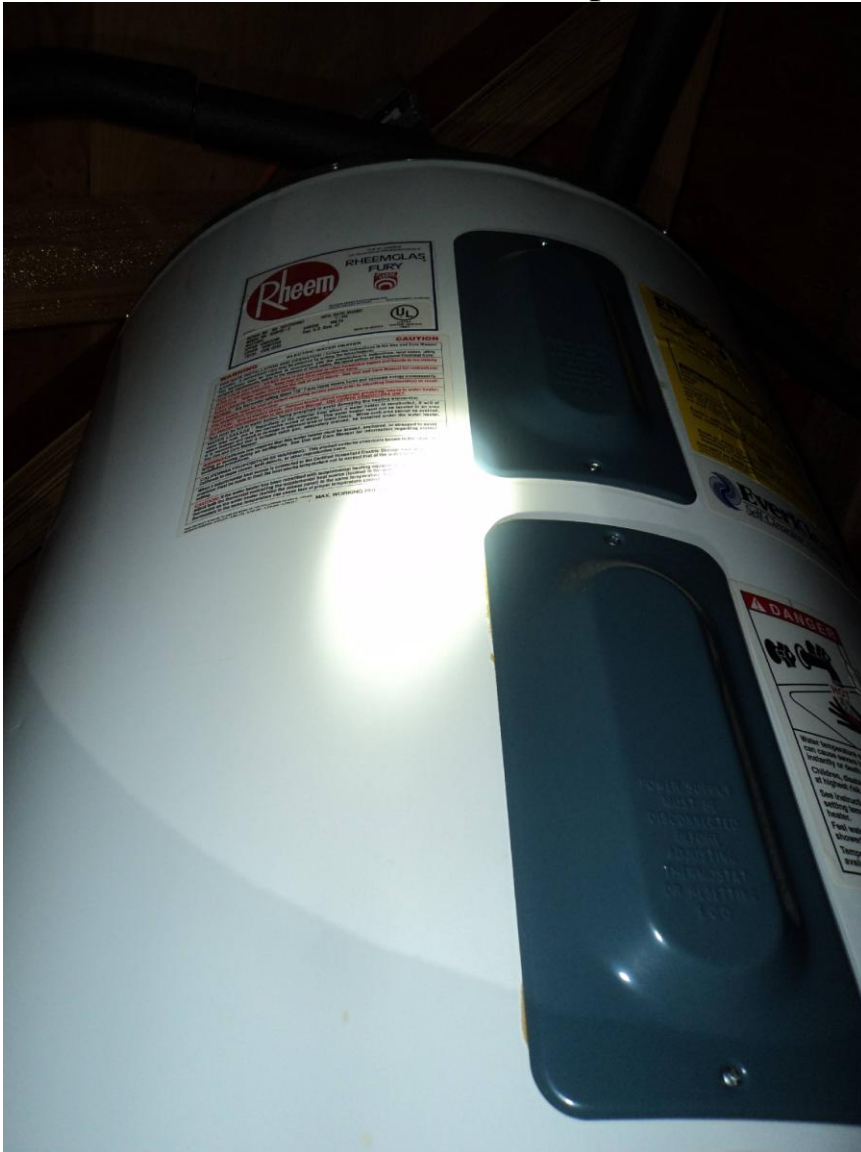
The hot water in the pool house was fed from a 47 gallon electric hot water heater and was found to be working properly at the time of the inspection. This hot water heater is located in the attic of the pool house.

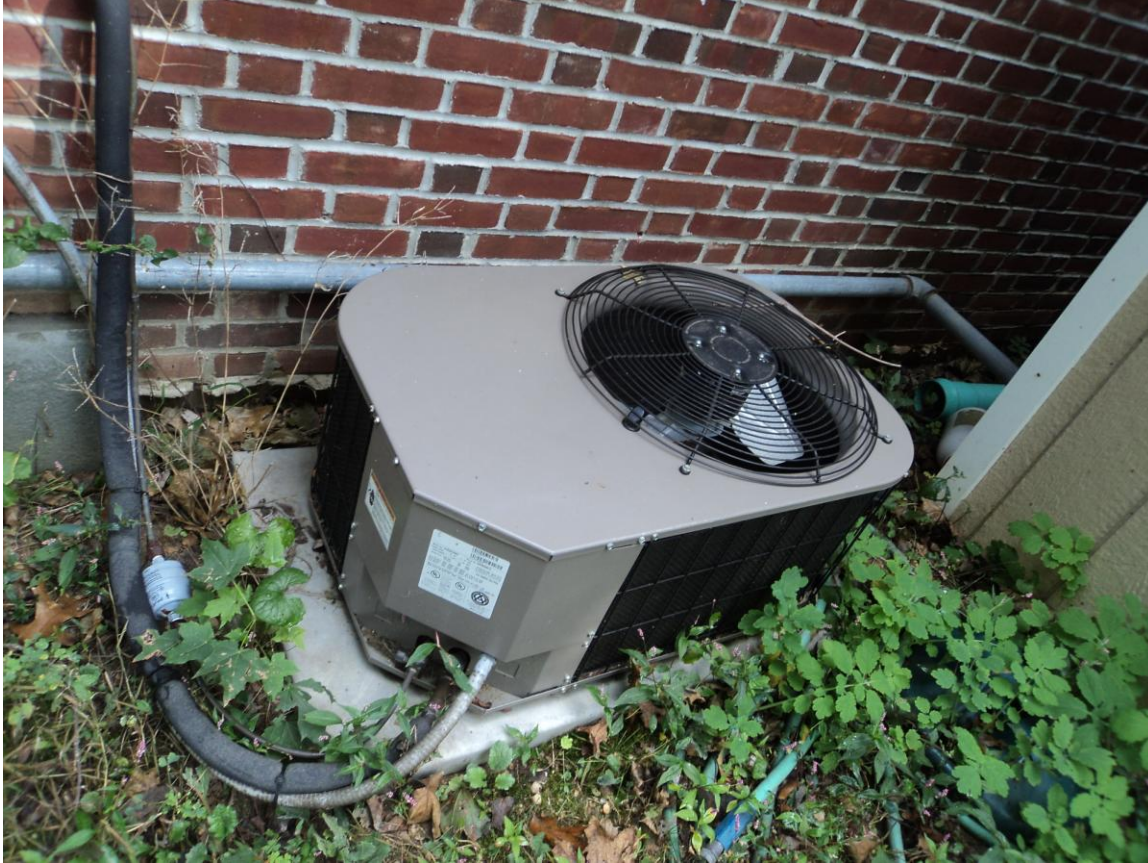
The heat in the room above the garage was fed from a York gas fired 80,000 btus forced hot air system. The system was tested during the inspection and found to be working properly. The air condition in the room above the garage was tested during the inspection and was found to be working properly with an 11 degree delta.

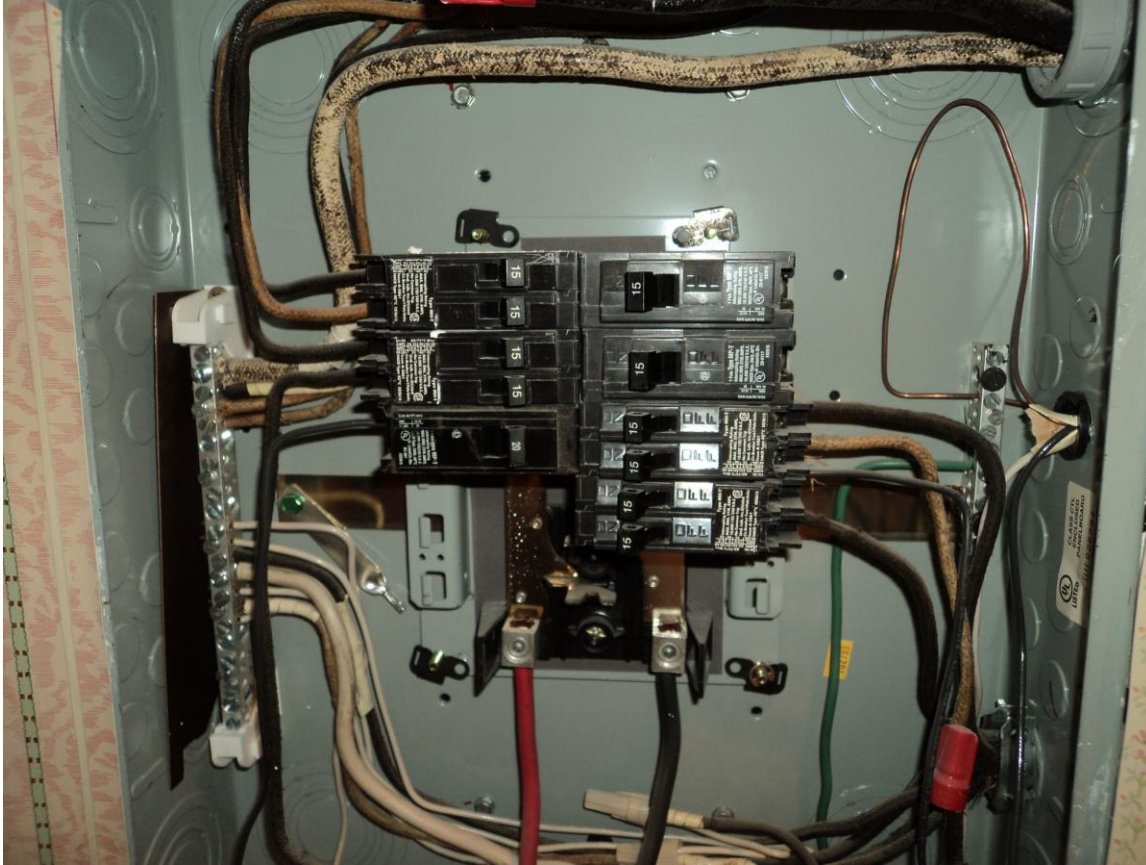
There was a sub panel located on the 2nd floor of the house with 11 breakers.

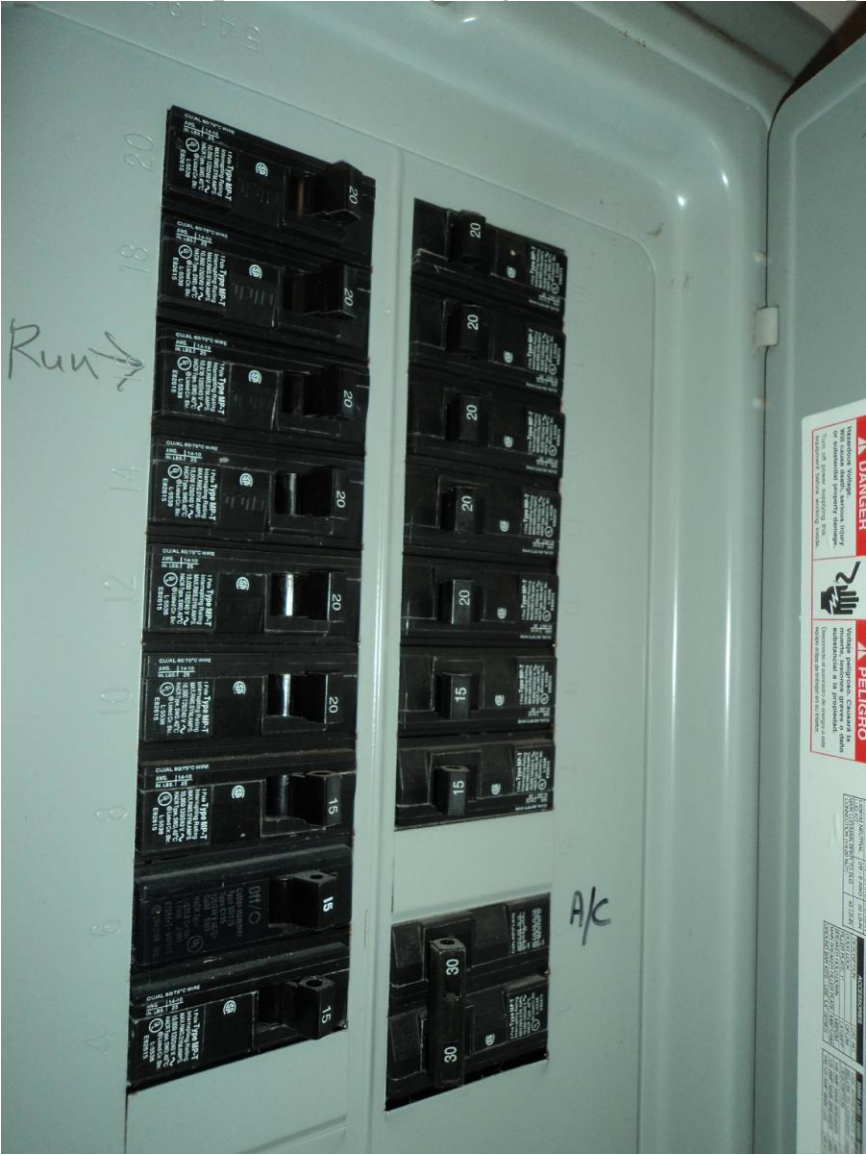
The electric panel in the garage was a 17 breaker panel fed from the main house.

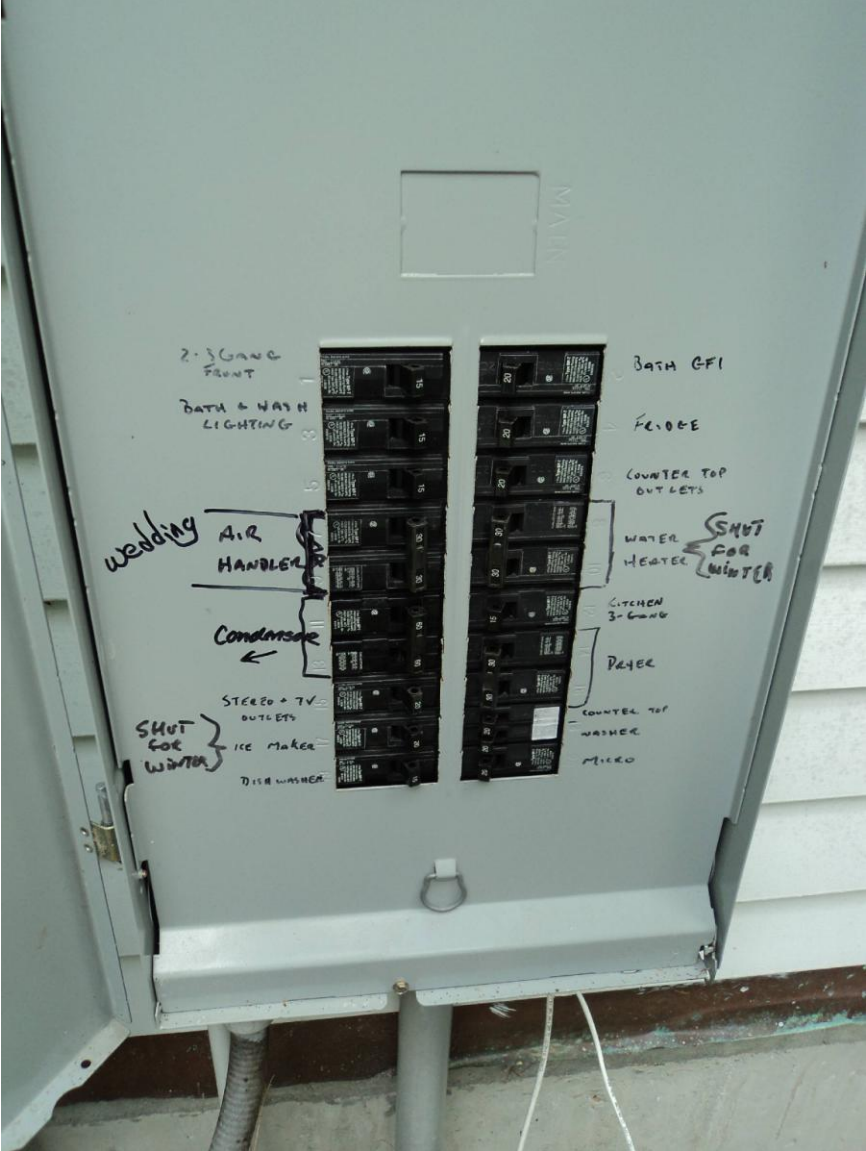
The electric in the pool house was fed from the main house. This panel is a 125 amp panel located in the rear of the pool house with 17 breakers.
