# **AC & E HOME INSPECTION CORP.**

## **CONCLUSION**

12/10/2011

DESCRIPTION OF HOUSE: Two Story

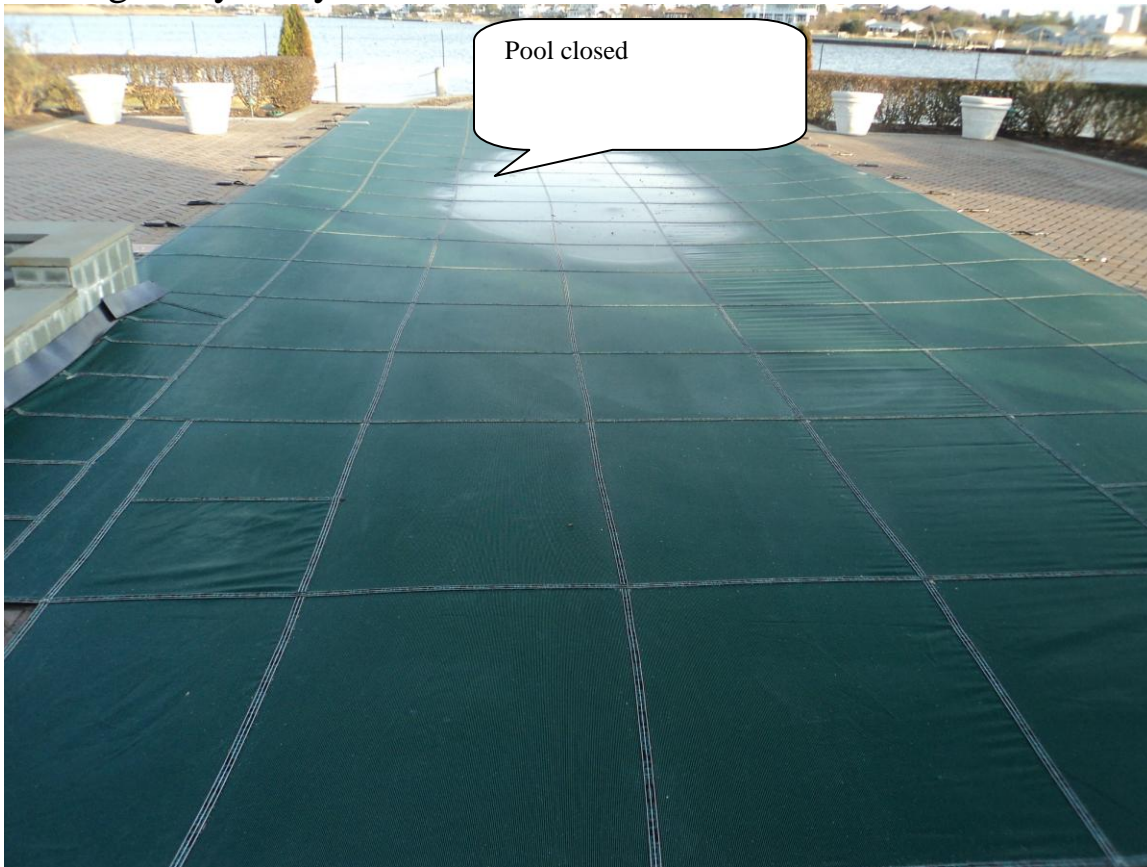
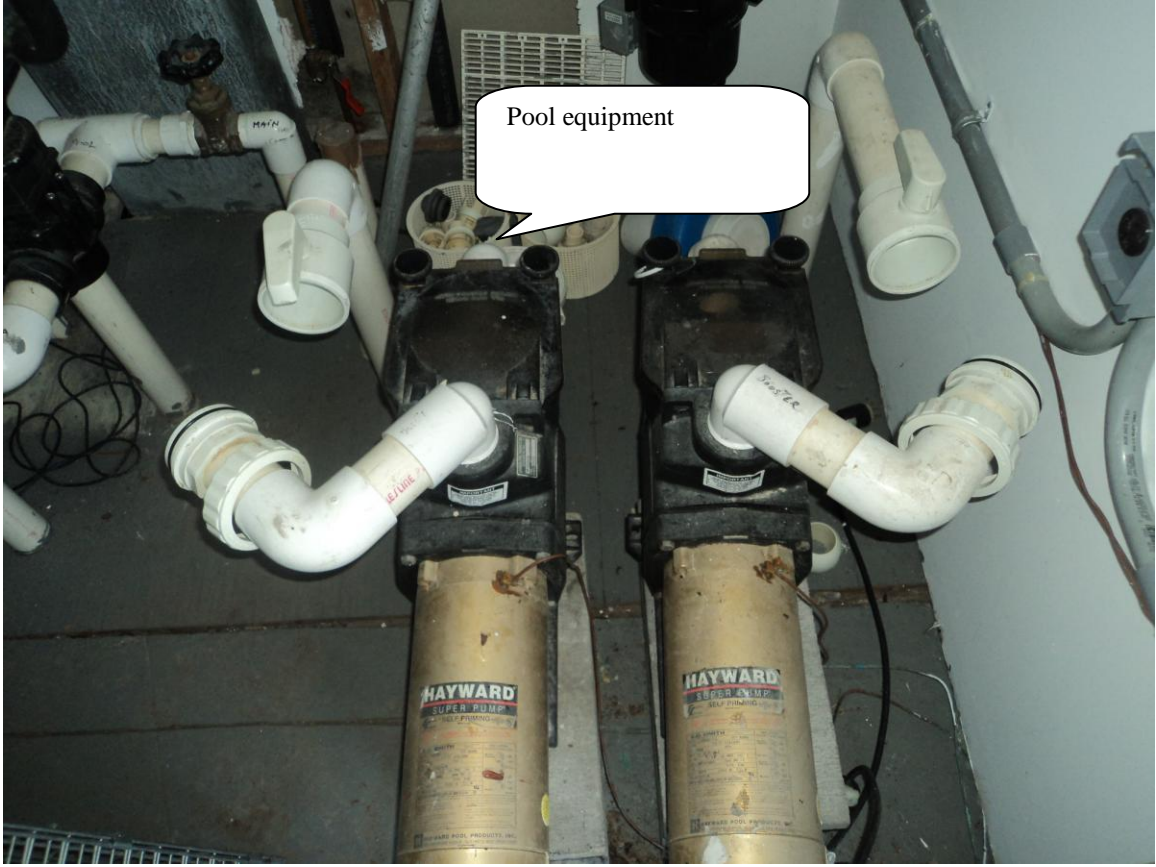
Pool equipment

An in-ground pool is present in the rear yard. On day of inspection, the pool was covered for winter making it inaccessible for a visual evaluation. Recommend the current homeowner verify that the pool (i.e., liner, filter, pumps, heaters (heat exchanger) etc.) is in proper working order and free of leaks. If the pool is a gunite pool recommend checking on the last marble dusting? All gunite pools require re-dusting every 6-7 years.

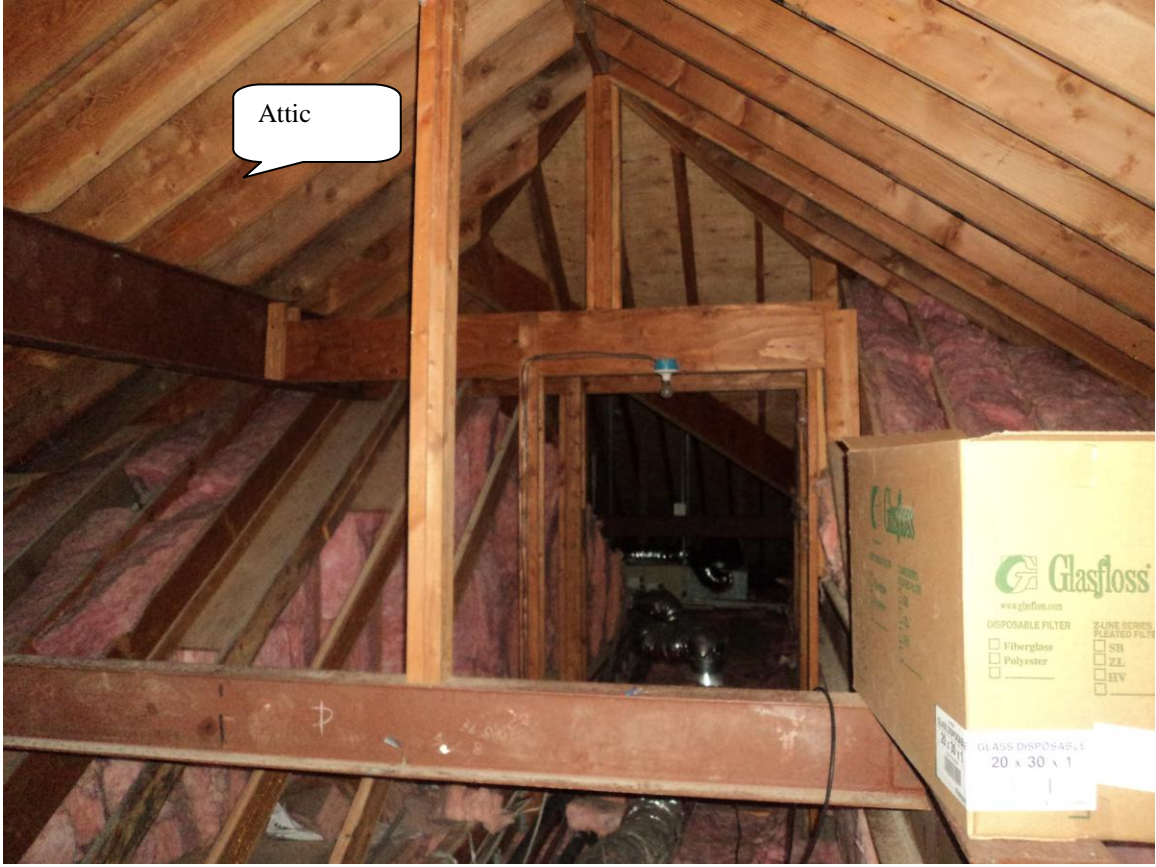
Attic

**RECOMMENDATIONS:** A thorough inspection was made from the roof area from the outside, and where visible from the inside. The roof did appear to be leaking at this time.

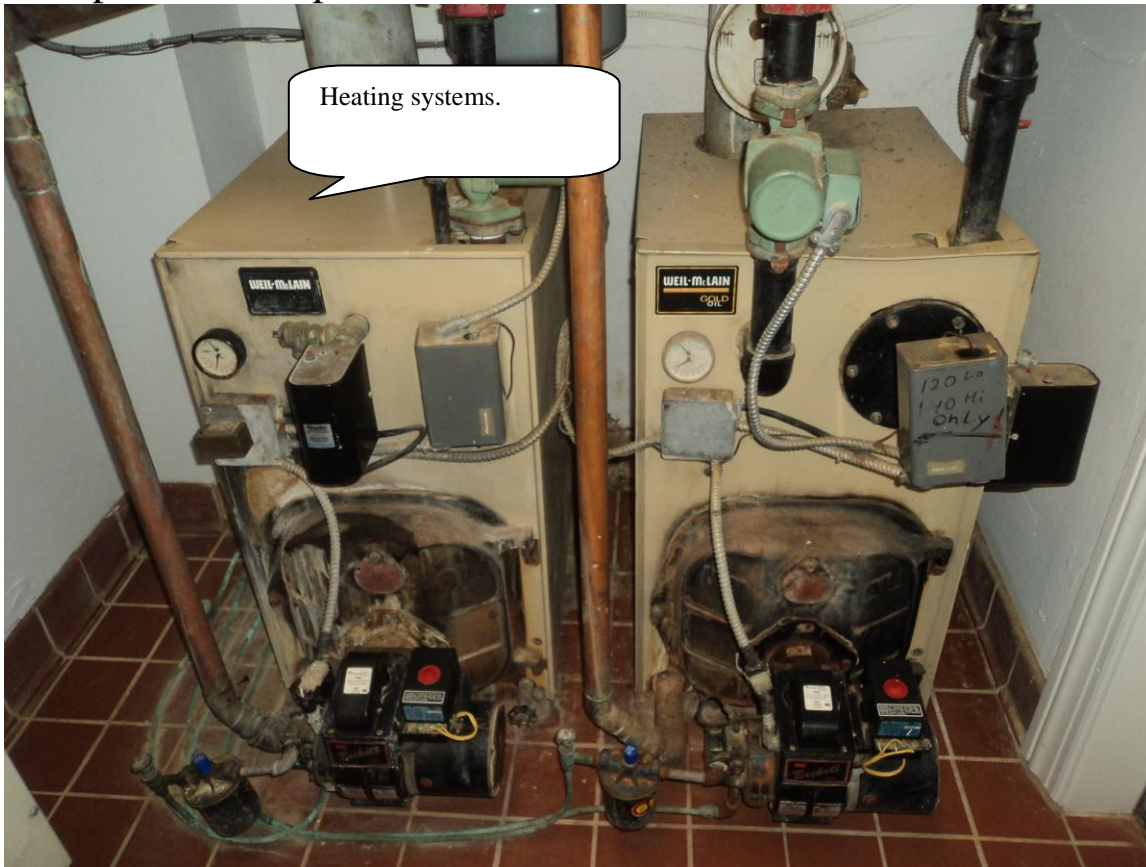
TYPE: Weil Mclain oil fired hydronic forced hot air fed from 2 ea 249,000 btus systems. The systems feed the house and are used for the heat exchanger for the pool and spa heat. The pool house does not have heat.

Inspection of the heating systems shows damage to both internal firebox protective wraps on the heating systems. Recommend having both heating system fireboxes re-wrapped at this time. Failure of this can cause the boiler cores to crack.

RECOMMENDATIONS: Recommend having the units serviced and maintaining a service contract.

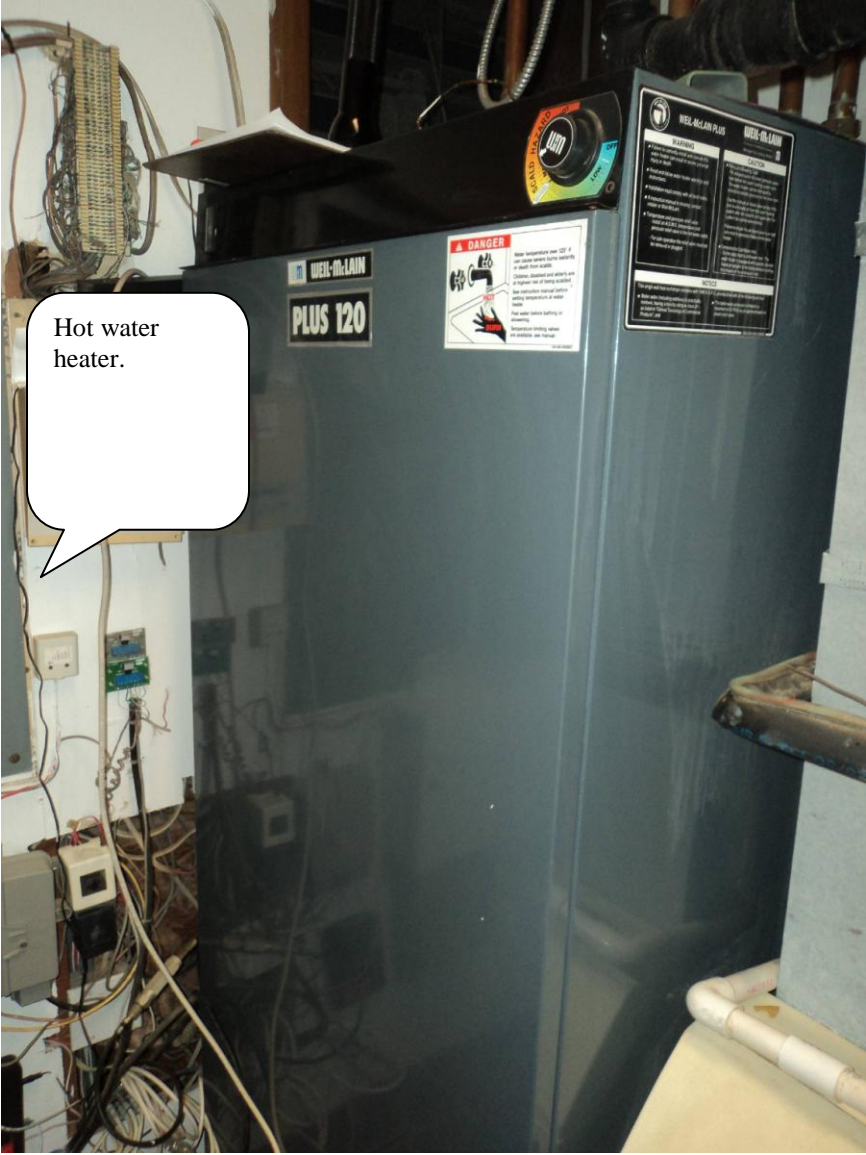
Recommend repairing the pin leak on the pipes leading into the hot water heater at the top.
